**IDENTIFICATION OF COATING DEFECT WITH THE HELP  
OF CLOSE INTERVAL POTENTIAL LOGGING (CIPL) &  
DIRECT VOLTAGE GRADIENT (DCVG) SURVEYS TO  
UNDERTAKE REPAIRS**

**“IDENTIFICATION OF COATING DEFECT WITH THE HELP OF CLOSE  
INTERVAL POTENTIAL LOGGING (CIPL) & DIRECT VOLTAGE GRADIENT  
(DCVG) SURVEYS TO UNDERTAKE REPAIRS”**

(Pipeline Engineering)

GAIL (India) Limited

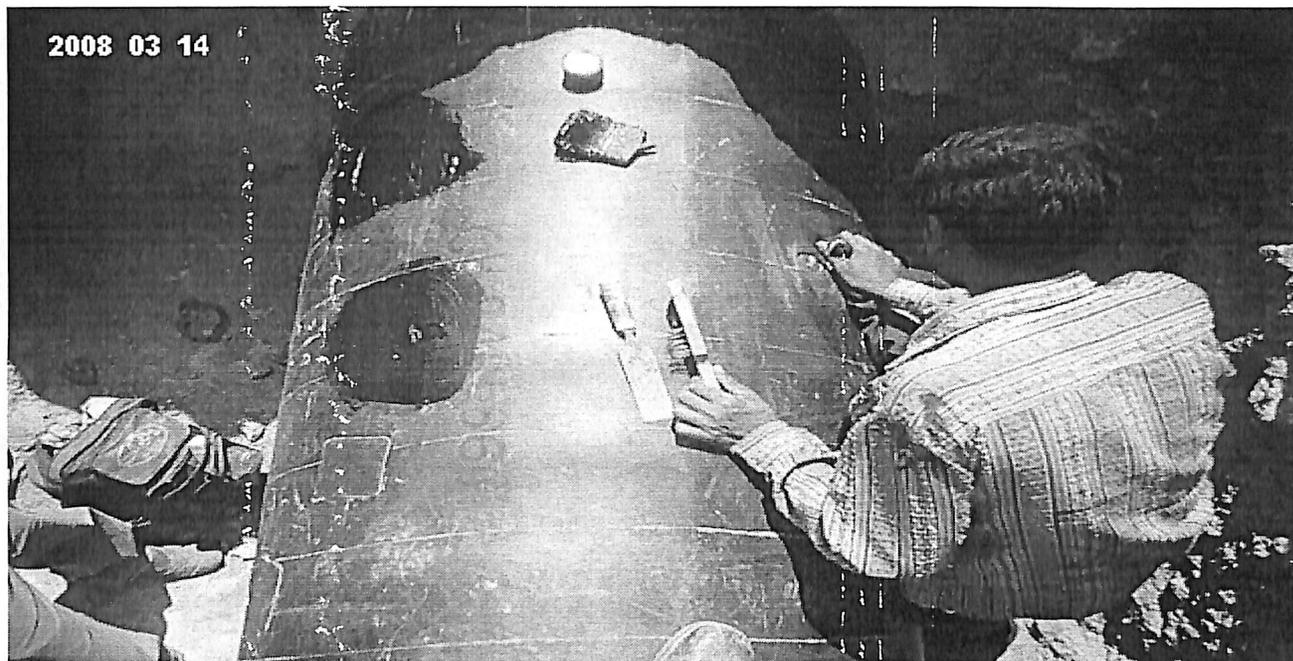
**Photo1: Minor defect: chainage 306.813: Patch repair**

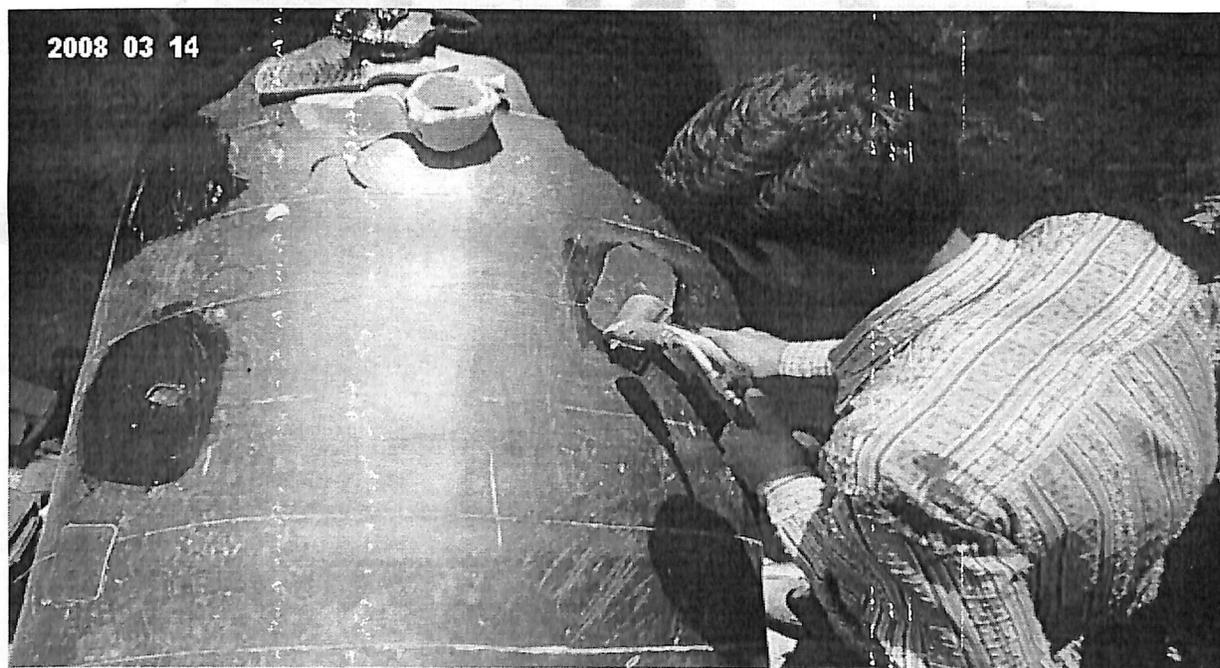
**Photo2: Minor defect: chainage 308.498: Patch repair**

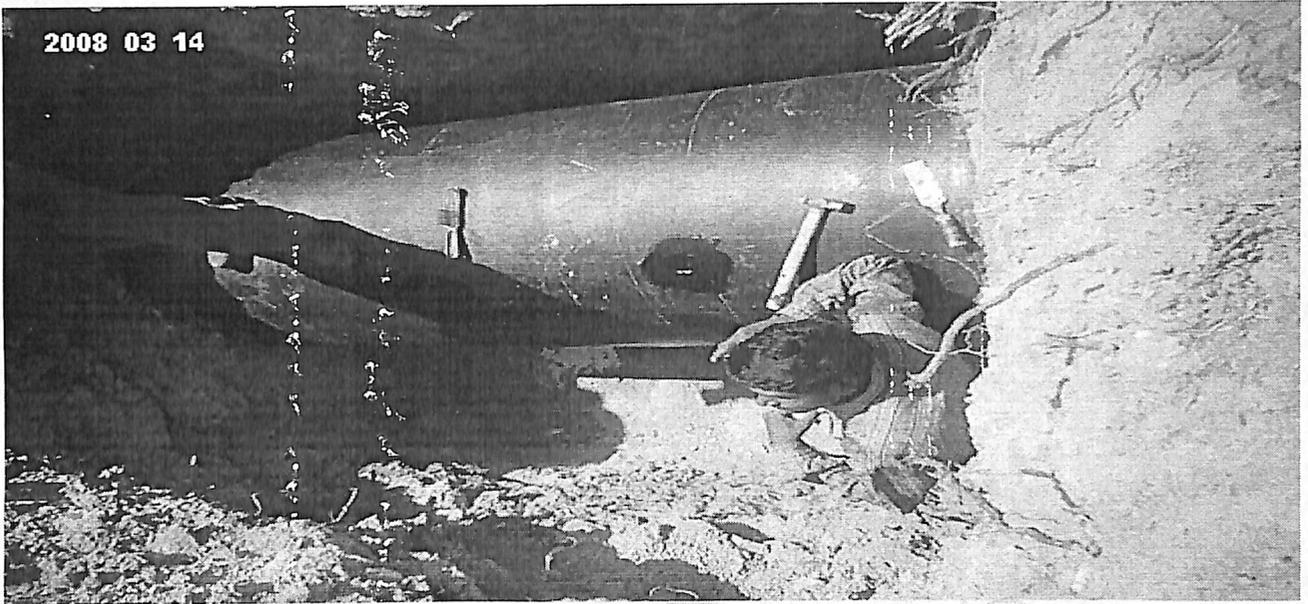
**Photo3: Minor defect: chainage 308.645: Patch repair**

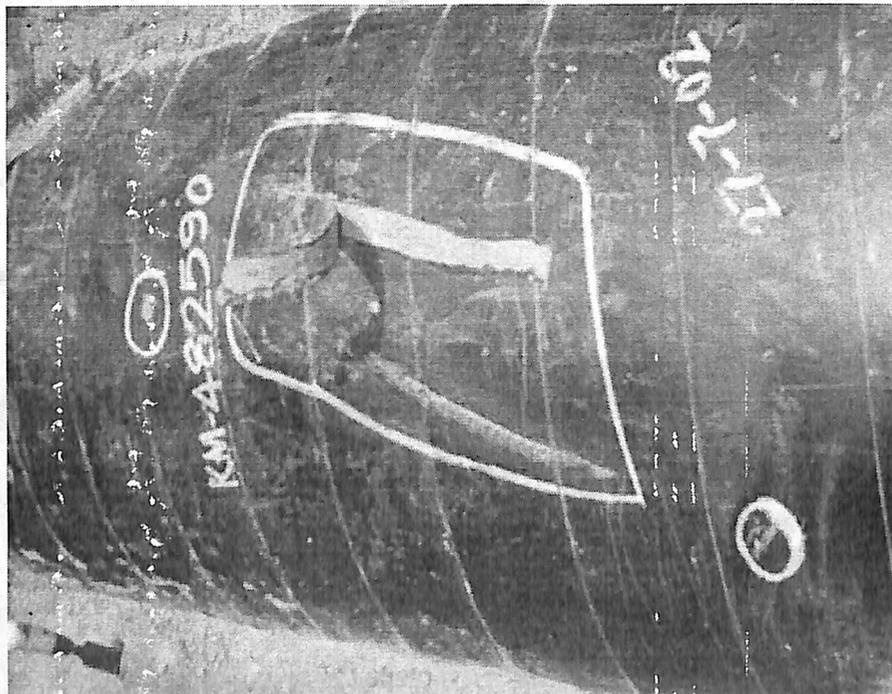
**Photo4: Major defect: chainage 307.453: Cold Tape repair**
