CHAPTER 3

ENGINEERING ANALYSIS & ASSESSMENT OF EXISTING WATERMILLS

Analysis & Redesigning of Watermills for Sustainable Development of Rural Areas of Uttarakhand

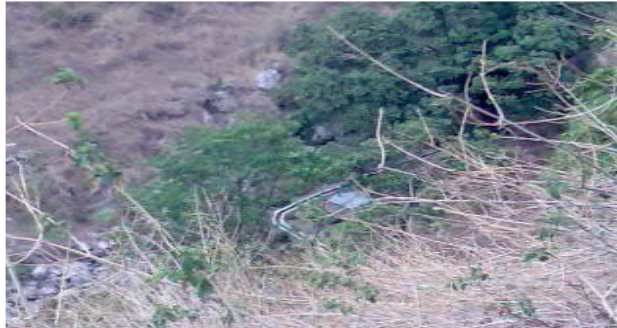
- Majority of watermills are defunct due to maintenance problems.
- The distance of watermill from village and the road head make the owner disinterested in operating and maintaining the watermill.

(Fig 3.2: Photograph of a watermill taken just below the road head at Pipalkoti, Chamoli dated 22.06.2008)

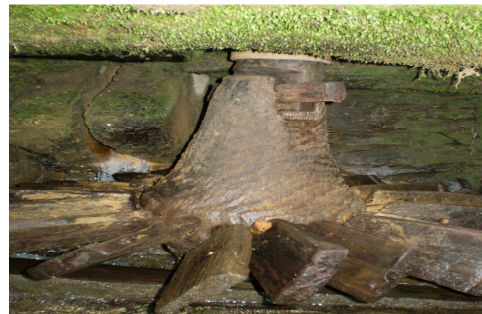
- Heavy weight of wooden turbine causes low RPM and hence low output per hour.
- Mis-match by fabricating heavy turbine vis-a-vis available hydro power potential (head, flow etc)

Fig 3.3: Traditional runner of a watermill at Ukhimath dated 23.06.2008)

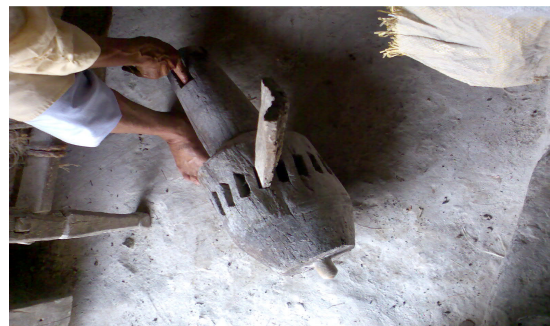
- Wooden runner and blades get damaged quite frequently. Blades come out of runner.

(Fig 3.4: Miller showing his damaged runner of a watermill at Ukhimath dated 23.06.2008)

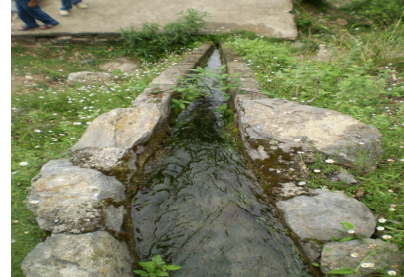
- Use of open channel made up of stones as penstock causing loss of head due to friction, spillage of water.
- Unavailability of screen at entrance of channel causing trash and boulders to be carried up to turbine.
- Deposition of elegy and growth of plants in channel causes loss of head.

(Fig 3.5:Open penstock of a watermill at Chakrata dated 18.06.2008)

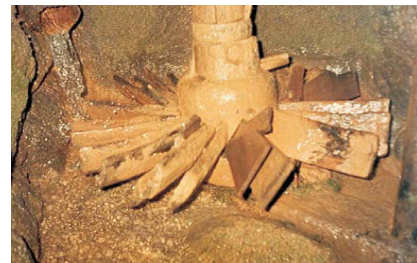
- Improper angle of penstock nozzle, causing imperfect strike of water on turbine blade. Damaged penstock nozzle causing water to spill all over.

(Fig 3.6:Damaged Penstock Nozzle at a Watermill at Bhatwari dated 20.06.2008)

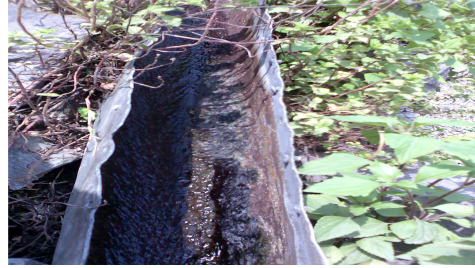
- There was breaching of the open channel just before the fore bay tank which reduced the discharge.

(Fig3.8:Breached Channel at a site in Bhimtal dated 28.06.2008)

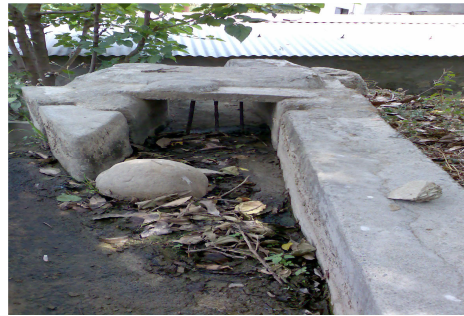
- The channel is situated just downhill the road, so the slope lead to the direct dropping of leaves and other waste materials in the channel.
- This garbage material was blocking the way of penstock

(Fig3.9:Trash accumulation at a site in Almora dated 29.06.2008)

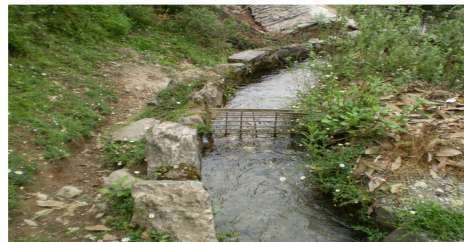
- The screening of materials has the temporary adjustments with wooden trap which was not efficient.

(Fig3.10:Wooden Screen at a site in Almora dated 29.06.2008)
