**IDENTIFICATION OF COATING DEFECT WITH THE HELP  
OF CLOSE INTERVAL POTENTIAL LOGGING (CIPL) &  
DIRECT VOLTAGE GRADIENT (DCVG) SURVEYS TO  
UNDERTAKE REPAIRS**

**“IDENTIFICATION OF COATING DEFECT WITH THE HELP OF CLOSE  
INTERVAL POTENTIAL LOGGING (CIPL) & DIRECT VOLTAGE GRADIENT  
(DCVG) SURVEYS TO UNDERTAKE REPAIRS”**

(Pipeline Engineering)

GAIL (India) Limited

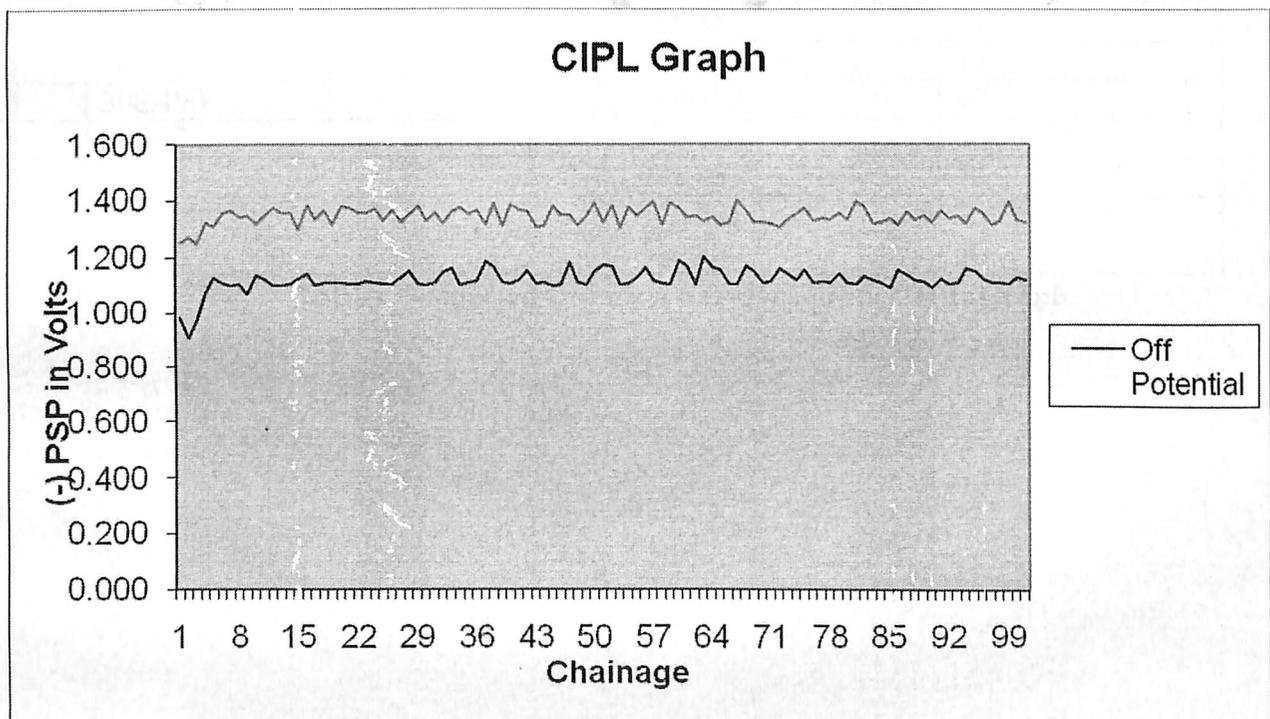
Fig.4.1 CIPL Graph

Now all reading regarding to 10 km should be taken. Now graph will be plotted in respect to these reading.

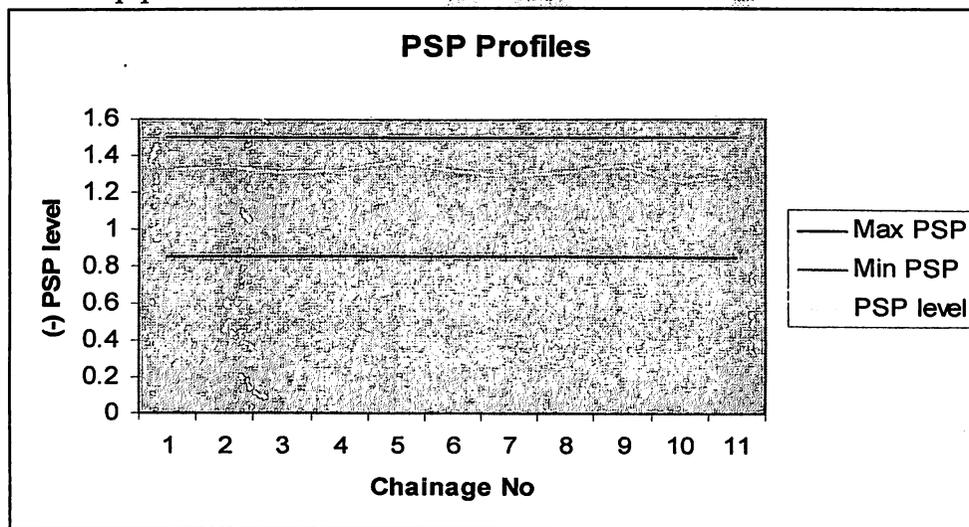
**Fig 5. i PSP profiles from 300.0 Chainage to 310.0 Chainage**

Before these survey starts we record the data from given instrument, its PSP level is measured, line temperature, pressure these does not effect on external environment. PSP recorded quarterly, this gives the overall view of pipeline.
