**Study of Rejuvenation Heat Treatment for Life
Extension of A-286 Gas Turbine Wheels**

Submitted
**IN PARTIAL FULFILLMENT OF THE REQUIREMENT OF
THE DEGREE OF DOCTOR OF PHILOSOPHY**

**UNIVERSITY OF PETROLEUM AND ENERGY STUDIES
DEHRADUN**

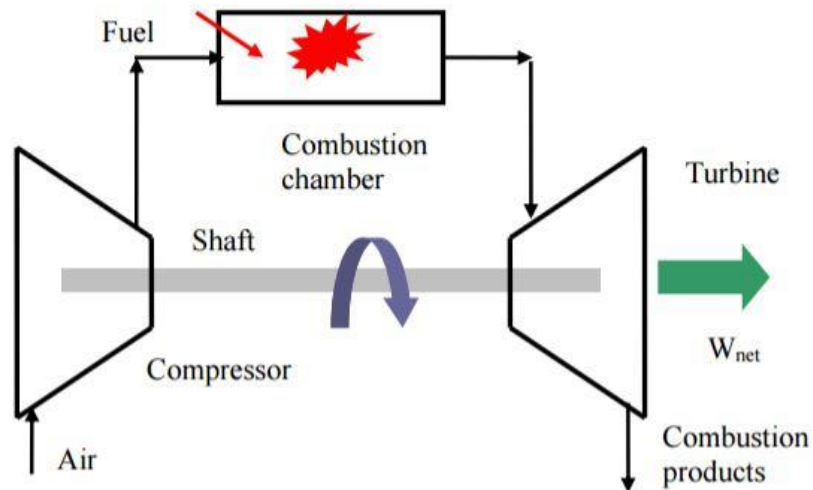
Figure 1.1: Schematic diagram of a gas turbine

Apropos to the earlier mentioned relevance, it is now important to understand the basics of a gas turbine. A gas turbine can be classified as an internal combustion engine. The operating principle of a gas turbine is based on the Brayton cycle. In this cycle, fuel and compressed air are mixed together at a constant pressure and combustion takes place. At the room temperature, the air enters through the compressor end. In the compressor section, the pressure and temperature of the air is increased. The increase in air pressure and temperature depends on the capacity of the gas turbine. Then the high-pressure air passes through the combustion chamber, wherein the combustion of the fuel occurs at a constant pressure. Then the combustion gases present at high temperatures and pressures enter the turbine section. The combustion gases then expand to working pressures and emit energy or the required work [24]. A schematic diagram of the gas turbine is shown in Figure 1.1., and the working principle is explained in the next section.

The gas turbine primarily consists of a compressor section, combustion chamber, and a turbine section (Ref Fig 1.1). The gas turbine commonly comprises of a single shaft onto which the compressor and turbine are mounted. The rotor consists of a set of compressor wheels on which the compressor blades are mounted. This single shaft rotor normally rotates at 3,600-6,000 rpm [24]. Thus, a typical gas turbine consists of a generator, compressor, fuel injector, combustor, turbine and heat exchanger as shown in Figure 1.2.

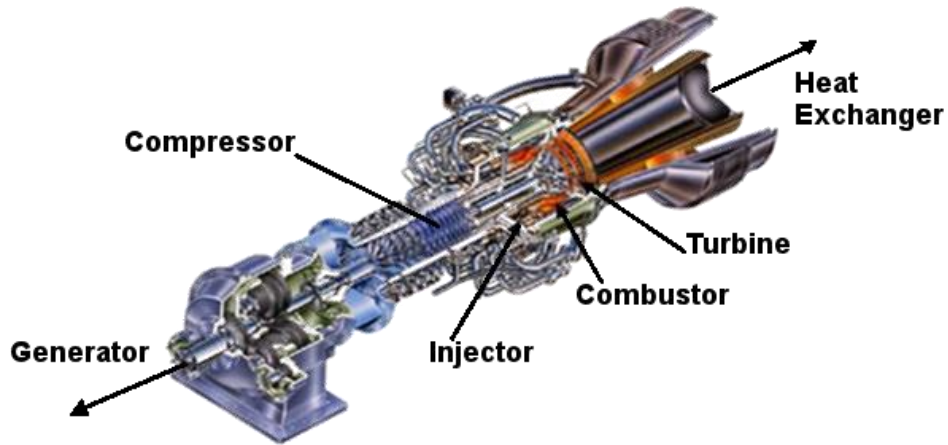
Figure 1.2: Different sections of gas turbine (Source: conservatoryhub.com)

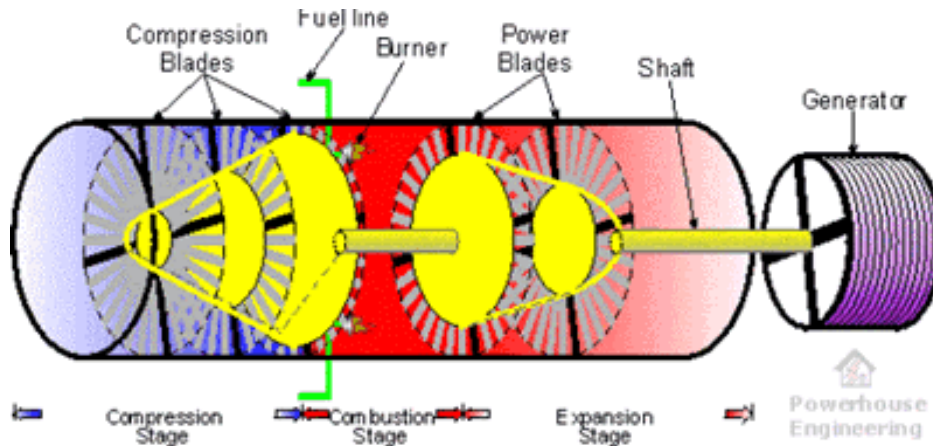
Furthermore, the turbine section consists of a turbine wheel, on which the vanes are mounted as shown in Figure 1.3.

Figure 1.3: Various components of a gas turbine (Source: powerhouseengineering.com)

During the compression stage, the air enters the compressor section and gets compressed by the compression blades of the first stage compressor wheel. The approximate compression is 25 times that of the original volume. This compressed air continuously propagates ahead to other stages and is further compressed to much lower volume (represented by dark blue in Figure 1.3). As the air is further compressed to reduce volume, it takes the shape of the turbine (shown as yellow cone in Figure 1.3). This compressor end is often referred to as the cold section.

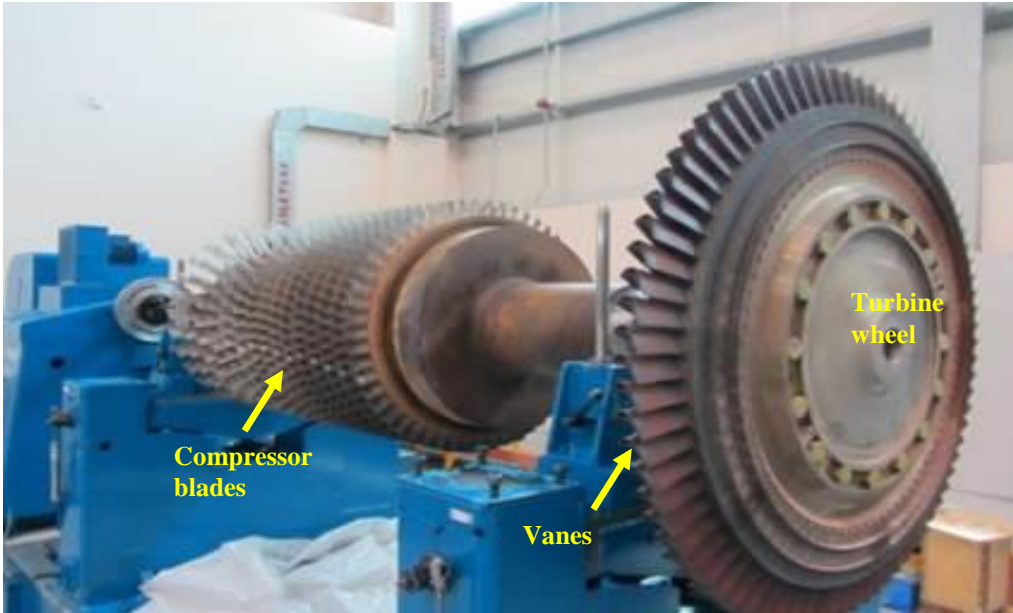
At this stage, it is important to understand the configuration of the turbine rotor assembly, as the focus of this research is the life extension of the A-286 gas turbine wheel. The turbine wheel is a part of the rotor assembly. The rotor consists of a compressor end and the turbine end. The compressor end consists of a rotor and has different stages. Each stage consists of a compressor wheel and there are in total 16 such stages. The compressor wheels are normally made of Cr-Mo steel or Ni-Cr-Mo steel. The compressor wheels have dove tail slots on which the compressor blades are mounted. The material of the compressor blades is SS 403 (12% Cr, 0.15% C, 1% Mn, 0.05% Si, Balance Fe). The turbine section comprises of a turbine wheel, and is made of A-286 (25% Ni, 15% Cr) or M152 (12% Cr, 2.5% Ni) material for Frame 3002 and Frame 5002 gas turbines. On the turbine wheel, vanes are mounted and that are made of GTD 111 or IN 738 (15% Cr, 9.5% Co, 3.85%W, Ni-balance) nickel based alloys. The Frame 5002 rotor assembly is shown in Figure 1.4.

Figure 1.4: A Frame 5002 rotor assembly (Source: Masaoood John Brown Rotor Workshop, Dubai)

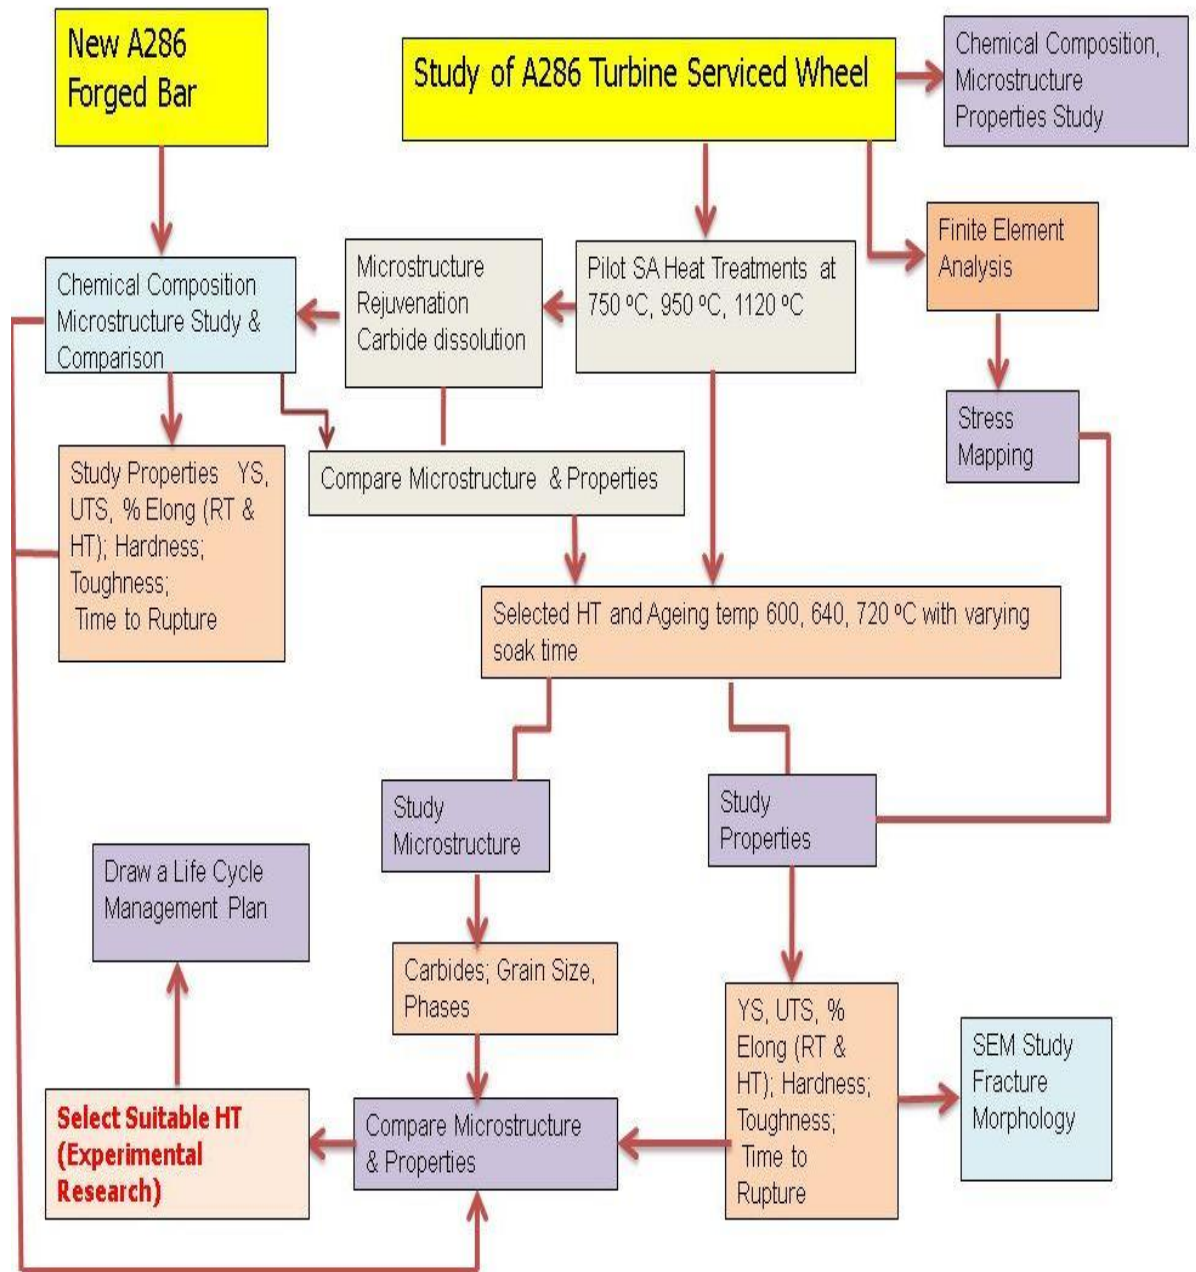
- Microstructural evaluation, hardness testing and Energy Dispersive X-ray Analysis (EDAX) shall be carried out on the serviced wheel section to study the transformations.
- Pilot heat treatments will be conducted on the serviced turbine wheel sections. The pilot heat treatments will comprise of solution annealing at 750°C, 950°C and 1120°C respectively. Based on these results further heat treatments such as solution annealing and age hardening with variations in holding time shall be carried out.
- After each individual heat treatment, the specimens shall be taken for the various destructive testings.
- The results after each heat treatment will be compared with the new forged A-286 bar results. The heat treatment with the best rejuvenated microstructure and properties shall be selected, after comparison.
- The research methodology is outlined in Figure 1.5.

Figure 1.5: Outline of Research Methodology

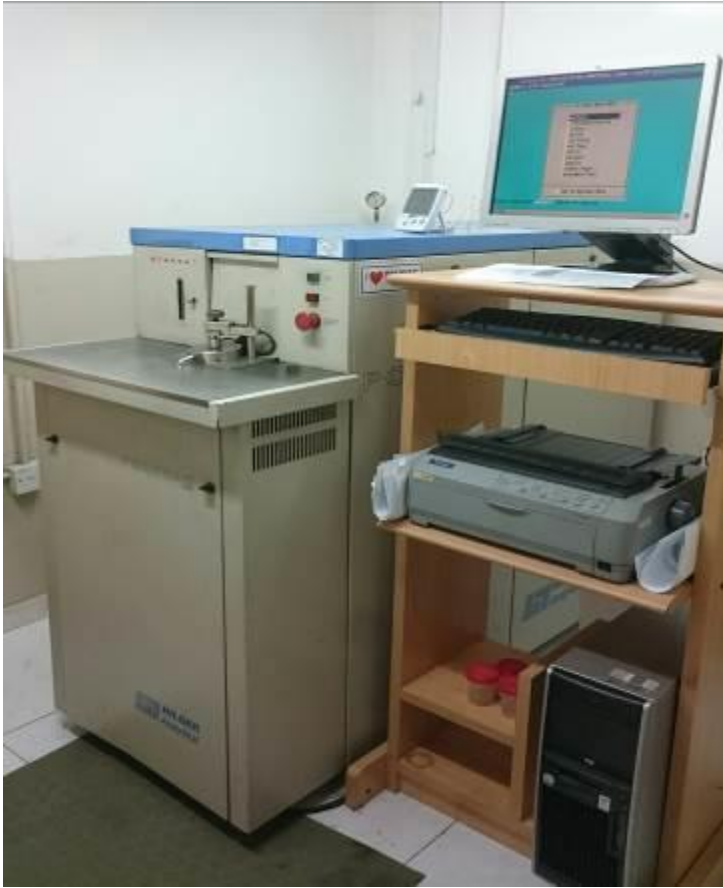
An OES, Make-HILGER Analytical, United Kingdom (Model Polyvac E982) was used. The calibration of the OES was done using the chromium and cobalt element blocks. A small piece (3 inch x 3 inch) from the new A-286 bar and the serviced turbine wheel was analyzed under OES in accordance to ASTM E1019 “Standard Test Method for Determination of Carbon, Sulfur, Nitrogen, and Oxygen in Steel, Iron, Nickel, and Cobalt Alloys by Various Combustion and Inert Gas Fusion Techniques” and ASTM E353 “Standard Test Method for Chemical Analysis of Stainless, Heat-Resisting, Maraging, and Other Similar Chromium-Nickel-Iron Alloys”. On each piece, 3 sparks were taken and the average percentage of element was reported. The OES used to determine the chemical composition of the A-286 new bar, and the serviced turbine wheel is shown in Figure 3.1.

Figure 3.1: Optical emission spectrometer used for chemical analysis

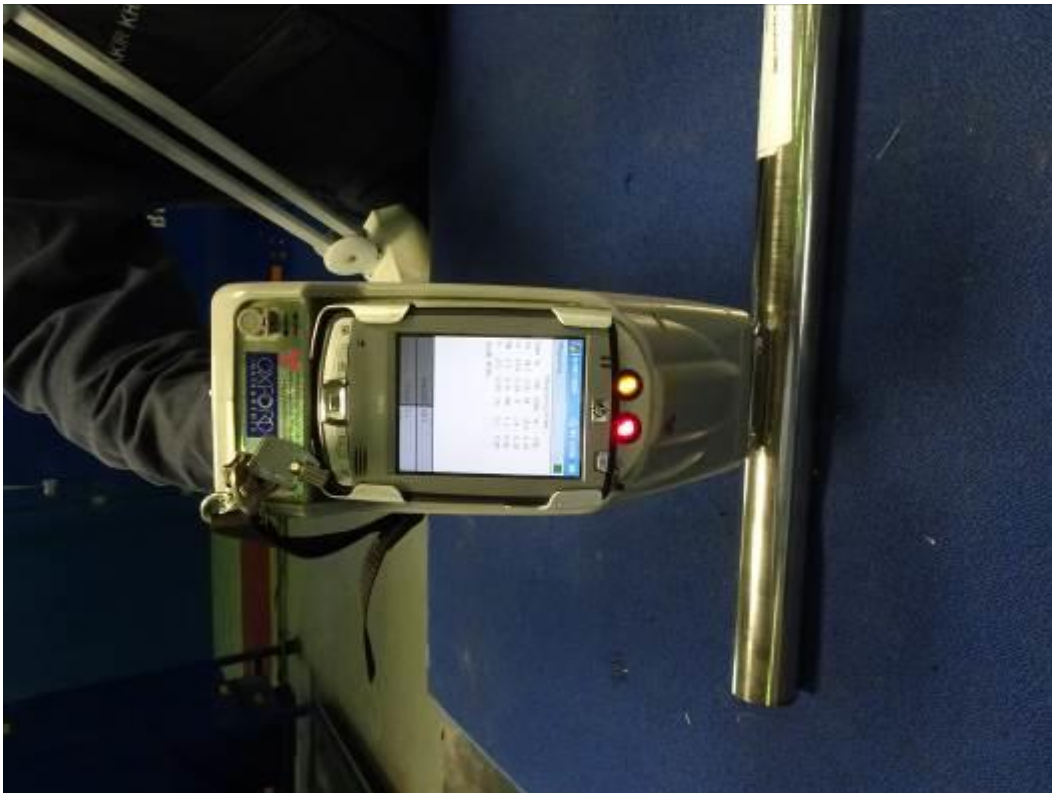
The XRF gun used is Oxford make, X-Met 3000+. Prior to testing of the specimens, the XRF gun was calibrated with the test block of SS 304 (Cr 18%, Ni 8 %). Total 3 sets of readings were taken on the samples of these materials and the average was reported. The photographs of the XRF analysis on the new A-286 bar and serviced wheel section are shown in Figures 3.2 and 3.3.

Figure 3.2: XRF analysis on a new A-286 bar

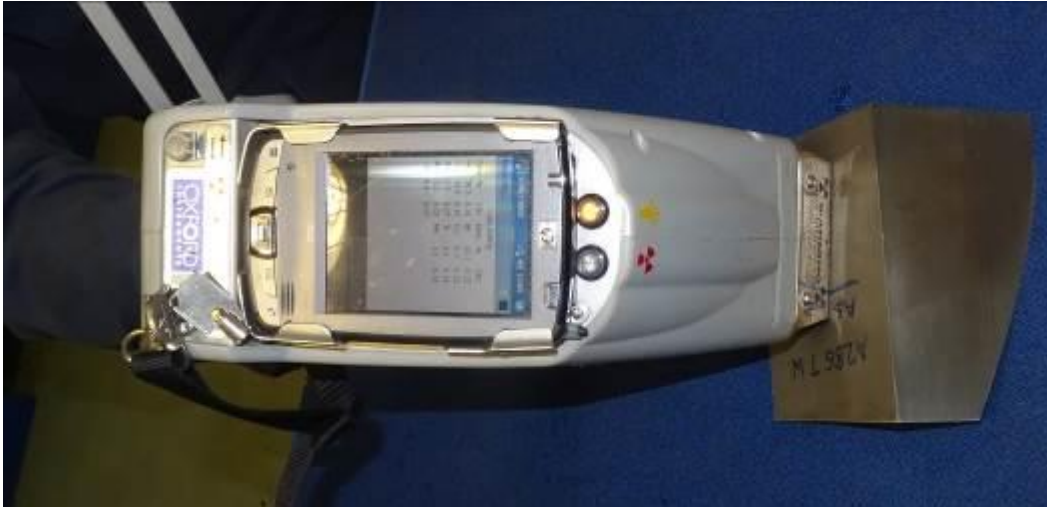
Figure 3.3: XRF analysis on a serviced turbine wheel section

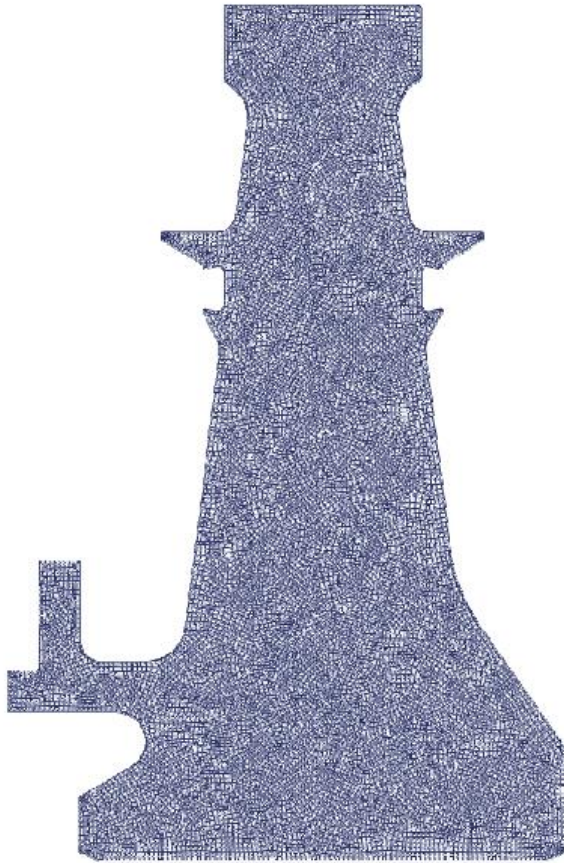
The basic material properties were based on the consensus values for alloy A-286: Density = 7940 kg/m³, Young's Modulus = 201 GPa, Poisson's Ratio = 0.3. The boundary conditions were applied as a lateral restraint in the axial direction considering the A-286 alloy data. The 2-Dimensional axisymmetric mesh was created using the ABAQUS pre-processor by taking linear quadrilateral elements (ABAQUS type CAX4R). This mesh was created to cover the entire area of the dissected wheel material as shown in Figure 3.4.

Figure 3.4: Mesh of a turbine wheel created for finite element analysis

The dimensions for the finite element model were primarily based on the measurements taken from the dissected section of the A-286 serviced turbine wheel. Considering the fact that the turbine wheel is aged in service, the wheel dimensions were adjusted with the nearest imperial dimensions to that of the wheel in as manufactured stage.

The boundary conditions were applied as a lateral restraint in the axial direction. The rotational speed of 4670 rpm was based on the normal operating speed value as supplied. The initial elastic analysis was run assuming no temperature gradient and thermal effects to inform the creep test conditions and identify the peak stress locations.

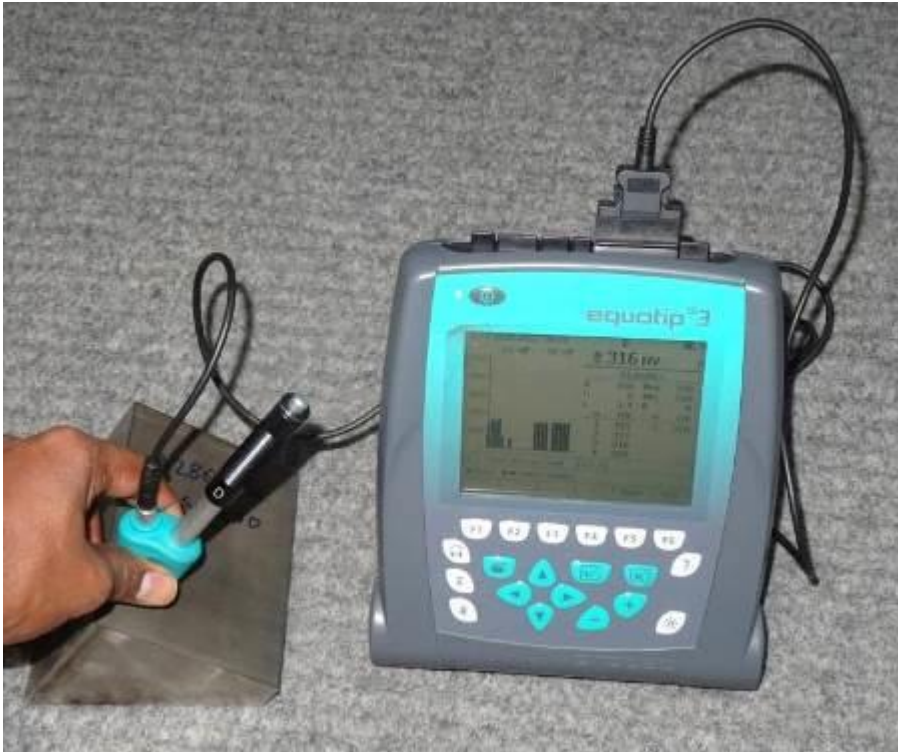
every 1-inch interval. At every location, 3 readings were taken and the average reading has been reported. The hardness survey was performed using an Equotip-3 portable hardness tester from Proceq, Switzerland. A photograph of the Equotip-3, hardness tester is shown in Figure 3.5.

Figure 3.5: Portable Equotip-3 hardness tester

The hardness survey was performed on the dissected turbine wheel to check for any hardness variations within the material from bore to dove tail areas. The hardness tester was calibrated using the calibration block and Surface preparation, in the form of grinding with a 400-grit silicon carbide wheel was done prior to portable hardness testing. Portable hardness test was carried out in accordance with ASTM A956 “Standard Test Method for Leeb Hardness Testing of Steel Products”. Starting from bore to dove tail area, hardness readings were taken at

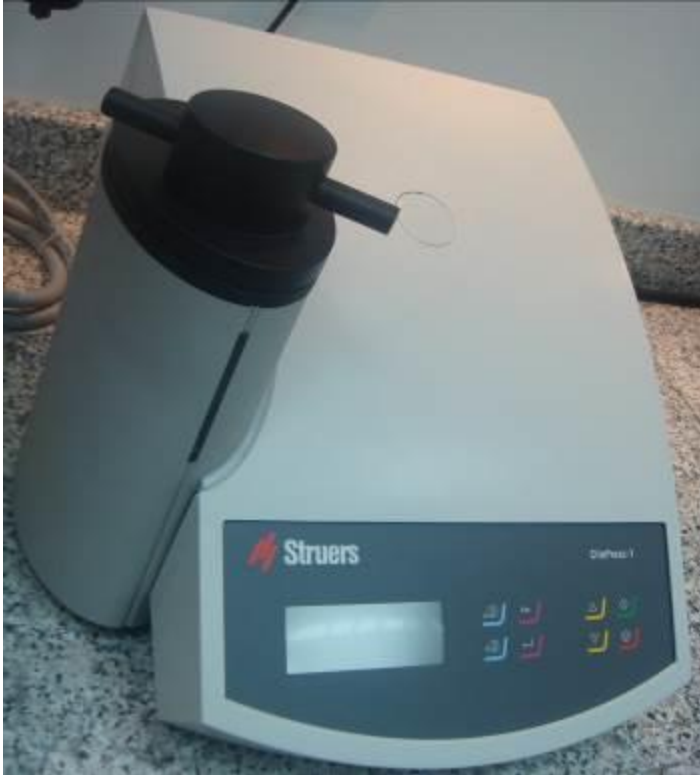
The dissected samples were cleaned in an ultrasonic bath for 30 minutes for hot mounting. The hot mounting is a process where the samples to be metallographically polished are embedded in the resin, to obtain a mold of 25mm diameter for ease of polishing. After the ultrasonic cleaning, the samples were placed on a hot mounting stage. The hot mounting press used was Citopress from Struers, Denmark as shown in Figure 3.6.

Figure 3.6: The hot mounting press - Citopress

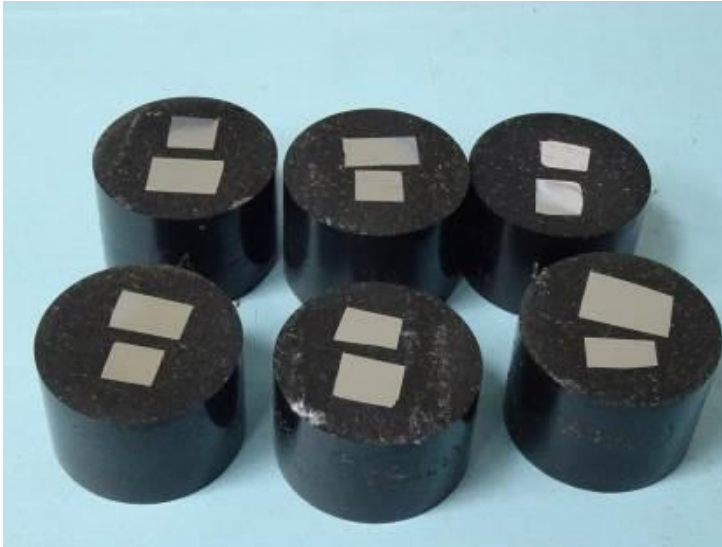
Two specimens, one with longitudinal section and other with transverse section were placed on the hot mounting stage. Multifast resin (from Struers, Denmark) was poured (around 2 spoons) over the sample stage. The mounting stage was then lowered and the start key on the machine was pressed. The Citopress was programmed for 2 minutes cycle (heating and cooling) for preparation of the mounts. On completion of the cycle, the alarm signal was displayed on the Citopress screen. The mounted sample was then again cleaned using acetone and water to get rid of any loose resin powder deposits. The representative hot mounts after mounting process are shown in Figure 3.7.

Figure 3.7: Prepared hot mounts

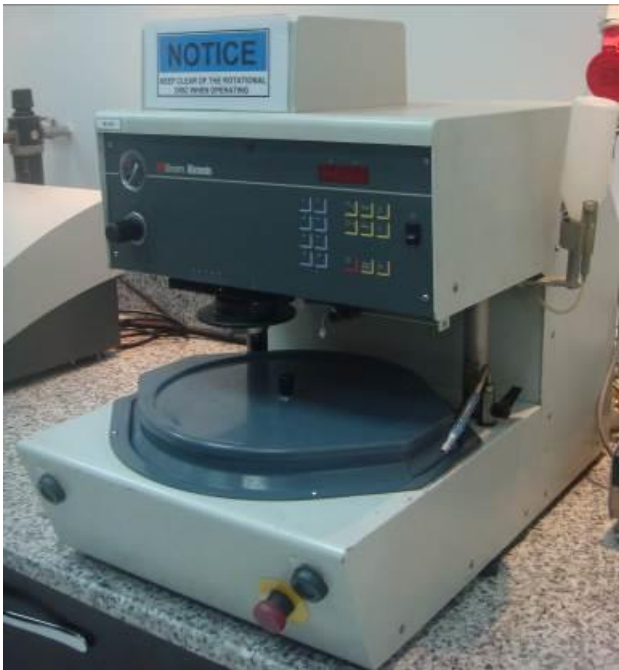
After mounting, the metallographic polishing was required in order to acquire the desired finish, so that the samples could be readily observed under the microscope. The metallographic polishing was done using Struers Polishing Machine – Abraham, Denmark that is shown in Figure 3.8.

Figure 3.8: Polishing machine “Abraham”, used for metallographic polishing

The samples for polishing were inserted in the fixture and placed on the polishing unit. The timer for polishing cycle was set for 2 minutes for each step. The polishing was done using silicon carbide grit papers of 220, 320, 500 and 1000. Fine polishing was done over a micro-cloth using 6 micron and 1 micron diamond suspensions. The final polishing was done using colloidal silica on a velvet cloth. After the final polishing, the mounts were cleansed with water and acetone, and were dried-up with a hot gun dryer, manufactured by Struers, Denmark. The specimens were observed in the un-etched and etched conditions. The etching was done using Aqua Regia for about 30 seconds to reveal the microstructure. The etching solution was prepared by mixing of concentrated hydrochloric acid and concentrated nitric acid (HCl: HNO₃) with ratio of 3:1. This entire etching process was done under a fume hood.

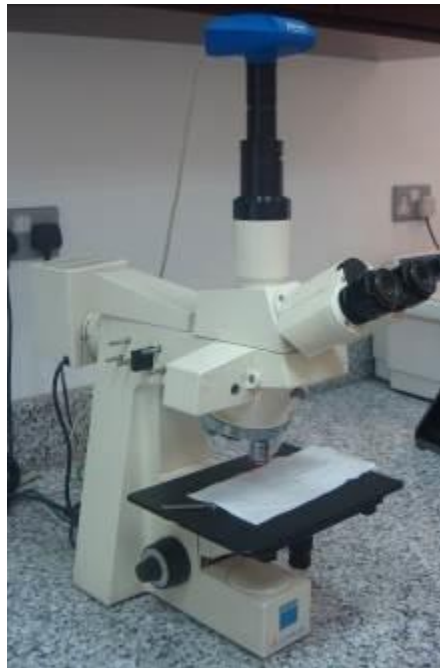
The mounted specimens were examined under the optical microscope in the un-etched and etched conditions. The as polished and etched sections were examined at magnifications of 50x, 100x and 200x. A CCD camera was attached on to the microscope to obtain the image on the computer screen. The images were captured using the PAXIT software. An Optical Microscope, Upright, Model-Axioskop, Carl Zeiss, Germany was used and is shown in Figure 3.9.

Figure 3.9: Optical Microscope used for microscopic evaluation

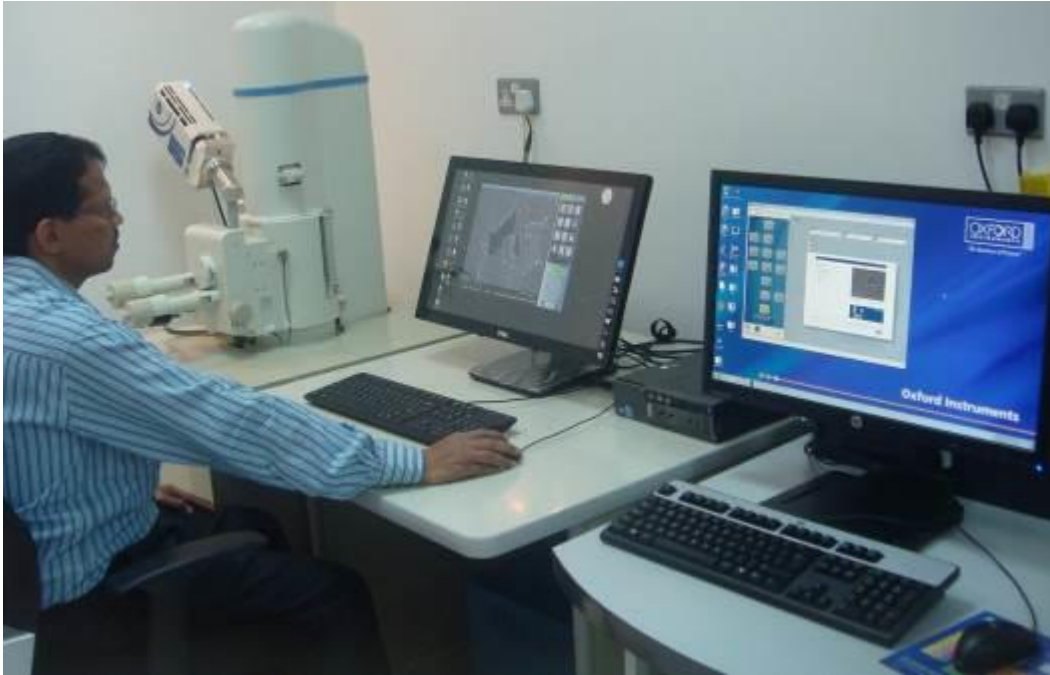
The etched samples were examined under the SEM at magnifications varying from 500x to 2000x. The mounted samples were made conductive by wounding copper tapes before placing on to the SEM stage. A Scanning Electron Microscope, Model-JSM 6010LV, JEOL, Japan was used and is shown in Figure 3.10.

Figure 3.10: The Scanning Electron Microscope

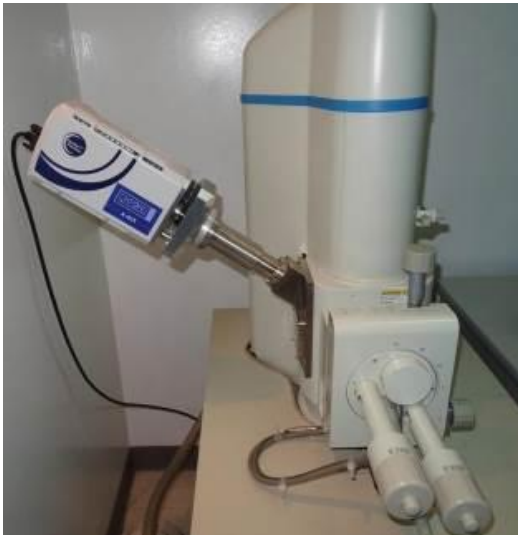
The SEM was also equipped with an Energy Dispersive Analysis of X-Ray (EDAX) from Oxford, England. The EDAX was used for the elemental analysis of a particular phase or bulk of the sample. The carbide mapping on the serviced wheel sections was done using the EDAX. The EDAX detector on the SEM is shown in Figure 3.11.

Figure 3.11 – EDAX Detector on the SEM

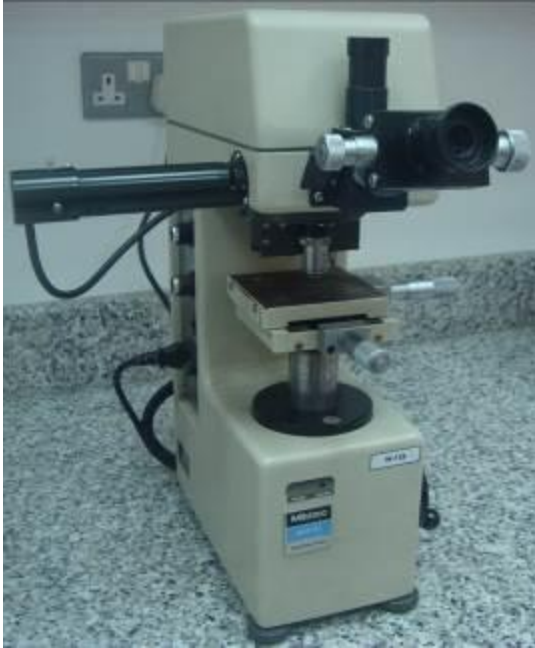
The micro-hardness testing was performed on all the prepared metallographic samples. The micro-hardness testing procedure was in accordance with the ASTM E-384, EN ISO 6507, and ASTM E-92 standard specifications. The etched mounts were placed on the micro-hardness tester stage. A load of 300 gm was applied for a short period. The diagonal lengths of the pyramid were measured using the micrometer on the hardness tester by viewing through the eyepiece at a magnification of 500x. On each mounted section, 5 hardness readings were taken and average was reported. The Vickers Microhardness tester used to measure the hardness of the prepared samples was of Mitutoyo, Japan, and is shown in Figure 3.12.

Figure 3.12: Microhardness tester used for hardness measurements

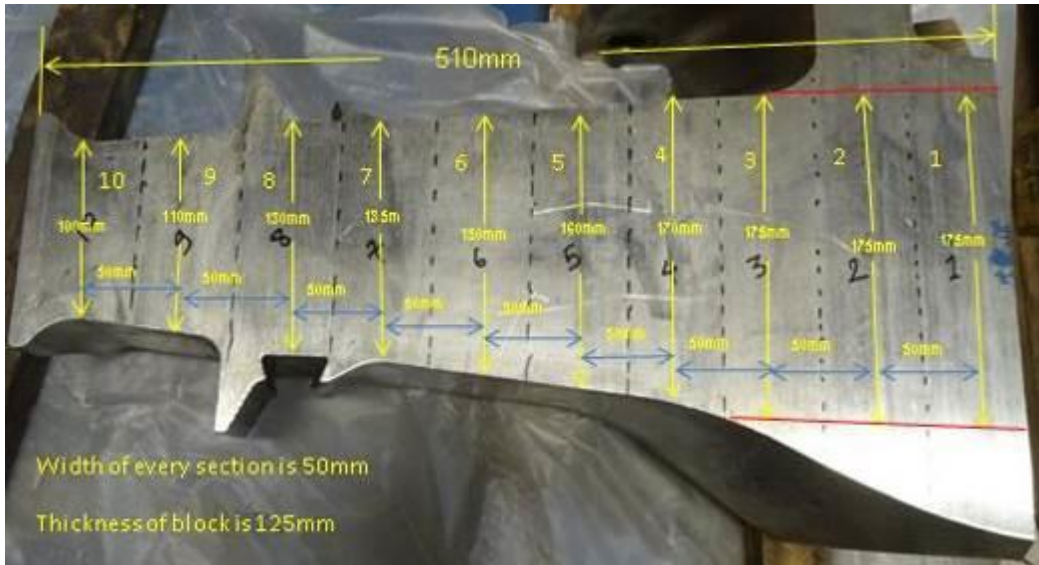
The portion available from the serviced A-286 turbine wheel for testing was 510 mm in length and 125 mm in thickness. The dimensional measurements were taken on the dissected block in order to plan for the individual sections for heat treatments and to cover the sample availability for destructive tests. The dimensions were mapped with a measuring tape. The turbine block section along with dimensions is shown in Figure 3.13.

Figure 3.13: Dissected portion of turbine wheel

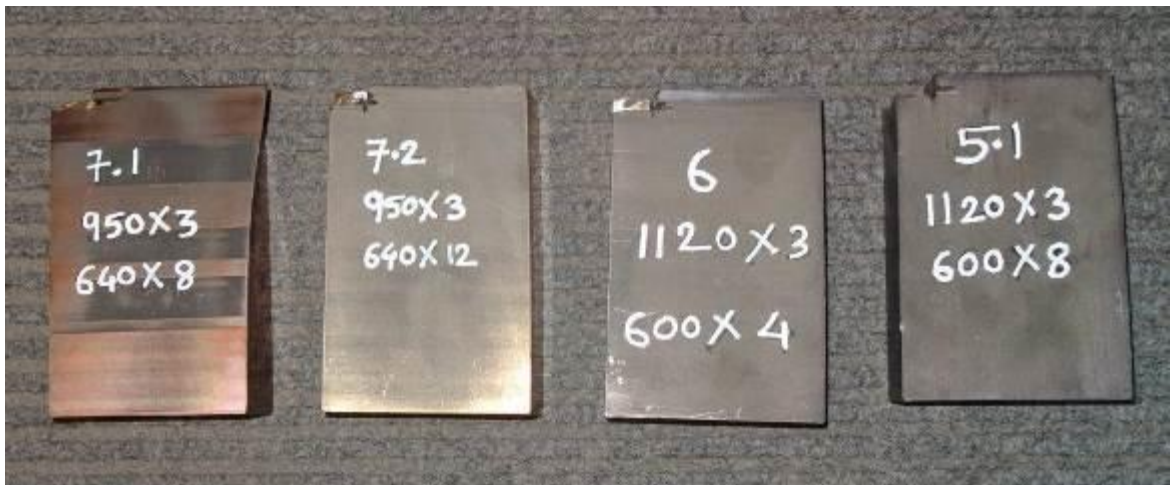
Figure 3.14 – Four different sections after further dissections

The representative photographs of the dissected sections after wire cutting is shown in Figures 3.14 and 3.15.

Overall, 10 different sections were marked and obtained from the original turbine block. The individual sectioning was done using Wire cutting method for taking out different sections from the dissected wheel portion. Some of the sections were further dissected into two halves for pilot runs. These sections were denoted with A, B, C and D. For example, if sections were taken from primary section 9, these were marked as 9A and 9B.

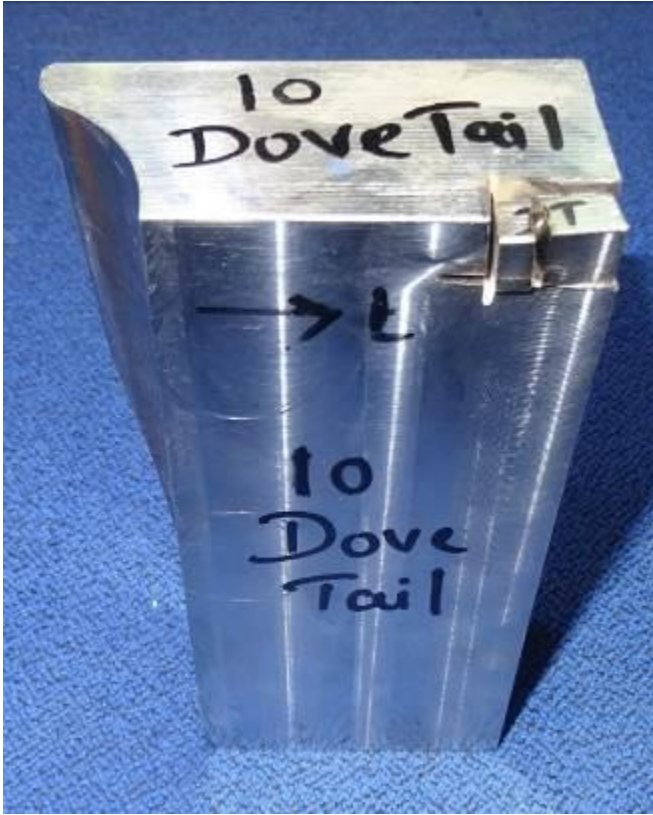
Figure 3.15: Section 10 near the dovetail area after further dissections

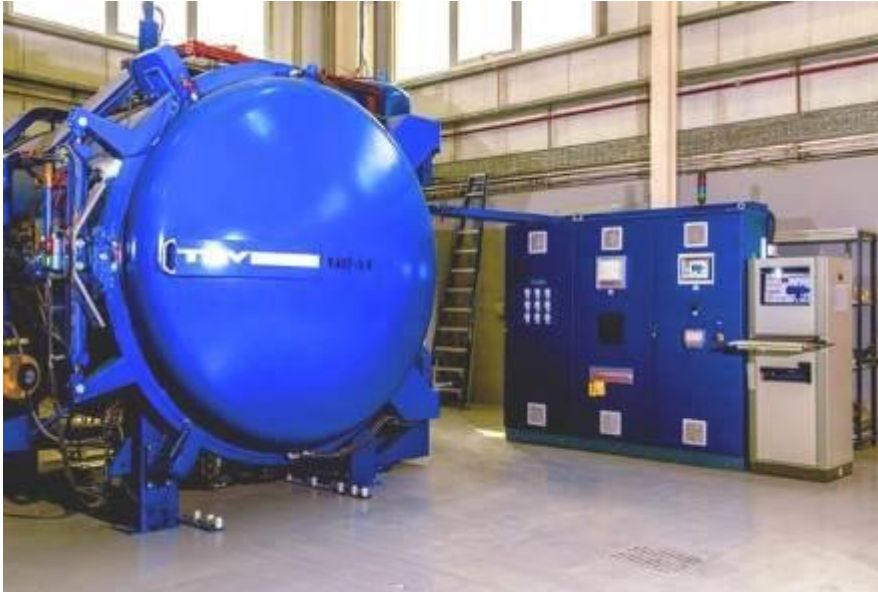
Figure 3.16 – Vacuum furnace used for heat treatments

The maximum working temperature of furnace is 1300°C, and the hot working zone dimensions are 1200 mm width x 1200 mm height x 1200 mm depth. The final vacuum attained by furnace was of 10^{-5} / 10^{-6} millibar. The furnace was equipped with an argon gas fan for rapid quenching/cooling. All the samples to be heat treated were placed on the fixture inside the furnace.

The vacuum furnace used is shown in Figures 3.16 and 3.17.

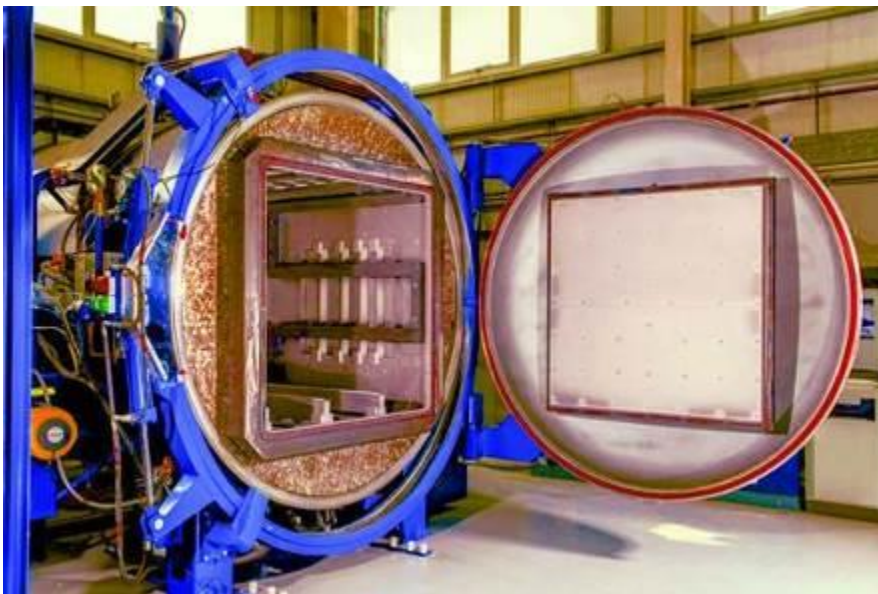
Figure 3.17 – Vacuum furnace showing the internal chamber

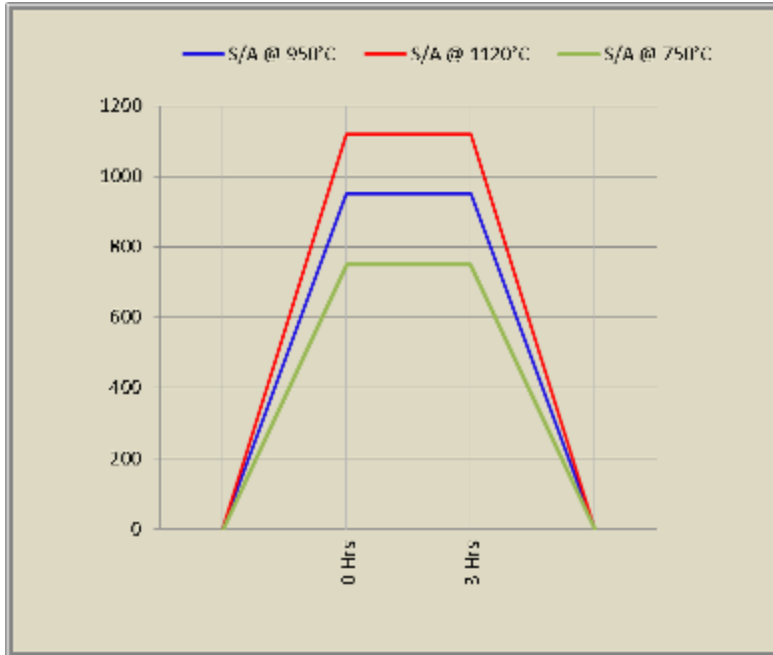
Figure 3.18 – Graphical representation of the pilot heat treatments

- Solution annealing at 750°C for 3 hours
- Solution annealing at 950°C for 3 hours
- Solution annealing at 1120°C for 3 hours

Solution annealing heat treatment involved holding the wheel sections in furnace for the above specified temperature and time followed by rapid cooling. The graphical representation of pilot heat treatments is given in Figure 3.18.

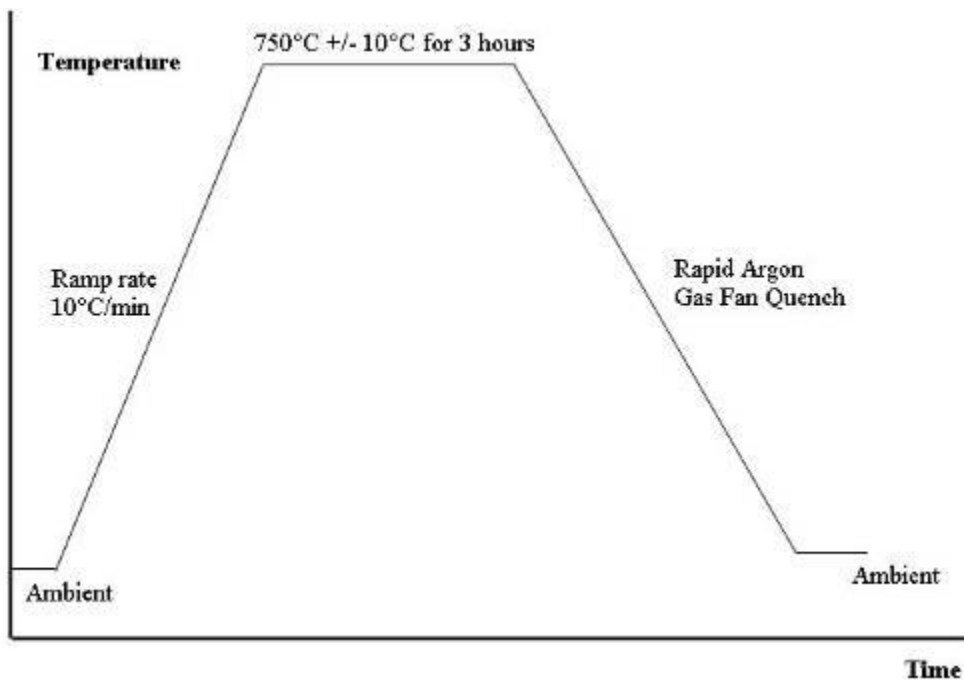
1. Pilot Heat Treatment Cycle – 1 (Section 9C) – Solution Annealing

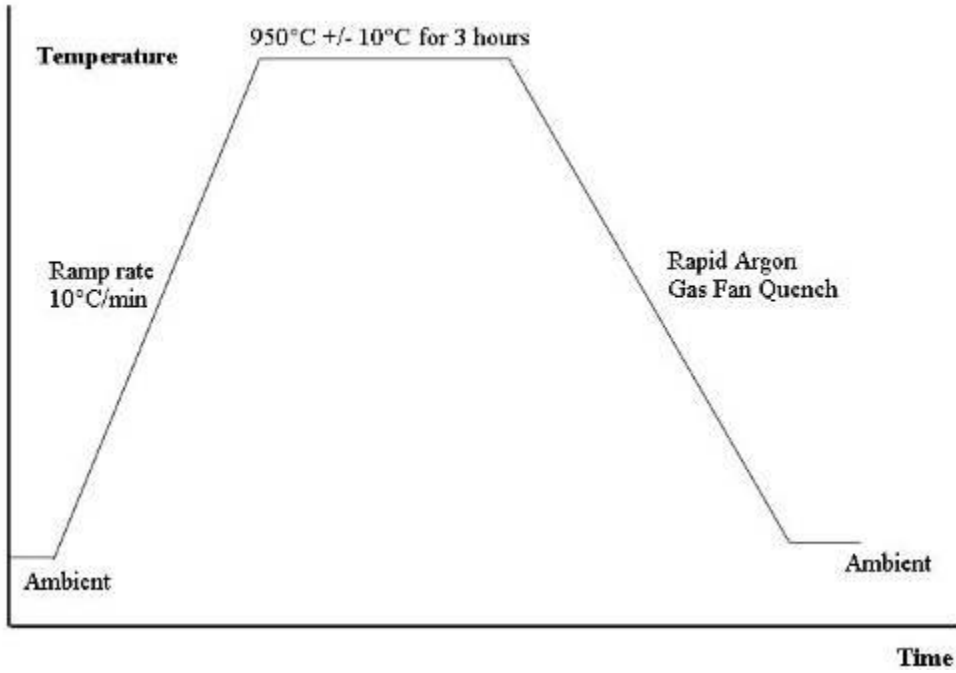
2. Pilot Heat Treatment Cycle – 2 (Section 9A) – Solution Annealing

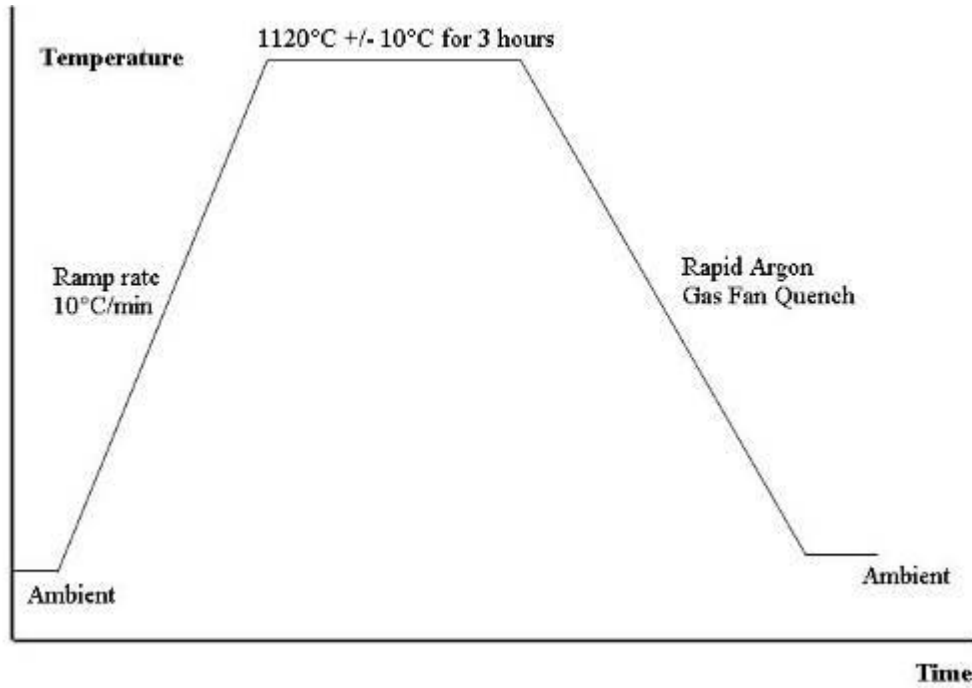
3. Pilot Heat Treatment Cycle – 3 (Section 9B) – Solution Annealing

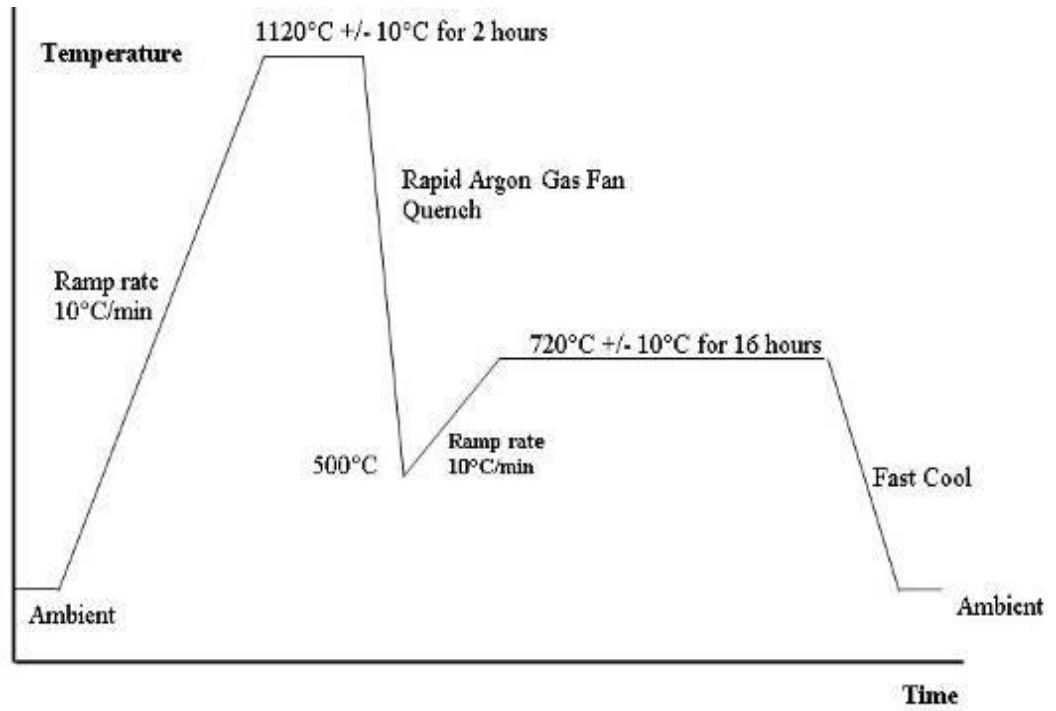
4. Heat Treatment Cycle – 4 (Section 10) – Solution Annealing + Ageing

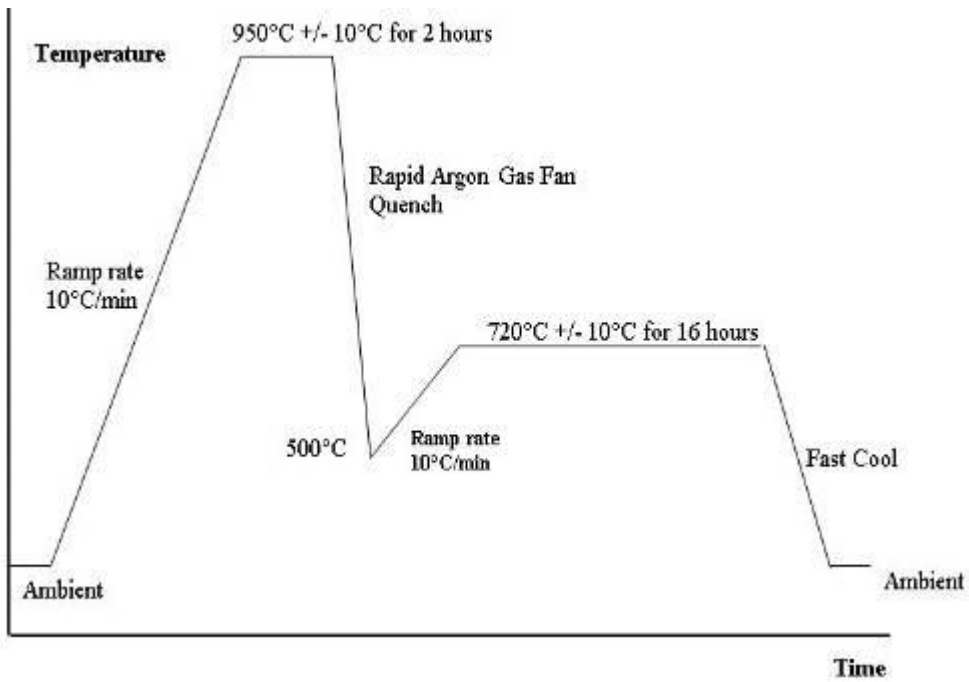
5. Heat Treatment Cycle – 5 (Section 2) - Solution Annealing + Ageing

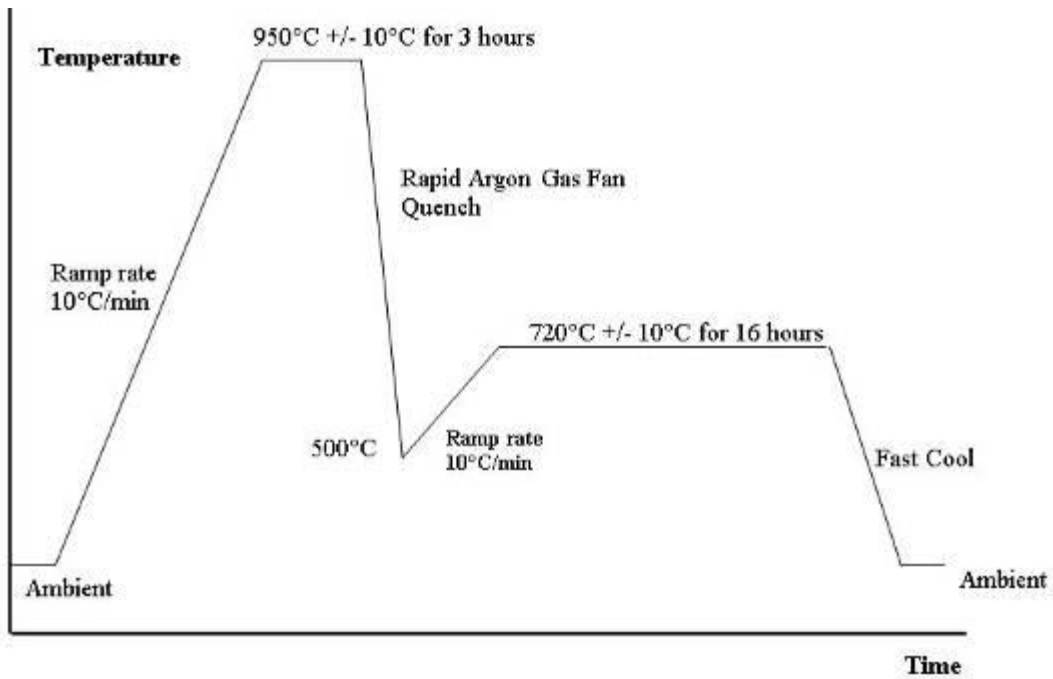
6. Heat Treatment Cycle – 6 (Section 9A) - Solution Annealing + Ageing

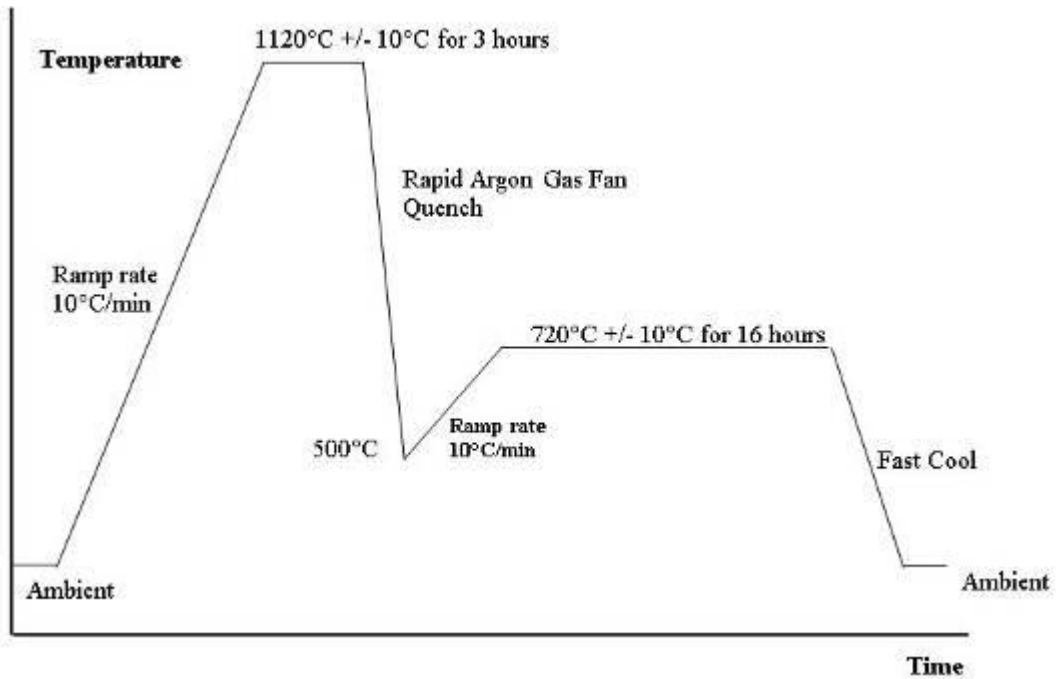
7. Heat Treatment Cycle – 7 (Section 9B) - Solution Annealing + Ageing

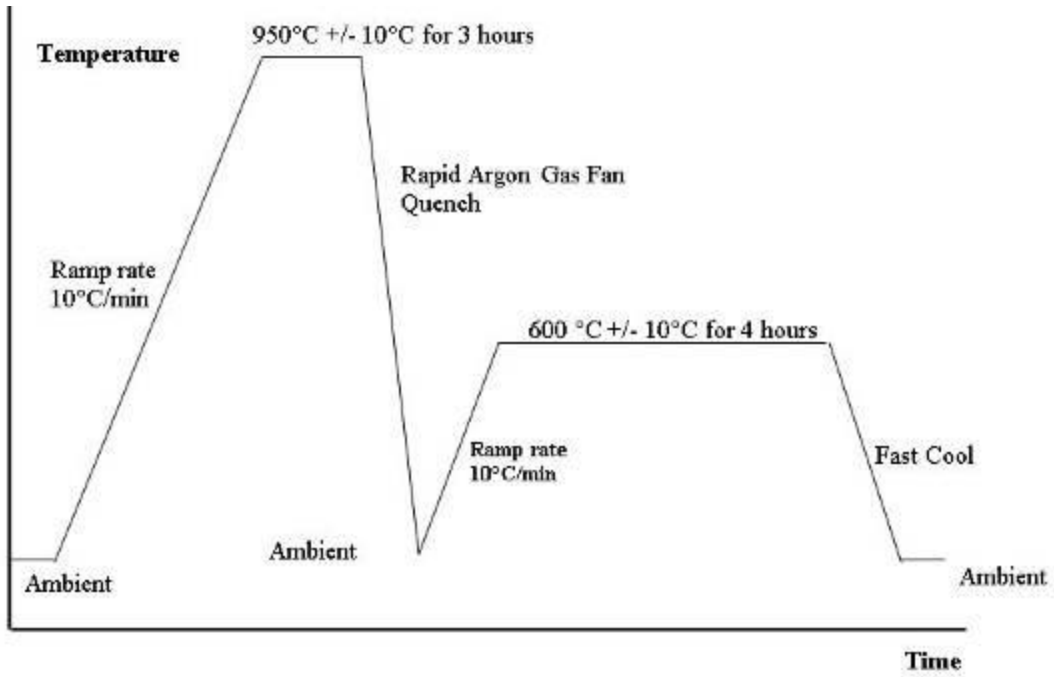
8. Heat Treatment Cycle – 8 (Section 8C-1) – SA + Age
