**Study of Rejuvenation Heat Treatment for Life
Extension of A-286 Gas Turbine Wheels**

Submitted
**IN PARTIAL FULFILLMENT OF THE REQUIREMENT OF
THE DEGREE OF DOCTOR OF PHILOSOPHY**

**UNIVERSITY OF PETROLEUM AND ENERGY STUDIES
DEHRADUN**

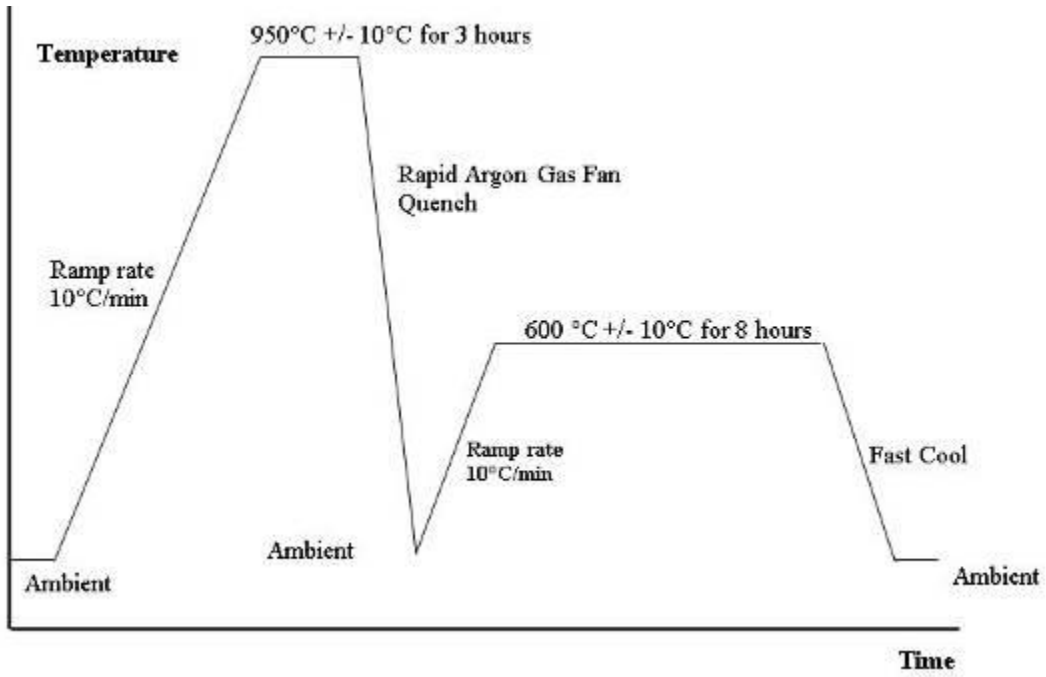
9. Heat Treatment Cycle – 9 (Section 8C-2) – SA + Age

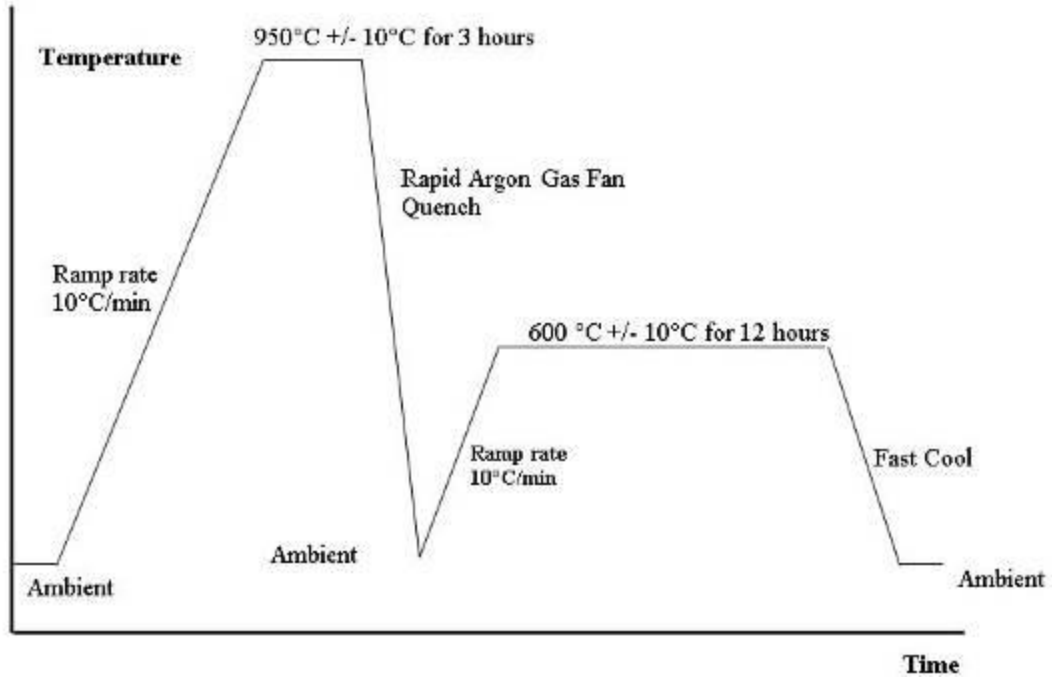
10. Heat Treatment Cycle – 10 (Section 8D-1) – SA + Age

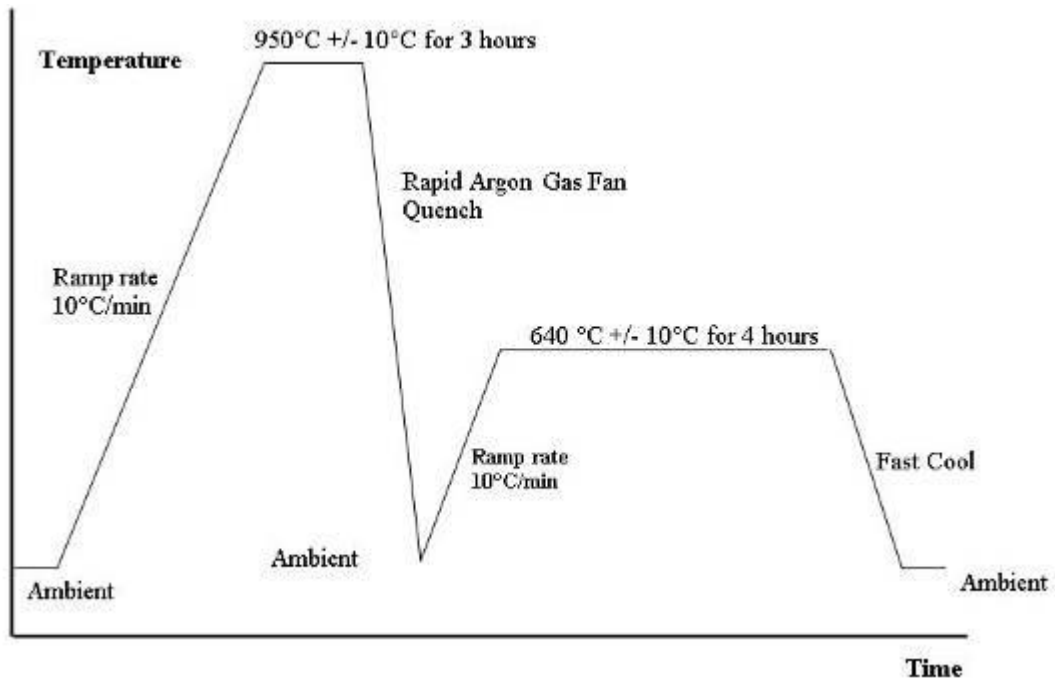
11. Heat Treatment Cycle – 11 (Section 8D-2) – SA + Age

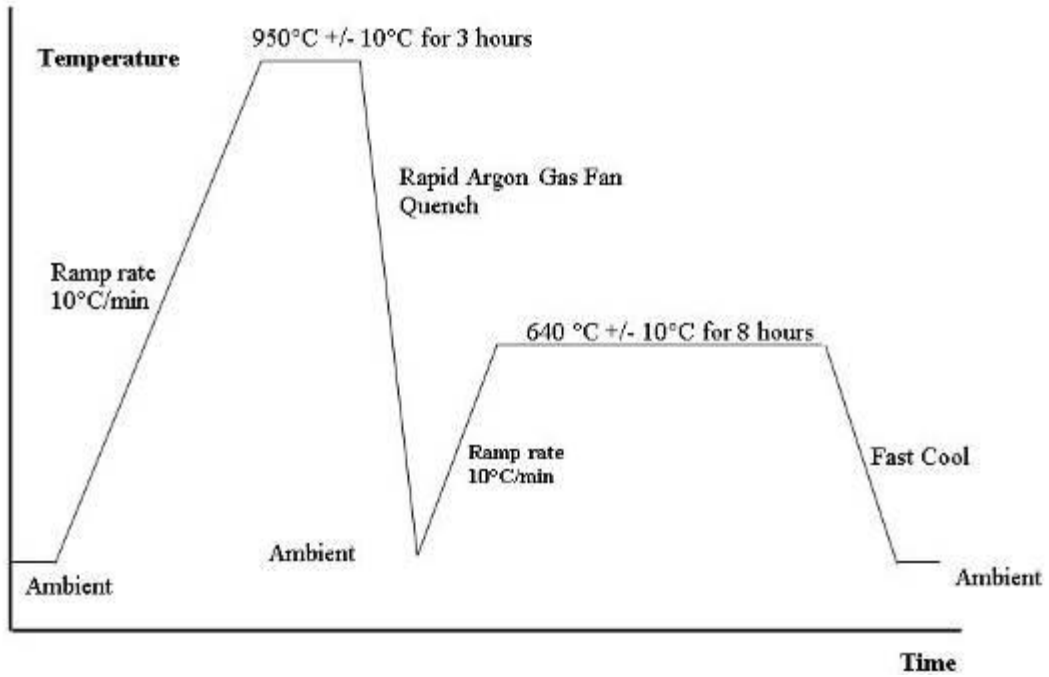
12. Heat Treatment Cycle – 12 (Section 7.1) – SA + Age

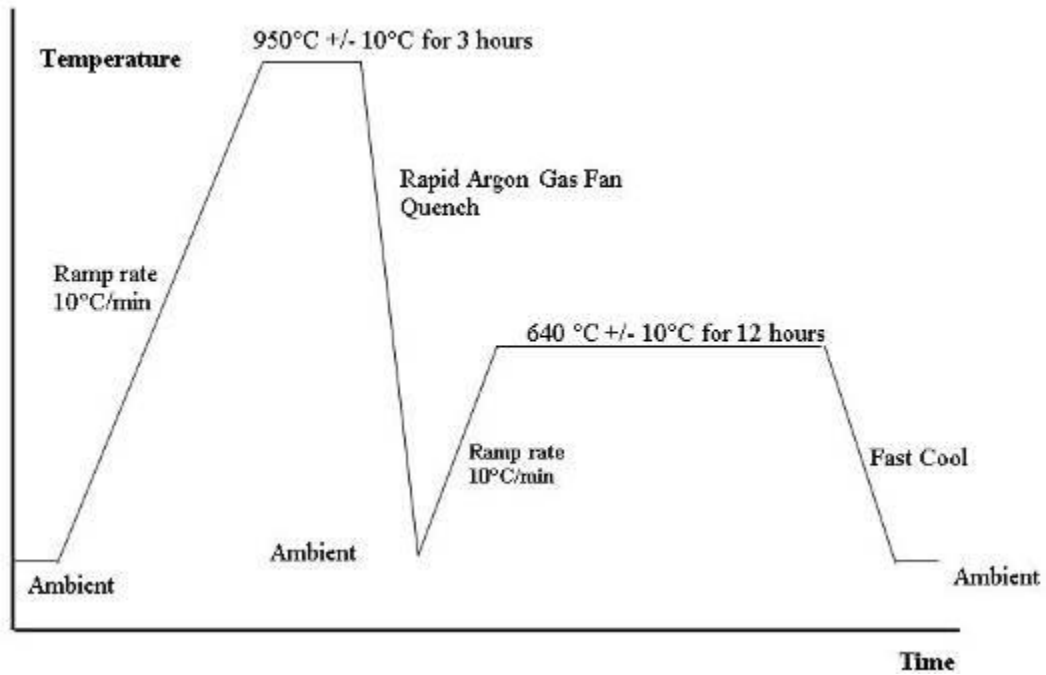
13. Heat Treatment Cycle – 13 (Section 7.2) – SA + Age

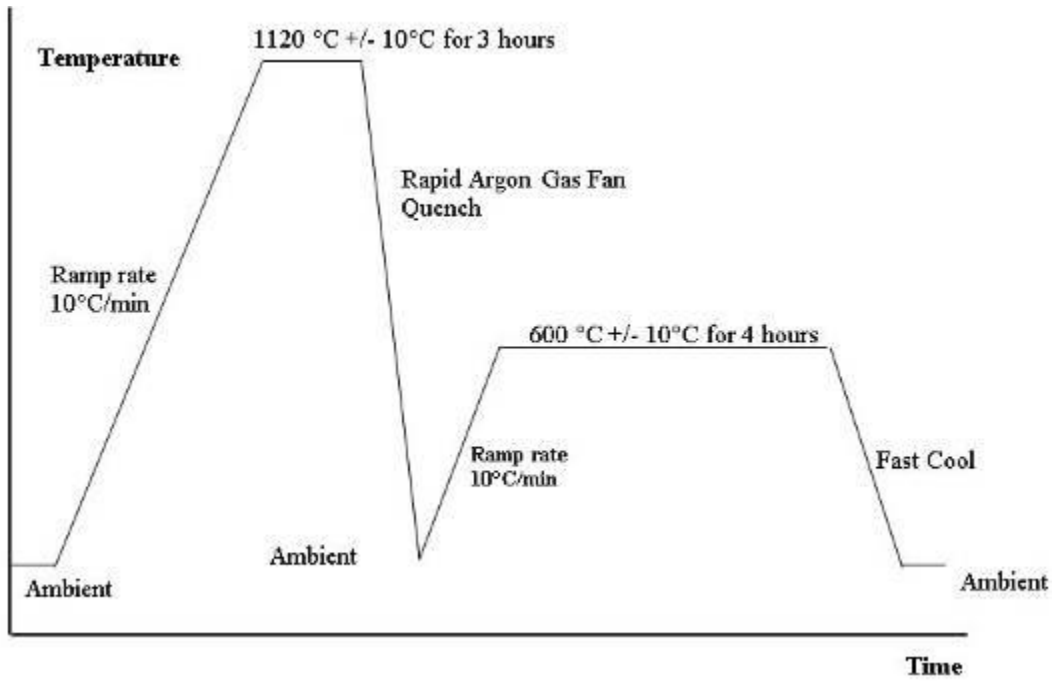
14. Heat Treatment Cycle – 14 (Section 6) – SA + Age

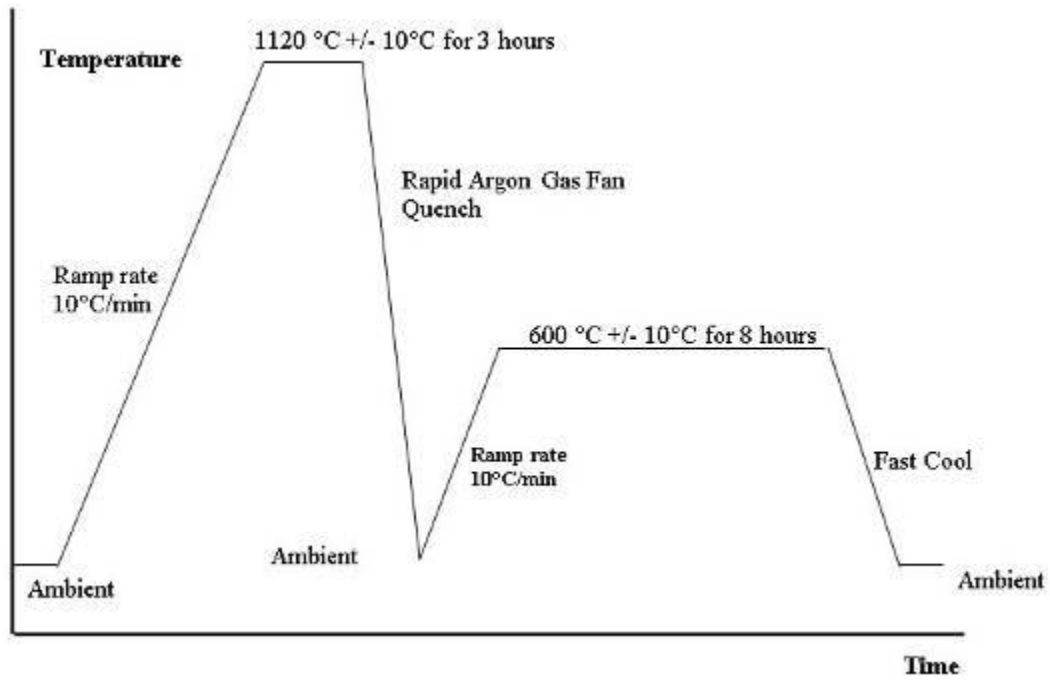
15. Heat Treatment Cycle – 15 (Section 5.1) – SA + Age

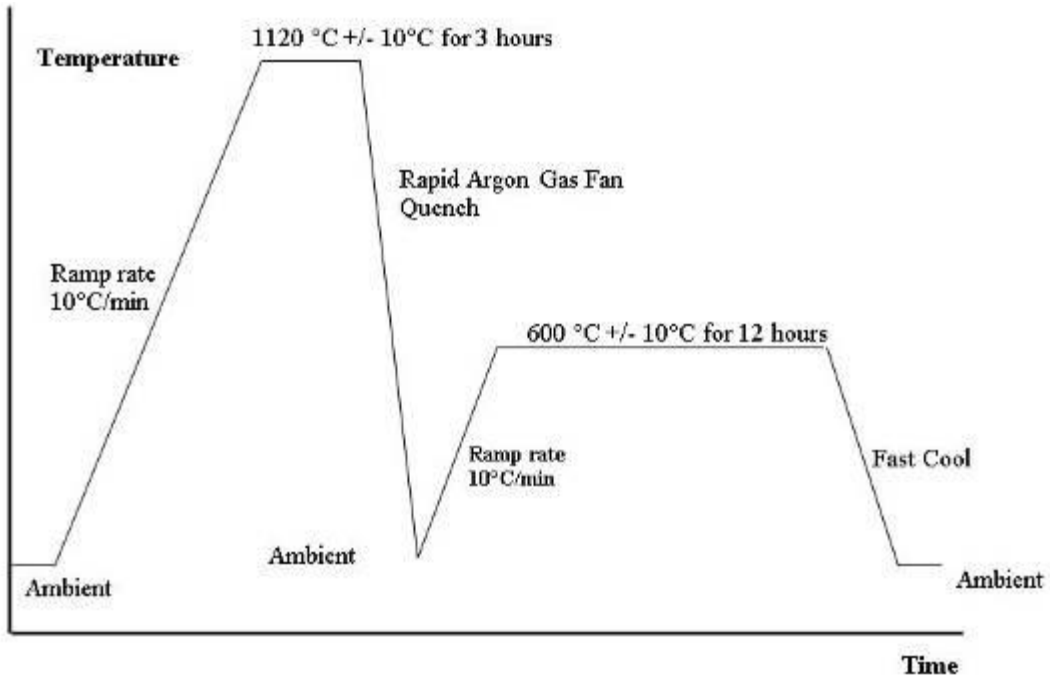
16. Heat Treatment Cycle – 16 (Section 5.2) – SA + Age

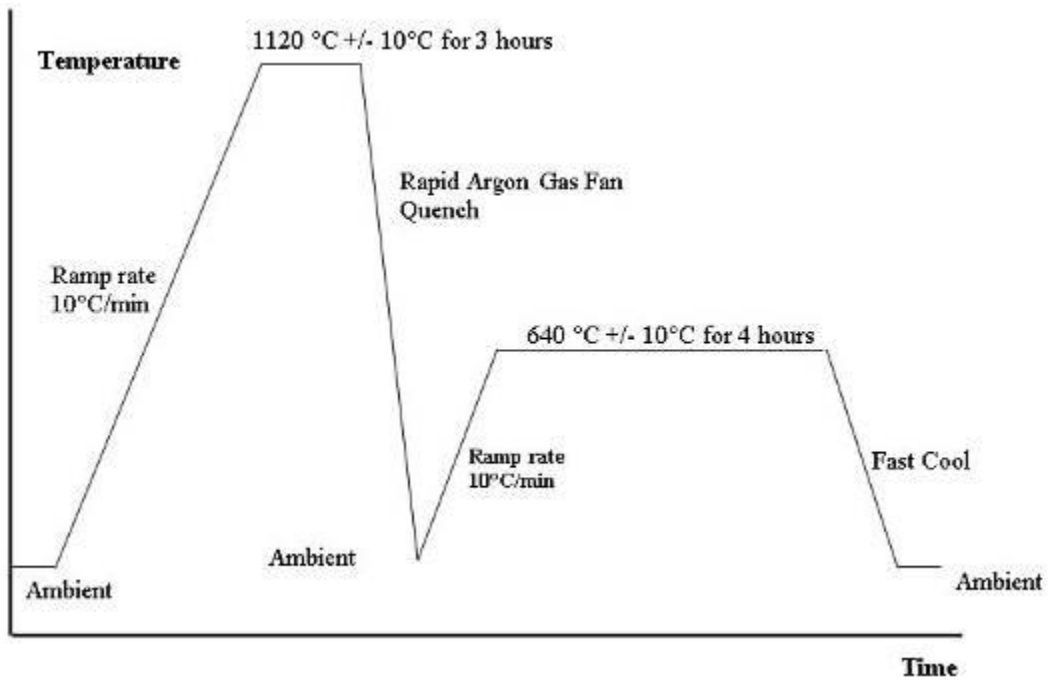
17. Heat Treatment Cycle – 17 (Section 4) – SA + Age

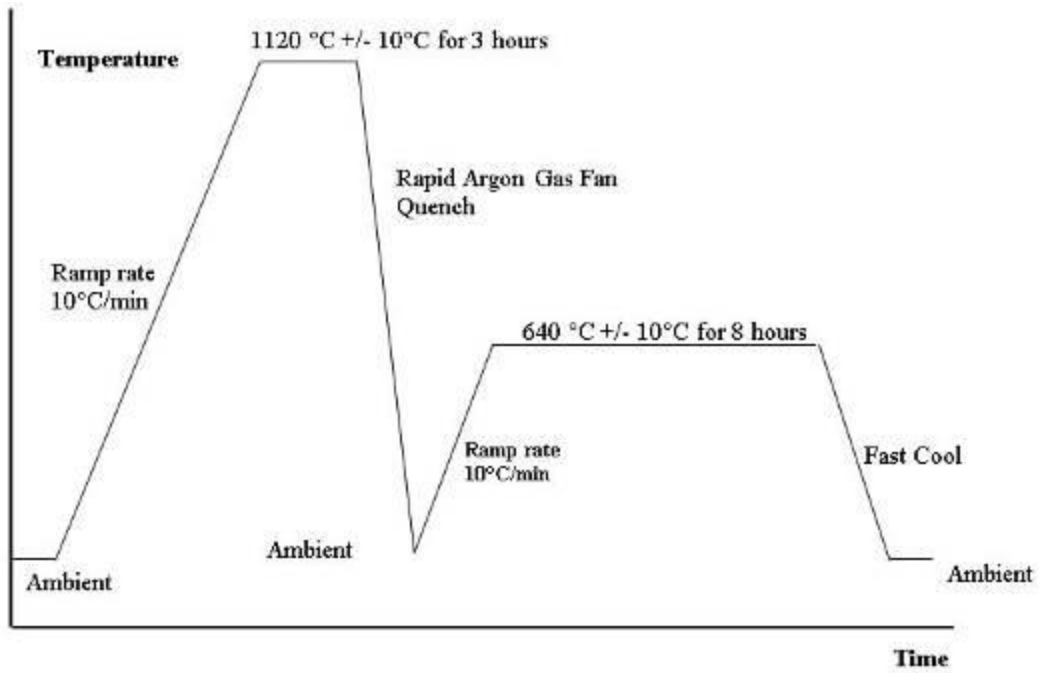
18. Heat Treatment Cycle – 18 (Section 3.1) – SA + Age

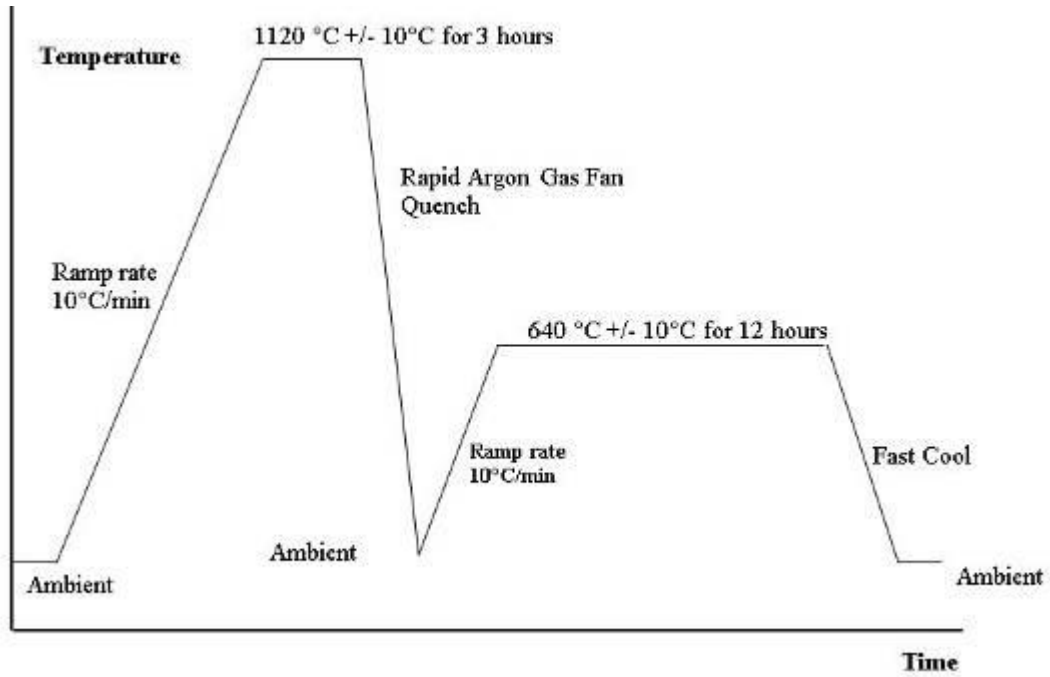
19. Heat Treatment Cycle – 19 (Section 7) – SA + Age

After each heat treatment, furnace charts/graphs were examined to check if the temperature and the soaking period were accurate. Each heat treatment cycle was named in accordance with the identified dissected section.

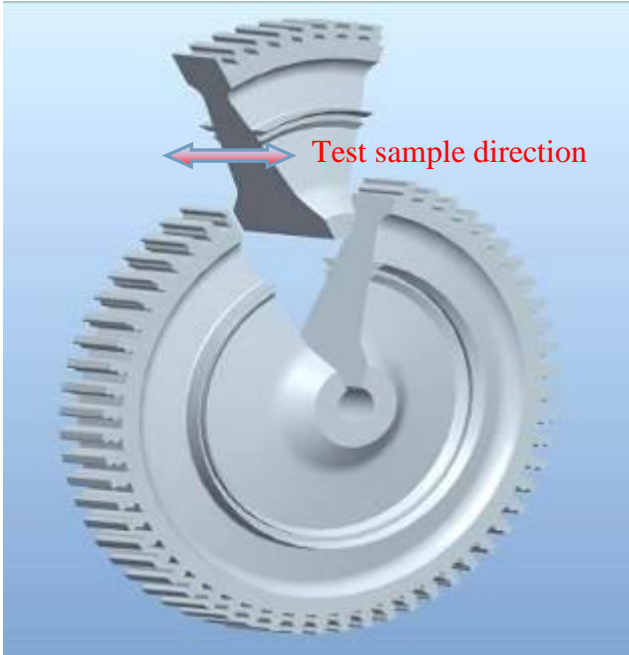
Figure 3.19: Schematic of the A-286 turbine wheel section showing the dissected section and sample direction for mechanical tests

The specimens for testing were along the thickness of the turbine wheel, as the maximum stresses are in this direction. The destructive mechanical testing direction for the sample on the test blocks is shown in Figure 3.19.

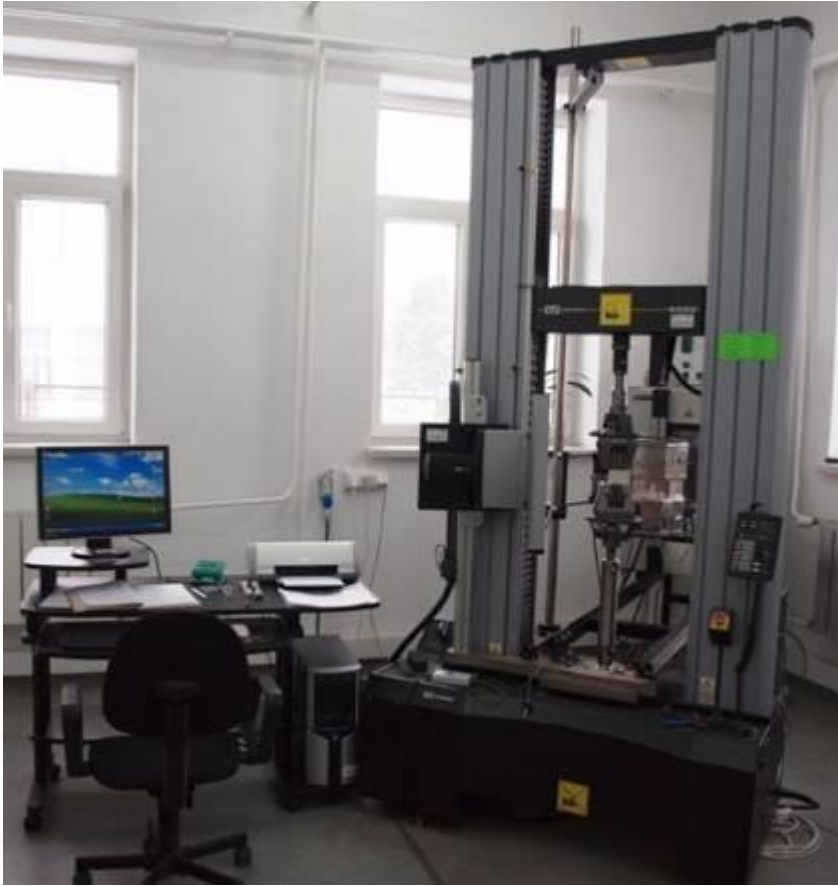
Figure 3.20: Instron 5582, room temperature tensile testing machine

out at Incotest and Westmoreland laboratories, United Kingdom. The tensile testing machine used were Instron 5582 (room temperature) and Instron 8561 (high temperature) both of 100 kN capacity. The machines used for room temperature and high temperature tensile testing are shown in Figures 3.20 and 3.21.

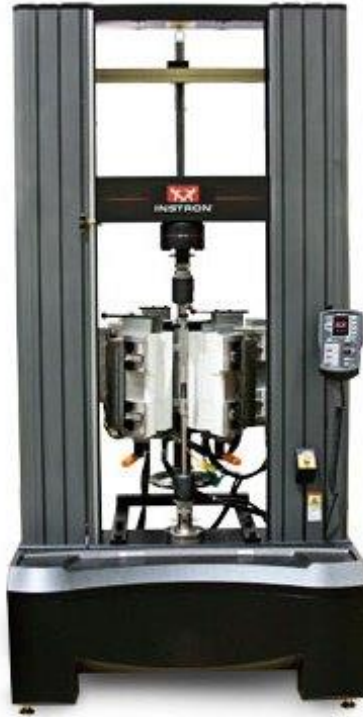
Figure 3.21: Instron 8561, high temperature tensile testing machine

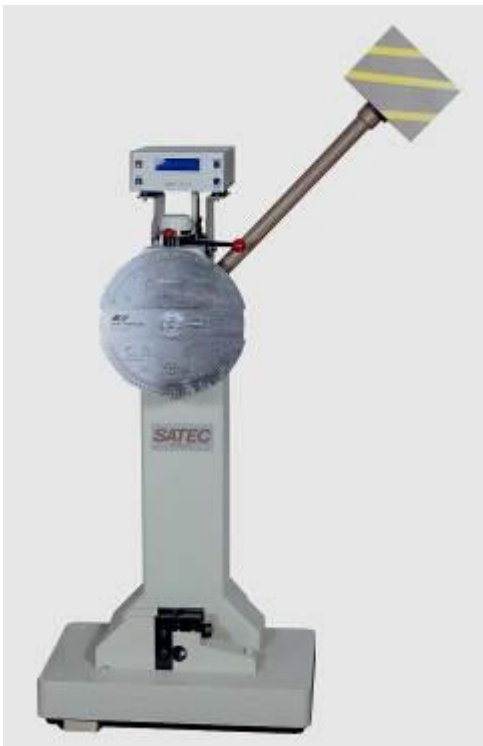
Figure 3.22: Satec Impact Testing Machine

The Charpy test is used to measure the impact energy required to break a material under certain impact load, normally at a predetermined temperature. Charpy impact tests were performed on the new A-286 bar and the serviced turbine wheel section before and after various heat treatments, in accordance with the ASTM E23 – “Standard Test Methods for Notched Bar Impact Testing of Metallic Materials”. The Charpy impact testing was carried out at Incotest and Westmoreland laboratories in the United Kingdom on Satec Systems Impact Testing Machine, Capacity: 240 ft-lbs. The Charpy testing machine used in the present study is shown in Figure 3.22.

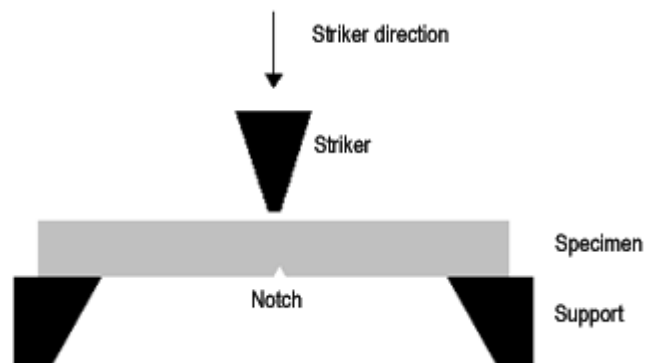
Figure 3.23: Schematic showing the principle of Charpy impact test

The Charpy impact test is primarily applied to know the material toughness or to determine whether the material is ductile or brittle [212]. On impact of the striking pendulum, the specimen absorbs energy until it yields. The specimen then starts to undergo plastic deformation at the notch. With the absorption of energy, the plastic zone at the notch work hardens. During this process and at a certain stage, the specimen would not be in a position to absorb any more energy, following which fracture occurs. The impact energy was then calculated based on the height to which the striker would have risen, if no test specimen was in place, and is compared with the height to which the striker actually rises [213]. Tough materials absorb a lot of energy, while brittle materials absorb very little energy prior to fracture. Fracture toughness can be evaluated by examining and studying the fracture surfaces [214]. The schematic in Figure 3.23 explains the mechanism of impact on the specimen.

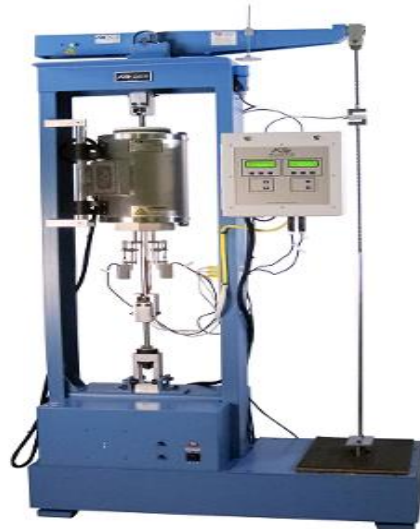
Figure 3.24: Stress Rupture Testing Machine

These parameters were finalized after discussion with Masood John Brown, Engineering Department. The parameters were so chosen that the design and actual operating conditions of the turbine wheel were covered. Stress rupture samples were machined to 6.34 mm diameter for 25.4 mm gauge length to apply a static stress at a specific temperature for 100 hours. The stress rupture tests were carried out on Qualicreep testing machine of 100 kN Capacity at Incotest and Westmoreland laboratories, United Kingdom. Stress rupture testing machine used is shown in Figure 3.24.

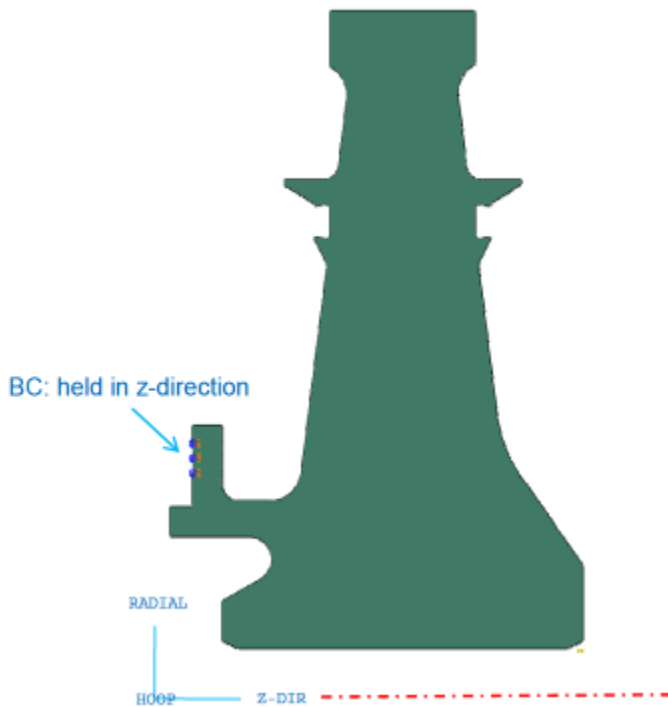
Figure 4.1: Boundary Conditions applied to Finite Element Model

Finite element analysis was performed on the serviced A-286 turbine wheel. The dimensions for the Finite Element model were primarily based on the measurements taken from the dissected section of the A-286 turbine wheel. The boundary conditions were applied as a lateral restraint in the axial direction, as shown in Figure 4.1.

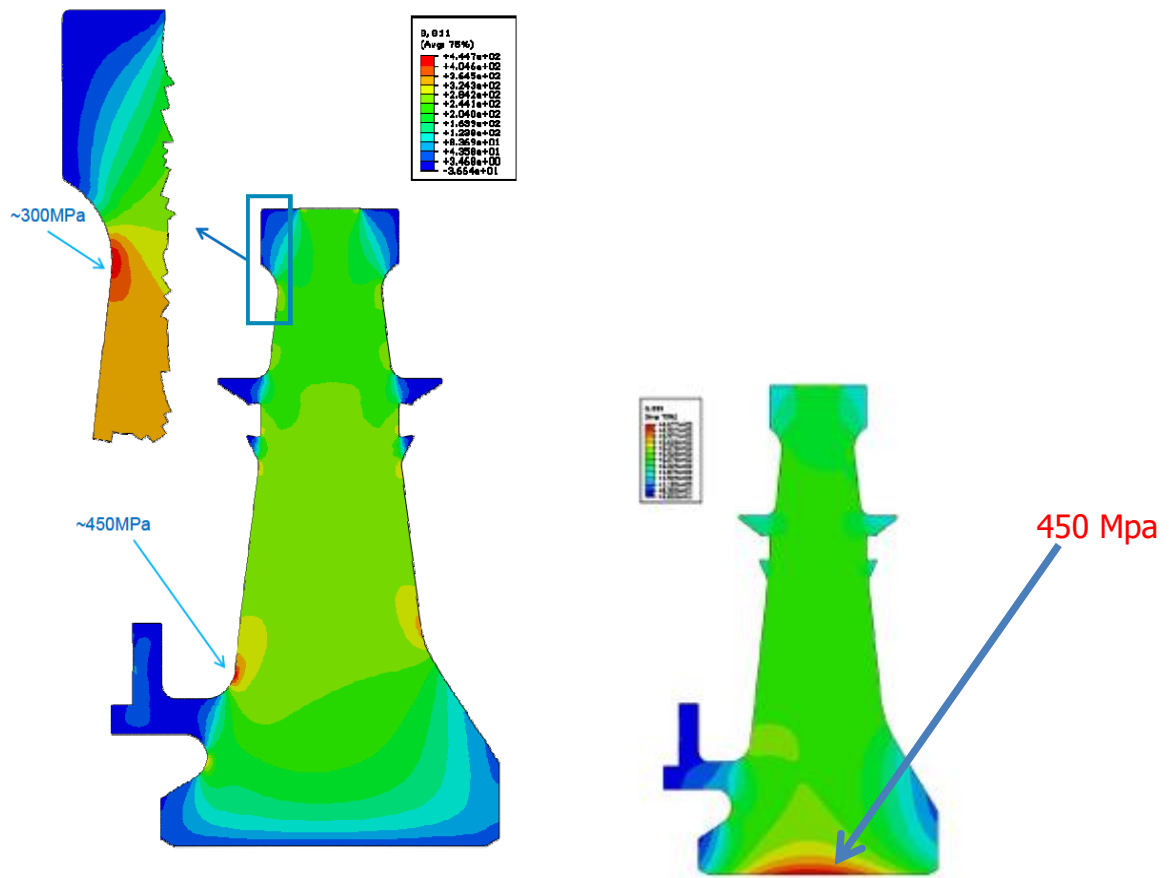
Figure 4.2: Stress Distribution Pattern in the serviced A-286 turbine wheel

The peak hoop stress occurs in the bore as would be expected. The radial stress distribution is more complex with stress concentrations occurring over a number of locations. The stress across the wheel was in the range of 300-450 MPa. While the locations are expected, the values are more dependent upon the geometry, boundary conditions and applied (blade) load. Obviously, the 2-D axisymmetric model does not include the dovetail slots; and hence the stress distribution shown near the rim is not representative of the real component. The stress distribution pattern on the serviced A-286 turbine wheel is shown in Figure 4.2.

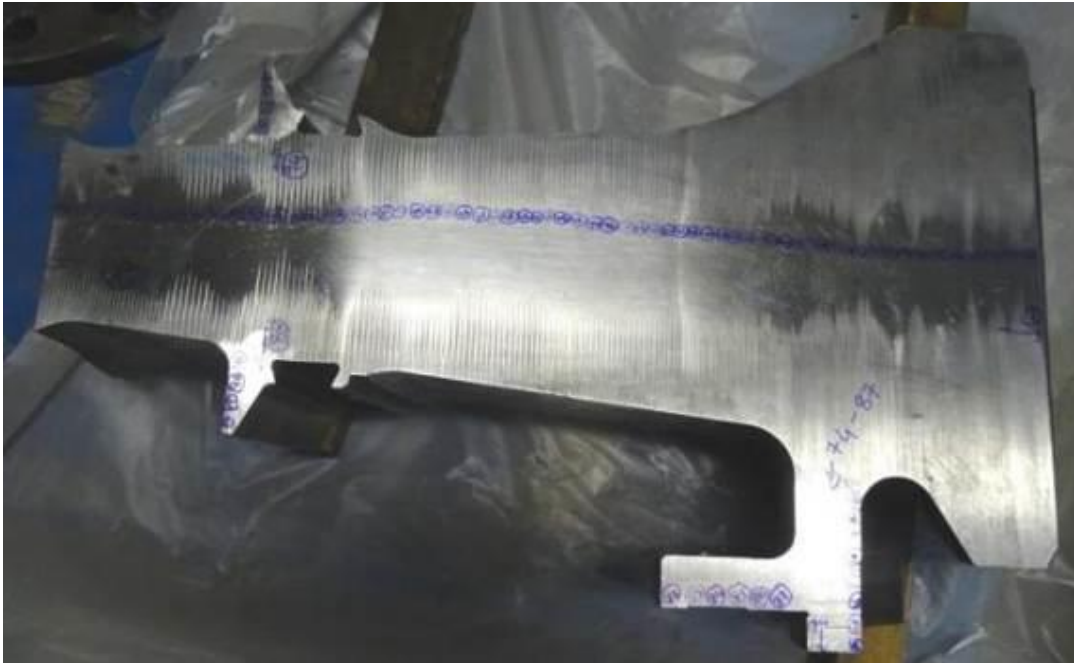
Figure 4.3: Portable hardness test locations on dissected section of A-286 test block

The portable hardness testing was conducted on the dissected section of the A-286 serviced wheel. The hardness measurement locations are shown in Figure 4.3.

It could be noted that there is no significant variation in the hardness. The hardness varies in the range of 314 to 344 HV.

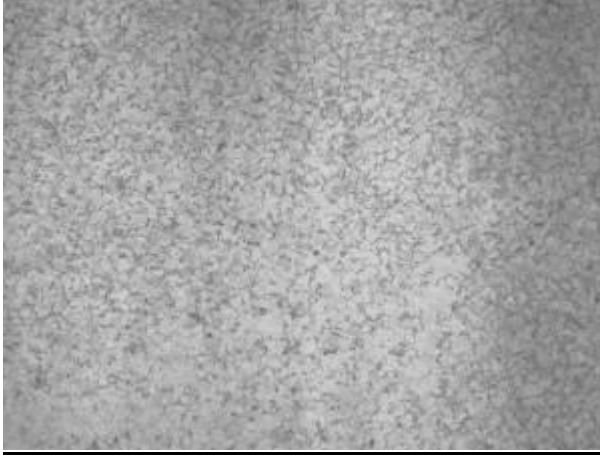
Figure 4.4: Micrograph of as new A-286 bar; transverse section showing the general microstructure; Etched; Original Magnification – 200x (GS:6-7)

The micrographs of the as new A-286 bar and serviced turbine wheel are presented in Figures 4.4 to Figure 4.7.

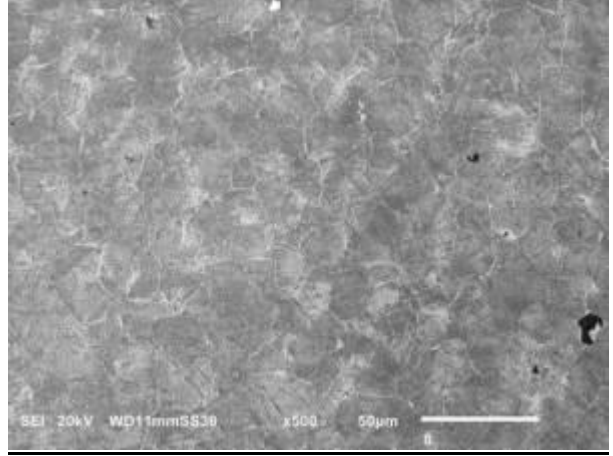
Figure 4.5: SEM micrograph of as new A-286 bar; transverse section; Etched; Original Magnification – 500x

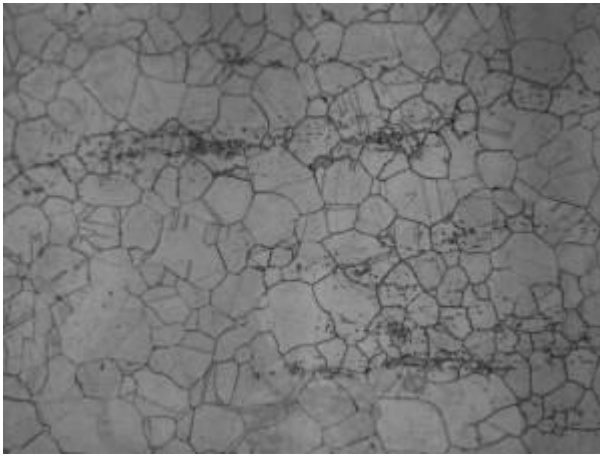
Figure 4.6: Micrograph of serviced turbine wheel; transverse section showing the general microstructure; Etched; Original Magnification – 200x (GS:4-5)

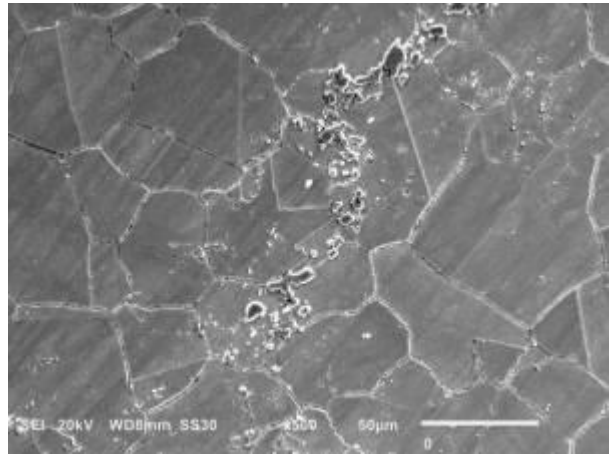
Figure 4.7: SEM micrograph of serviced turbine wheel; transverse section displays carbide network; Etched; Original Magnification – 500x

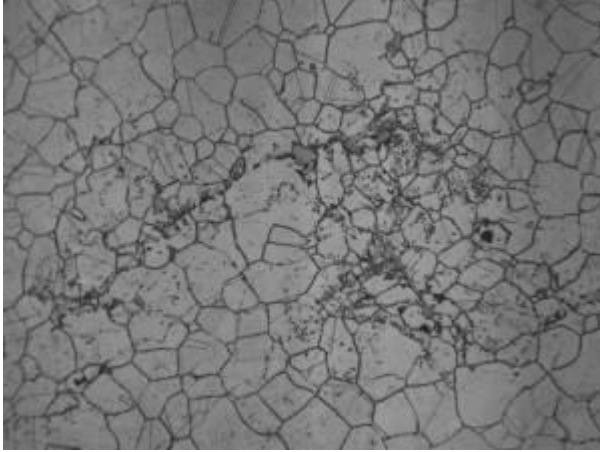
Figure 4.8: Micrograph of Transverse section after pilot HT (SA – 750 °C x 3hrs) showing the general microstructure; Etched; Original Magnification – 200x (GS:4-5)

The micrographs of the pilot solution annealing heat treatments are presented in Figures 4.8 to Figure 4.13.

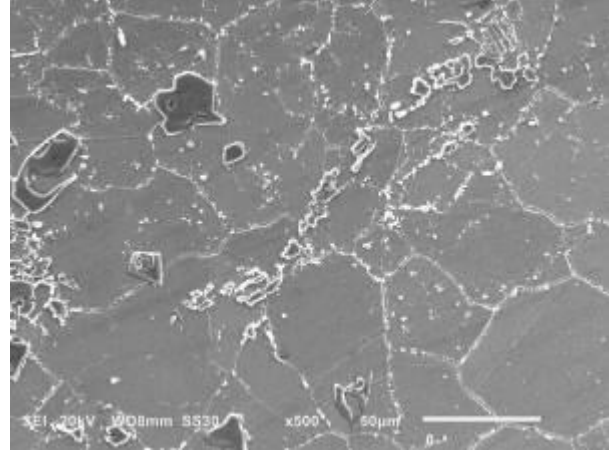
Figure 4.9: SEM micrograph of Transverse section after pilot HT (SA – 750 °C x 3hrs) showing the general microstructure Etched; Original Magnification – 500x

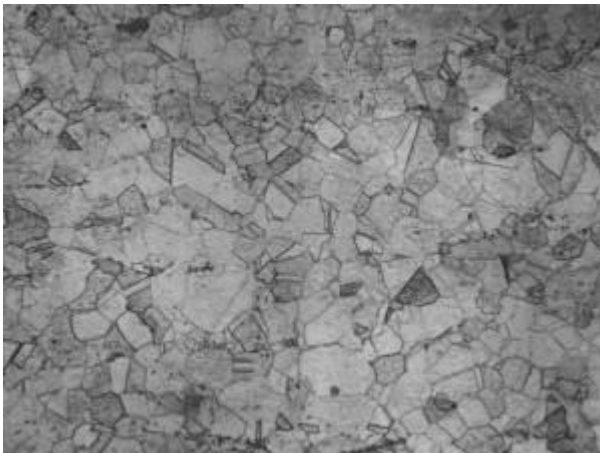
Figure 4.10: Micrograph of Transverse section after pilot HT (SA – 950 °C x 3hrs) showing the general microstructure; Etched; Original Magnification – 200x (GS:5-6)

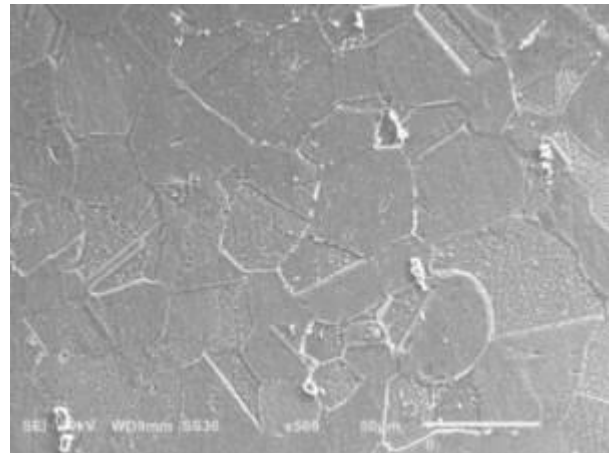
Figure 4.11: SEM micrograph of Transverse section after pilot HT (SA – 950 °C x 3hrs) showing the general microstructure; Etched; Original Magnification – 500x

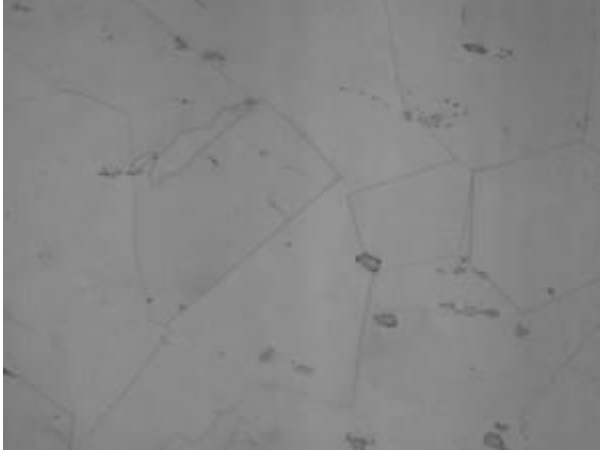
Figure 4.12: Micrograph of Transverse section after pilot HT (SA – 1120 °C x 3hrs) showing the general microstructure; Etched; Original Magnification – 200x (GS:1-2)

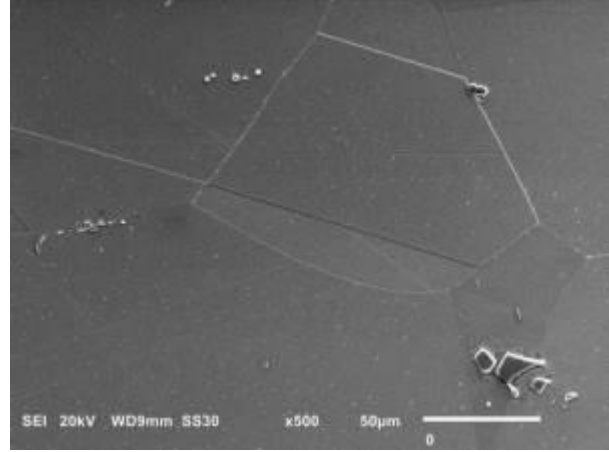
Figure 4.13: SEM micrograph of Transverse section after pilot HT (SA – 1120 °C x 3hrs) showing the general microstructure; Etched; Original Magnification – 500x

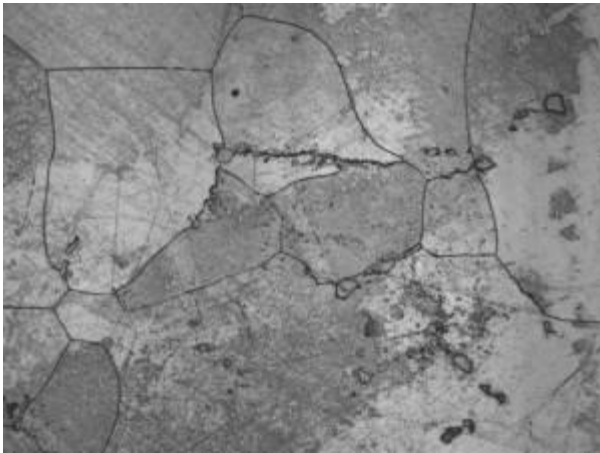
Figure 4.14: Micrograph of Transverse section after HT (SA – 1120 °C x 2hrs & Age 720 °C x 16hrs) showing the general microstructure; Etched; Original Magnification – 200x (GS:1-2)

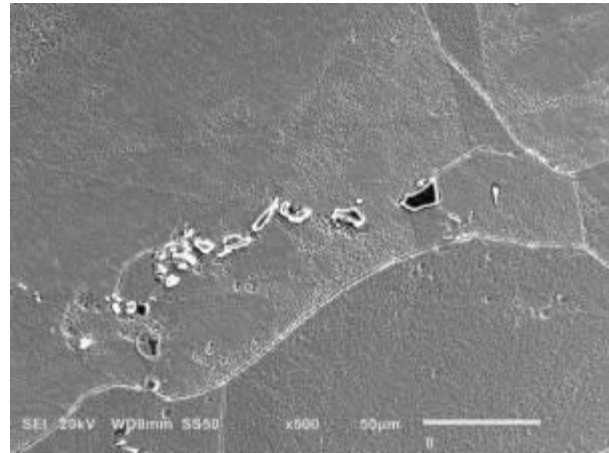
Figure 4.15: SEM micrograph of Transverse section after HT (SA – 1120 °C x 2hrs & Age 720 °C x 16hrs) showing the general microstructure; Etched; Original Magnification – 500x

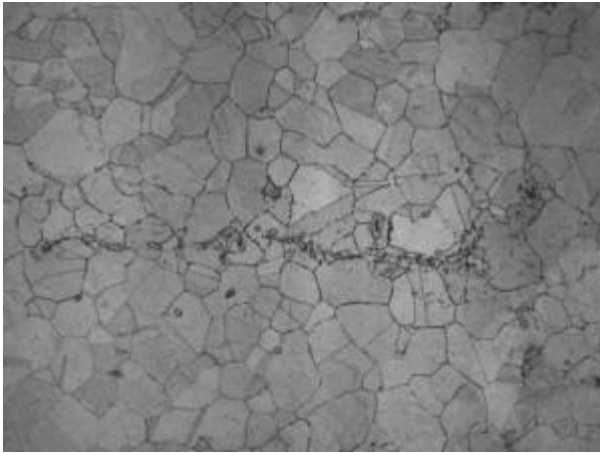
Figure 4.16: Micrograph of Transverse section after HT (SA - 950 °C x 2hrs & Age 720 °C x 16hrs) showing the general microstructure; Etched; Original Magnification - 200x (GS:4-5)

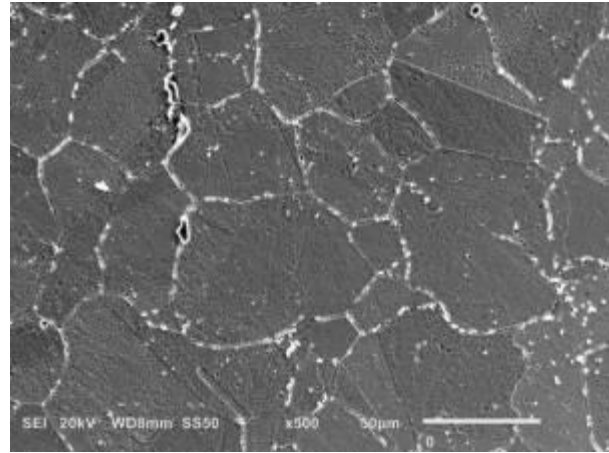
Figure 4.17: SEM micrograph of Transverse section after HT (SA - 950 °C x 2hrs & Age 720 °C x 16hrs) showing the general microstructure; Etched; Original Magnification - 500x

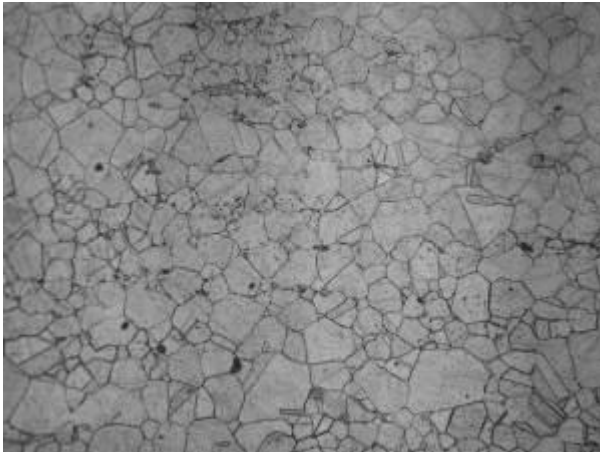
Figure 4.18: Micrograph of Transverse section after HT (SA - 950 °C x 3hrs & Age 720 °C x 16hrs) showing the general microstructure; Etched; Original Magnification - 200x (GS:5-6)

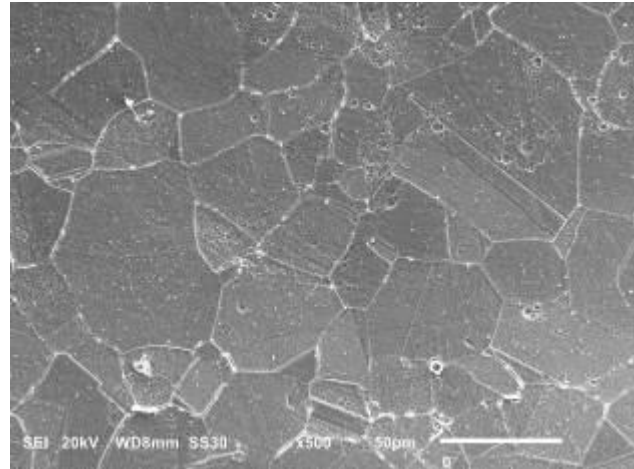
Figure 4.19: SEM micrograph of Transverse section after HT (SA - 950 °C x 3hrs & Age 720 °C x 16hrs) showing the general microstructure; Etched; Original Magnification - 500x

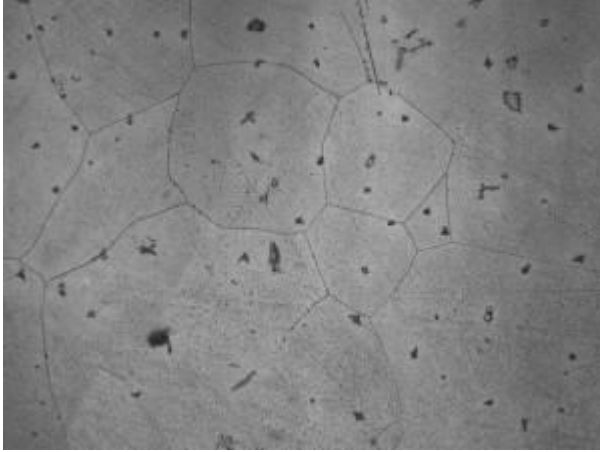
Figure 4.20: Micrograph of Transverse section after HT (SA – 1120 °C x 3hrs & Age 720 °C x 16hrs) showing the general microstructure; Etched; Original Magnification – 200x(GS:1-2)

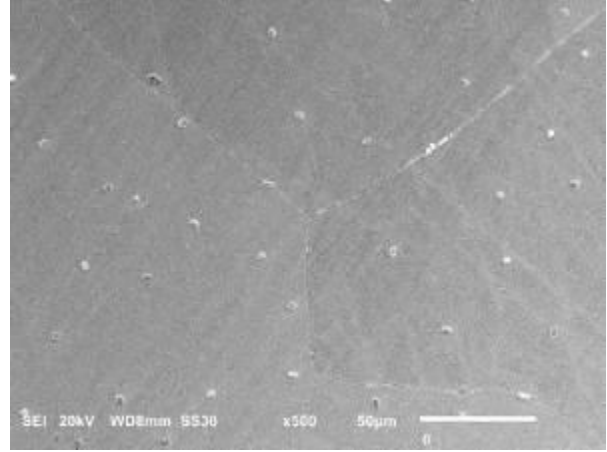
Figure 4.21: SEM micrograph of Transverse section after HT (SA – 1120 °C x 3hrs & Age 720 °C x 16hrs) showing the general microstructure; Etched; Original Magnification – 500x

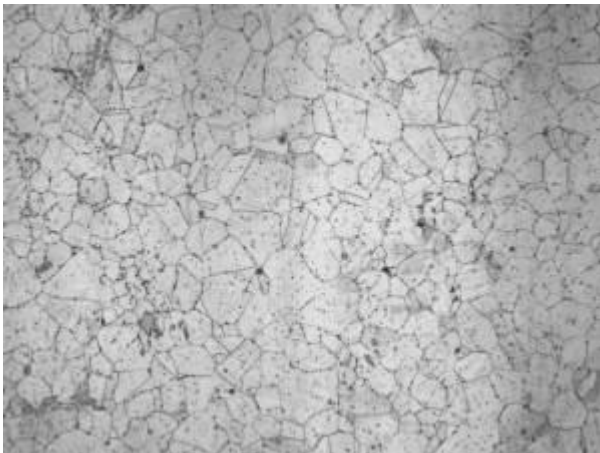
Figure 4.22: Micrograph of Transverse section after HT (SA – 950 °C x 3hrs & Age 600 °C x 4hrs) showing the general microstructure Etched; Original Magnification – 200x (GS:4-5)

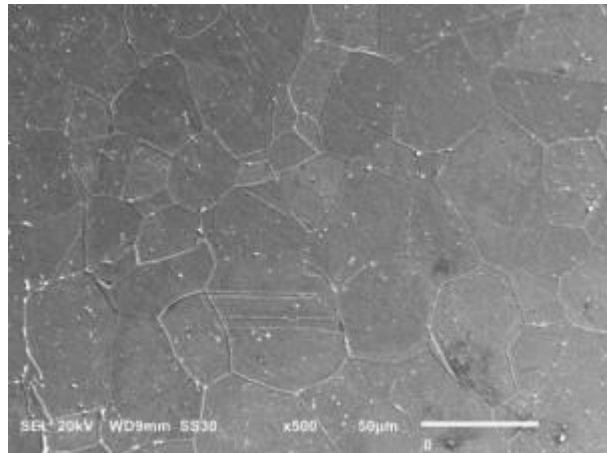
Figure 4.23: SEM micrograph of Transverse section; after HT (SA – 950 °C x 3hrs & Age 600 °C x 4hrs) showing the general microstructure Etched; Original Magnification – 500x

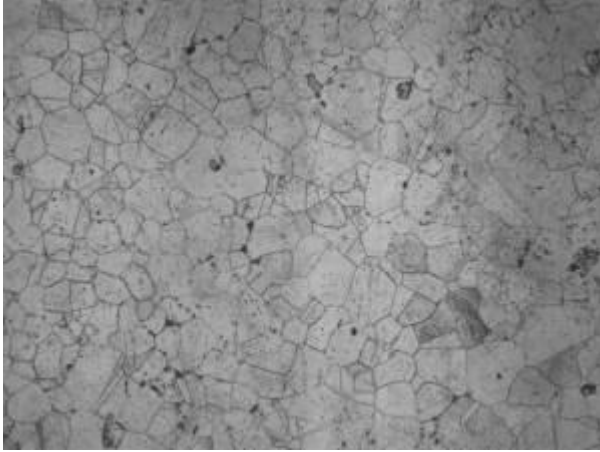
Figure 4.24: Micrograph of Transverse section after HT (SA - 950 °C x 3hrs & Age 600 °C x 8hrs) showing the general microstructure; Etched; Original Magnification - 200x (GS:4-5)

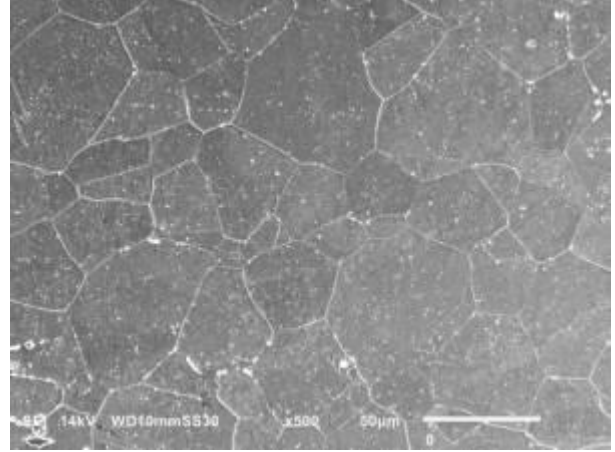
Figure 4.25: SEM micrograph of Transverse section after HT (SA - 950 °C x 3hrs & Age 600 °C x 8hrs) showing the general microstructure Etched; Original Magnification - 500x

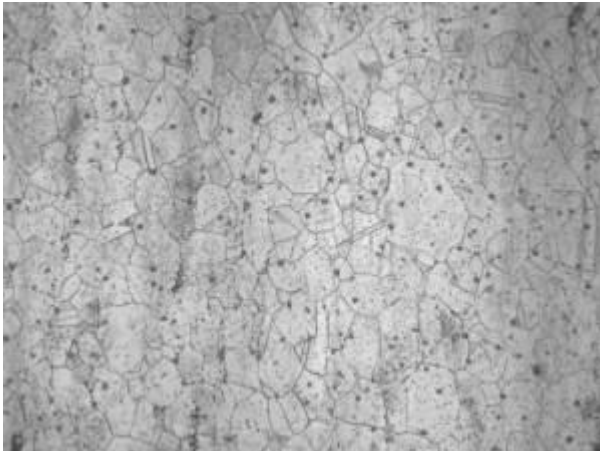
Figure 4.26: Micrograph of Transverse section after HT (SA - 950 °C x 3hrs & Age 600 °C x 12hrs) showing the general microstructure; Etched; Original Magnification - 200x (GS:5-6)

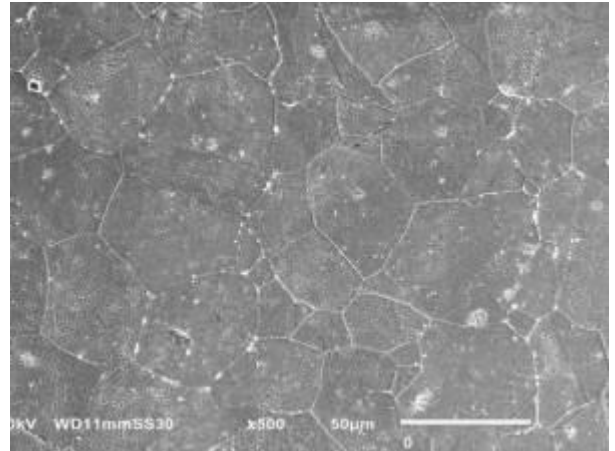
Figure 4.27: SEM micrograph of Transverse section after HT (SA - 950 °C x 3hrs & Age 600 °C x 12hrs) showing the general microstructure Etched; Original Magnification - 500x

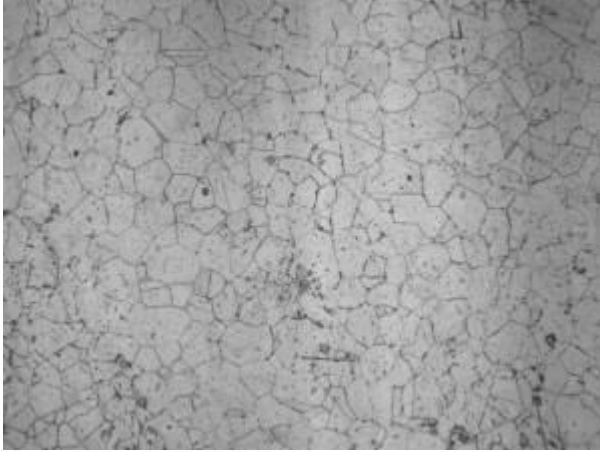
Figure 4.28: Micrograph of Transverse section after HT (SA – 950 °C x 3hrs & Age 640 °C x 4hrs) showing the general microstructure; Etched; Original Magnification – 200x (GS:5-6)

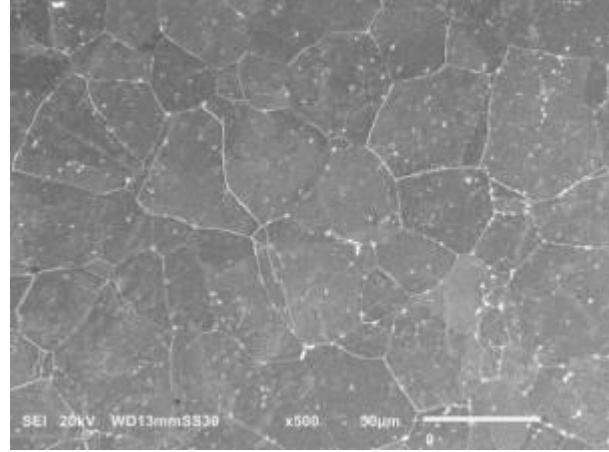
Figure 4.29: SEM micrograph of Transverse section after HT (SA – 950 °C x 3hrs & Age 640 °C x 4hrs) showing the general microstructure Etched; Original Magnification – 500x

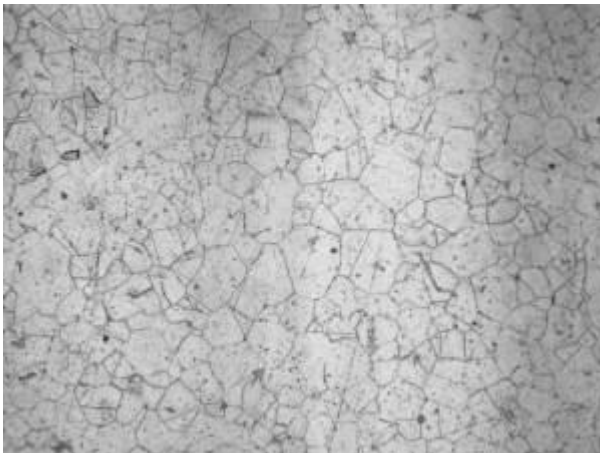
Figure 4.30: Micrograph of Transverse section after HT (SA – 950 °C x 3hrs & Age 640 °C x 8hrs) showing the general microstructure; Etched; Original Magnification – 200x (GS:5-6)

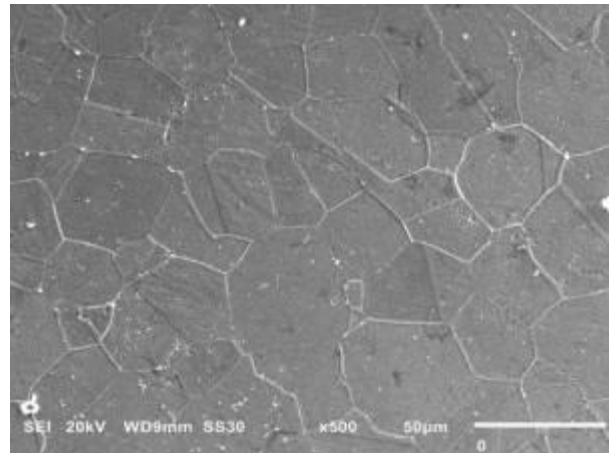
Figure 4.31: SEM micrograph of Transverse section after HT (SA – 950 °C x 3hrs & Age 640 °C x 8hrs) showing the general microstructure Etched; Original Magnification – 500x
