**Study of Rejuvenation Heat Treatment for Life
Extension of A-286 Gas Turbine Wheels**

Submitted
**IN PARTIAL FULFILLMENT OF THE REQUIREMENT OF
THE DEGREE OF DOCTOR OF PHILOSOPHY**

**UNIVERSITY OF PETROLEUM AND ENERGY STUDIES
DEHRADUN**

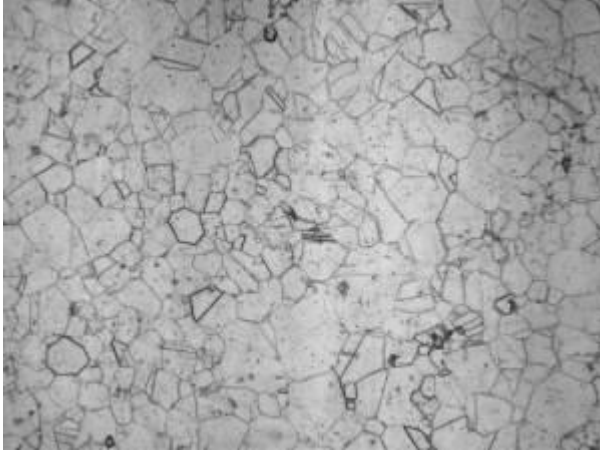
Figure 4.32: Micrograph of Transverse section after HT (SA - 950 °C x 3hrs & Age 640 °C x 12hrs) showing the general microstructure; Etched; Original Magnification - 200x (GS:6-7)

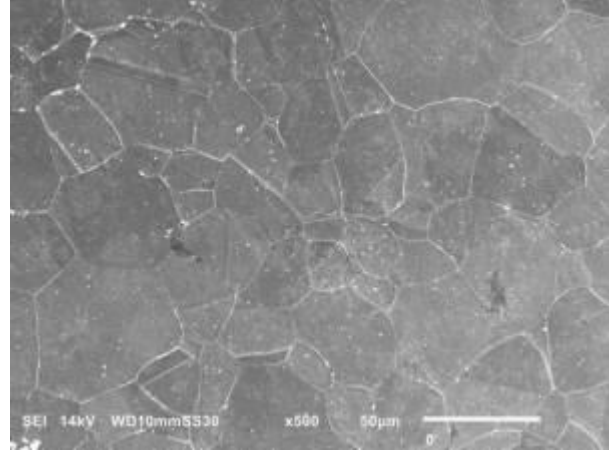
Figure 4.33: SEM micrograph of Transverse section after HT (SA - 950 °C x 3hrs & Age 640 °C x 12hrs) showing the general microstructure Etched; Original Magnification - 500x

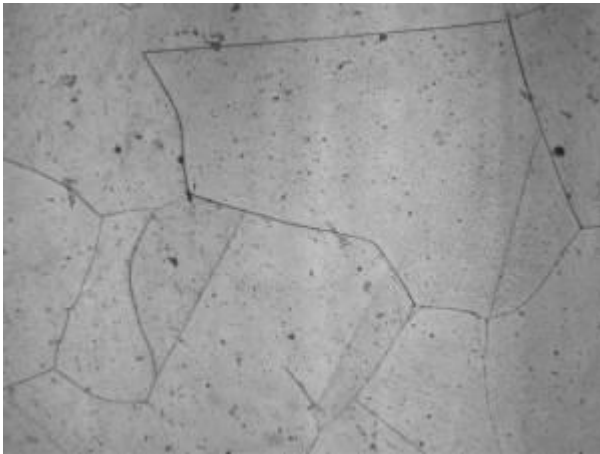
Figure 4.34: Micrograph of Transverse section after HT (SA - 1120 °C x 3hrs & Age 600 °C x 4hrs) showing the general microstructure; Etched; Original Magnification - 200x (GS:1-2)

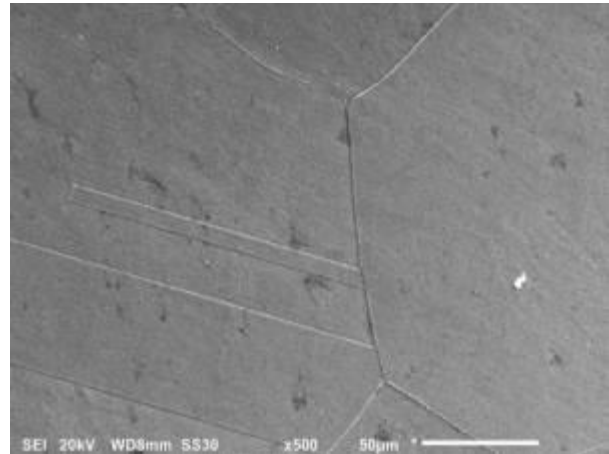
Figure 4.35: SEM micrograph of Transverse section after HT (SA - 1120 °C x 3hrs & Age 600 °C x 4hrs) showing the general microstructure; Etched; Original Magnification - 500x

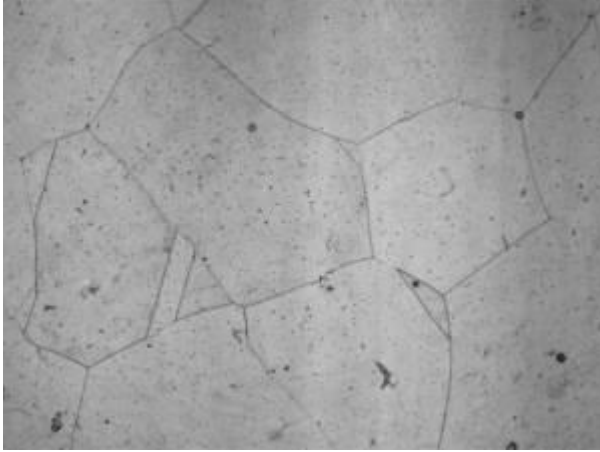
Figure 4.36: Micrograph of Transverse section after HT (SA – 1120 °C x 3hrs & Age 600 °C x 8hrs) showing the general microstructure; Etched; Original Magnification – 200x (GS:2-3)

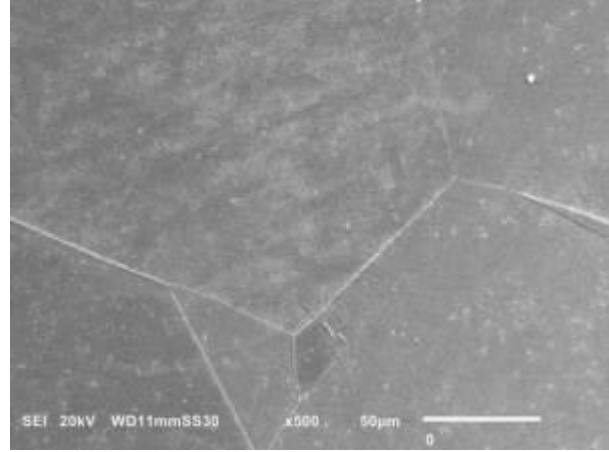
Figure 4.37: SEM micrograph of Transverse section after HT (SA – 1120 °C x 3hrs & Age 600 °C x 8hrs) showing the general microstructure; Etched; Original Magnification – 500x

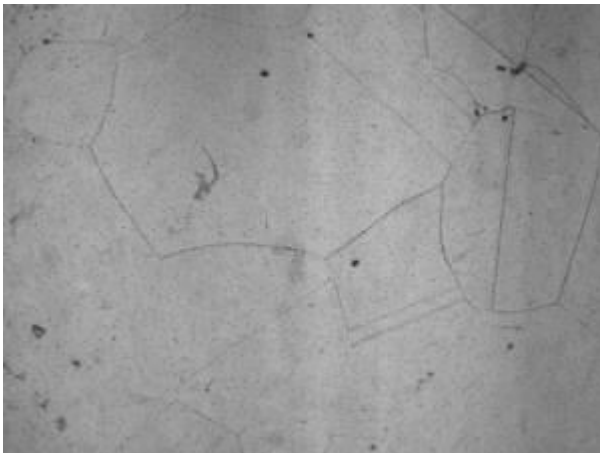
Figure 4.38: Micrograph of Transverse section after HT (SA – 1120 °C x 3hrs & Age 600 °C x 12hrs) showing the general microstructure; Etched; Original Magnification – 200x (GS:2-3)

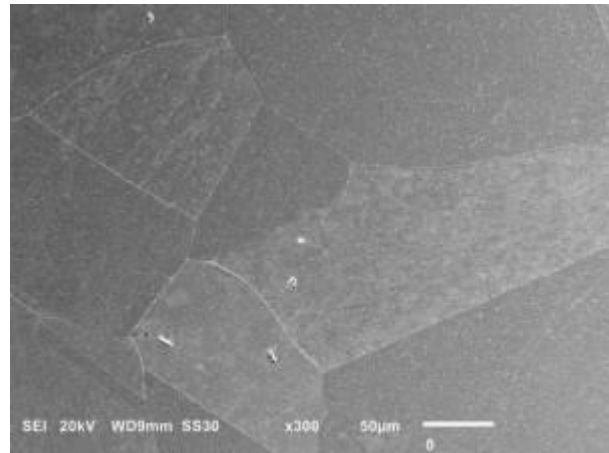
Figure 4.39: SEM micrograph of Transverse section after HT (SA – 1120 °C x 3hrs & Age 600 °C x 12hrs) showing the general microstructure Etched; Original Magnification – 500x

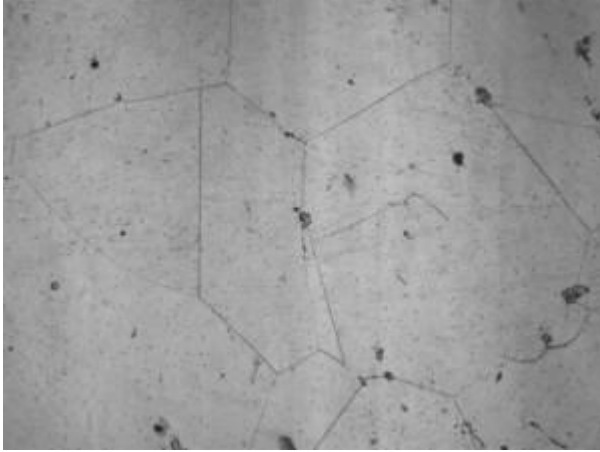
Figure 4.40: Micrograph of Transverse section after HT (SA – 1120 °C x 3hrs & Age 640 °C x 4hrs) showing the general microstructure; Etched; Original Magnification – 200x (GS:1-2)

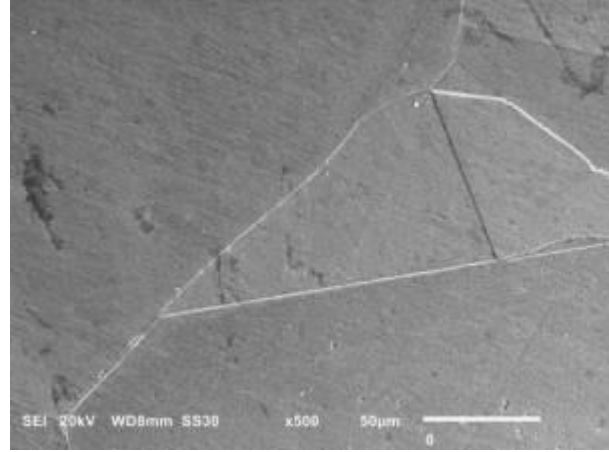
Figure 4.41: SEM micrograph of Transverse section after HT (SA – 1120 °C x 3hrs & Age 640 °C x 4hrs) showing the general microstructure; Etched; Original Magnification – 500x

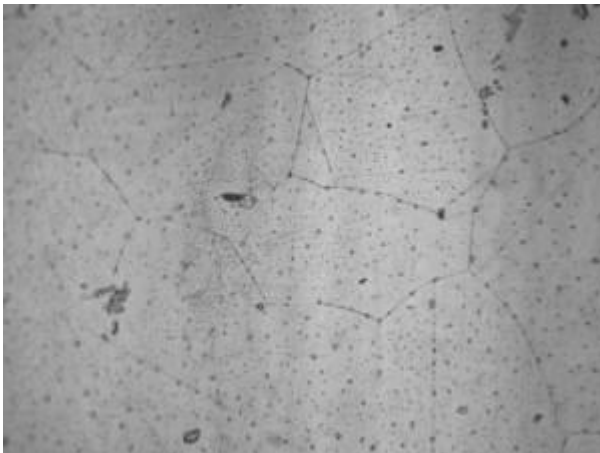
Figure 4.42: Micrograph of Transverse section after HT (SA – 1120 °C x 3hrs & Age 640 °C x 8hrs) showing the general microstructure; Etched; Original Magnification – 200x (GS:2-3)

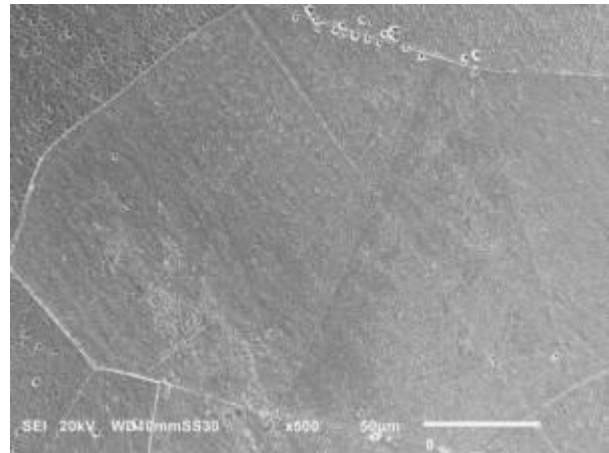
Figure 4.43: SEM micrograph of Transverse section after HT (SA – 1120 °C x 3hrs & Age 640 °C x 8hrs) showing the general microstructure; Etched; Original Magnification – 500x

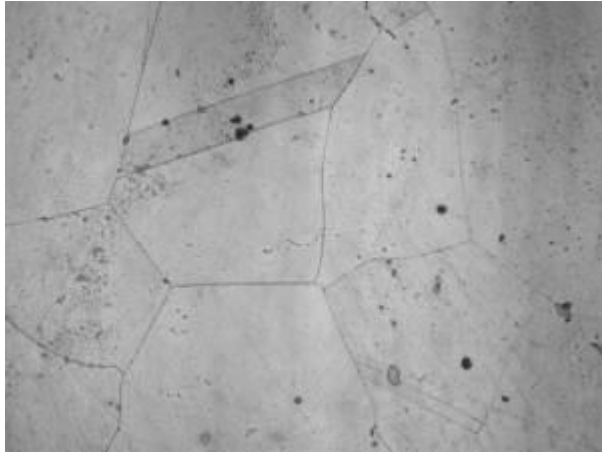
Figure 4.44: Micrograph of Transverse section after HT (SA – 1120 °C x 3hrs & Age 640 °C x 12hrs) showing the general microstructure Etched; Original Magnification – 200x (GS:2-3)

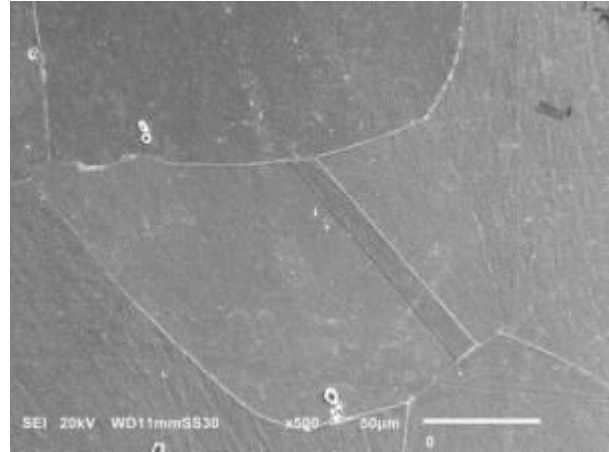
Figure 4.45: SEM micrograph of Transverse section after HT (SA – 1120 °C x 3hrs & Age 640 °C x 12hrs) showing the general microstructure Etched; Original Magnification – 500x

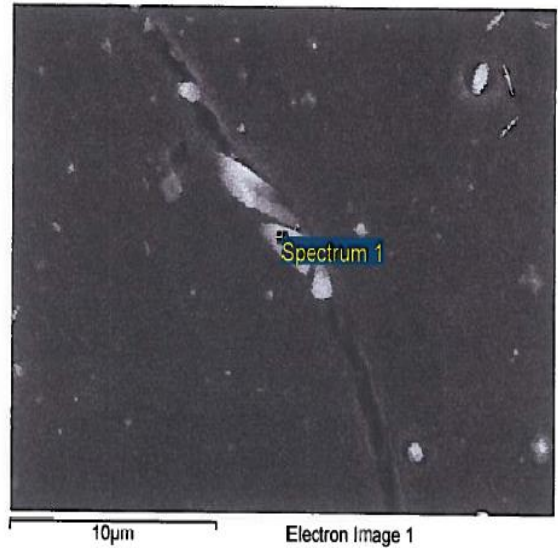
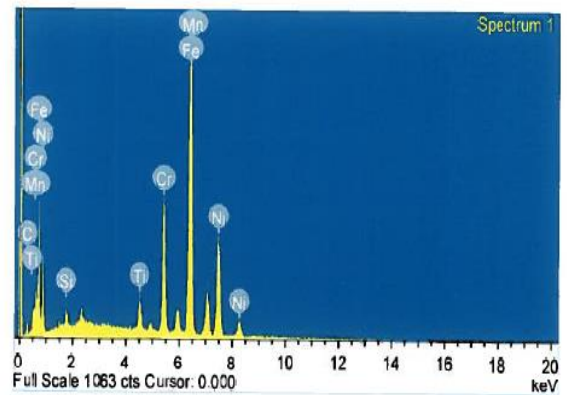
Elem ... Weight% Atomic%

Comment: sample 4A- GB carbide

It is observed that the carbides along the grain boundaries are rich in chromium and titanium. The carbides primarily mapped by EDAX are a combination of $M_{23}C_6$; M_6C ; and MC type carbides.

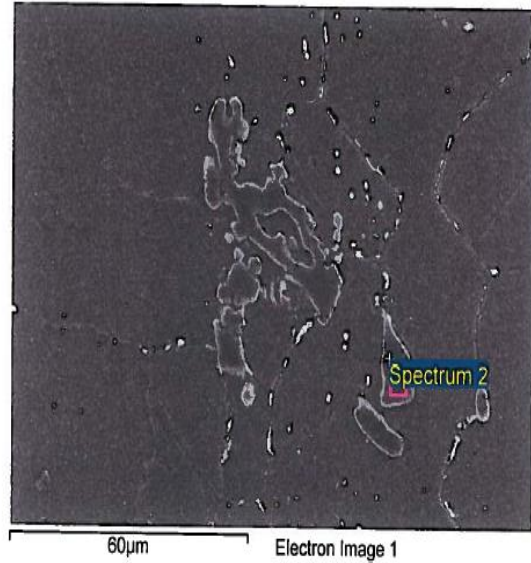
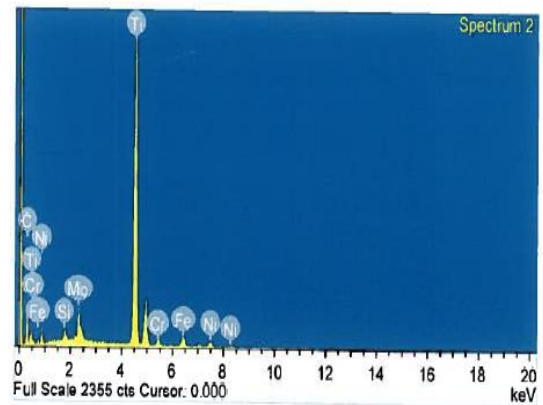
C K	20.61	52.14
Si K	0.71	0.77
Ti K	63.97	40.59
Cr K	1.55	0.90
Fe K	3.71	2.02
Ni K	2.96	1.53
Mo L	6.50	2.06

Comment: sample 4A- GB Carbide 1

Figure 4.47: EDAX Analysis of carbides at location-2 in serviced turbine wheel

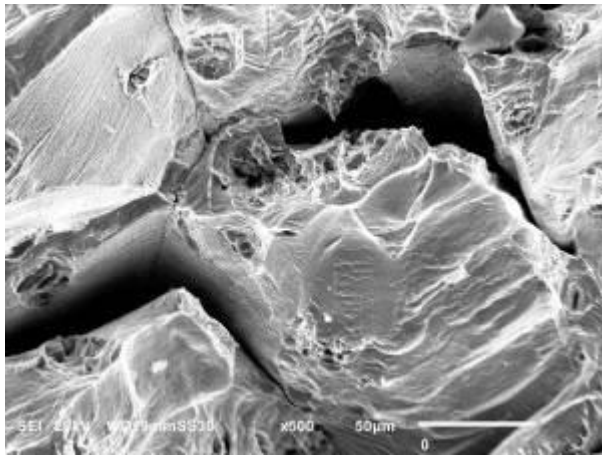
Figure 4.48: SEM micrograph of as new A-286 bar fractured tensile sample at 21°C; Original Magnification – 500x

The fractured surfaces after the mechanical tests, such as tensile, charpy and stress rupture have been examined under scanning electron microscope to study the fracture morphology.

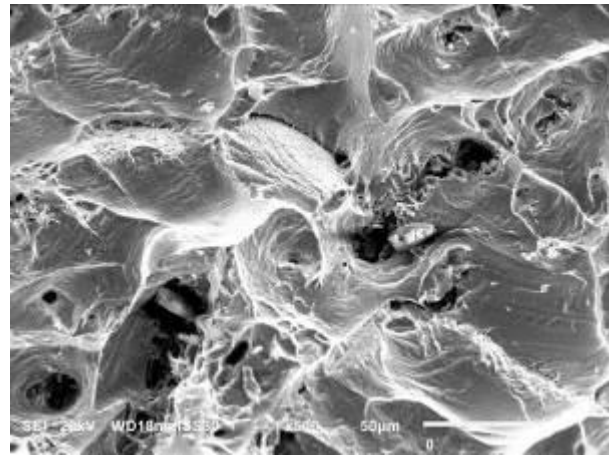
Figure 4.49: SEM micrograph of as new A-286 bar fractured tensile sample at 450°C; Original Magnification – 500x

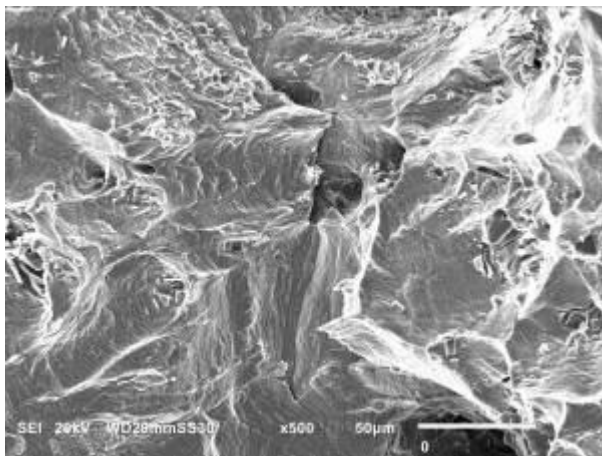
Figure 4.50: SEM micrograph of as new A-286 bar fractured Charpy sample; Original Magnification – 500x

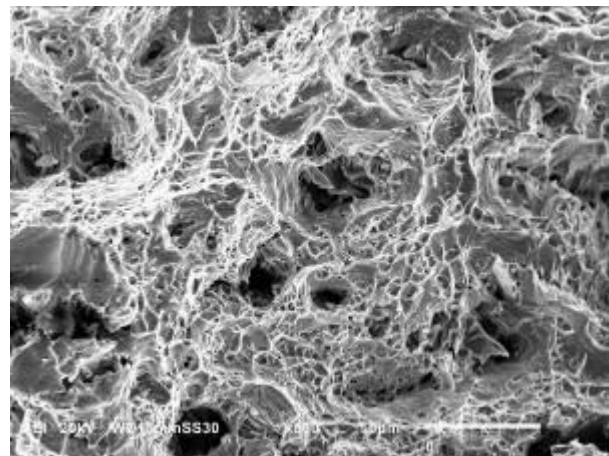
Figure 4.51: SEM micrograph of serviced A-286 wheel fractured tensile sample at 21°C; Original Magnification – 500x

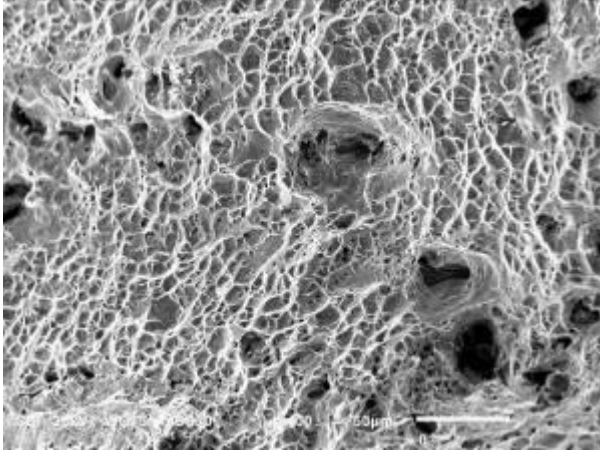
Figure 4.52: SEM micrograph of serviced A-286 wheel fractured tensile sample at 450°C; Original Magnification – 400x

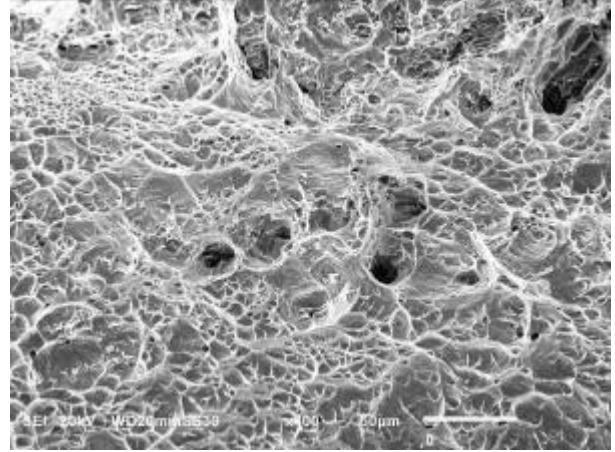
Figure 4.53: SEM micrograph of serviced A-286 wheel fractured Charpy sample; Original Magnification – 400x

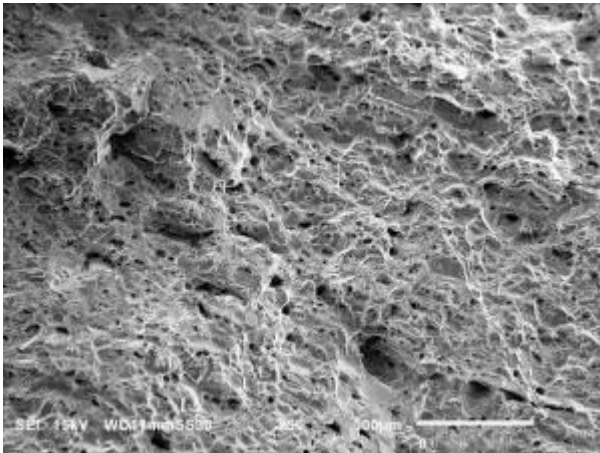
Figure 4.54: SEM micrograph of serviced A-286 wheel fractured stress rupture sample; Original Magnification – 50x

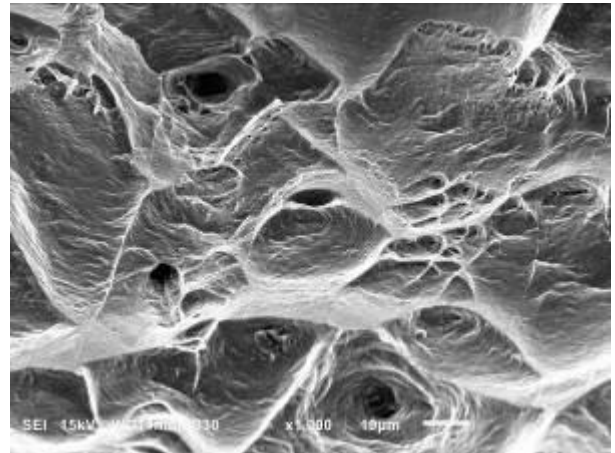
Figure 4.55: SEM micrograph of serviced A-286 wheel fractured stress rupture sample; Original Magnification – 1000x

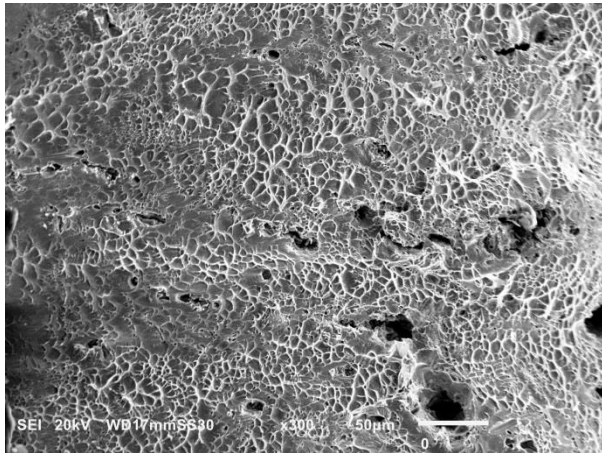
Figure 4.56: SEM micrograph of fractured tensile sample at 21 °C, (SA - 1120 °C x 2 hrs + Age - 720 °C x 16 hrs); Original Magnification - 300x

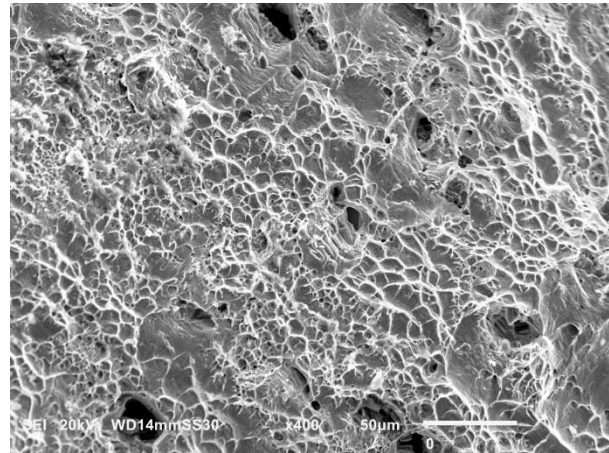
Figure 4.57: SEM micrograph of fractured tensile sample at 450 °C, (SA - 1120 °C x 2 hrs + Age - 720 °C x 16 hrs); Original Magnification - 400x

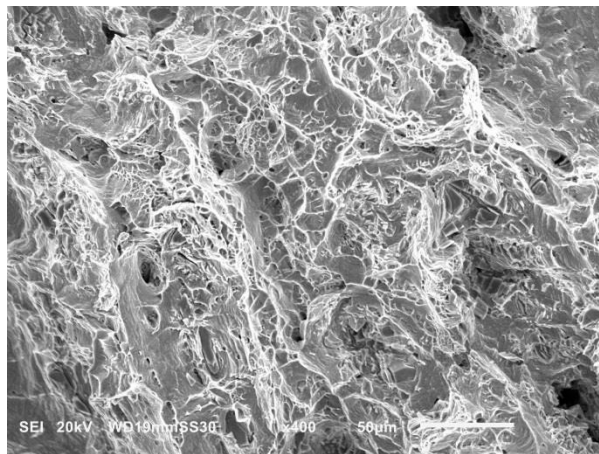
Figure 4.58: SEM micrograph of fractured Charpy sample (SA - 1120 °C x 2 hrs + Age - 720 °C x 16 hrs); Original Magnification - 400x

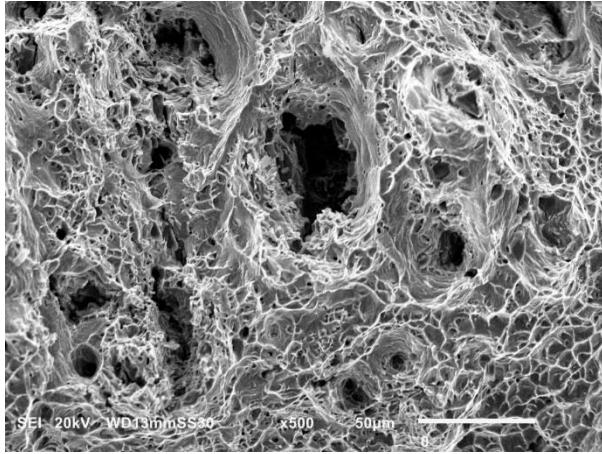
Figure 4.59: SEM micrograph of fractured tensile sample at 21 °C, (SA - 950 °C x 2 hrs + Age - 720 °C x 16 hrs); Original Magnification - 500x

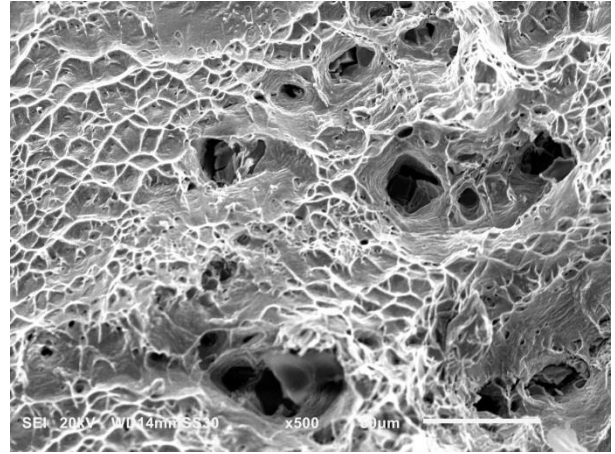
Figure 4.60: SEM micrograph of fractured tensile sample at 450 °C, (SA - 950 °C x 2 hrs + Age - 720 °C x 16 hrs); Original Magnification - 500x

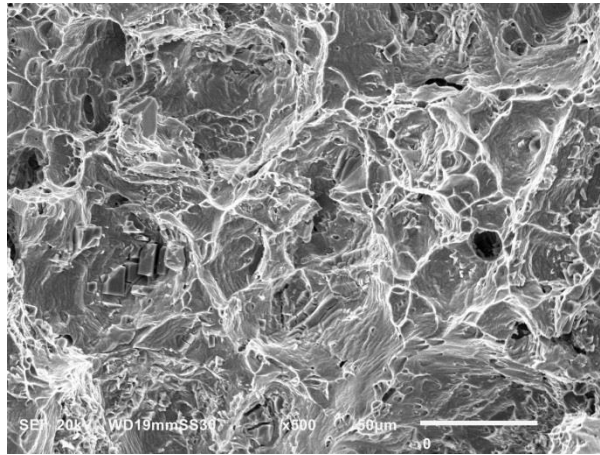
Figure 4.61: SEM micrograph of fractured charpy sample (SA - 950 °C x 2 hrs + Age - 720 °C x 16 hrs); Original Magnification - 500x

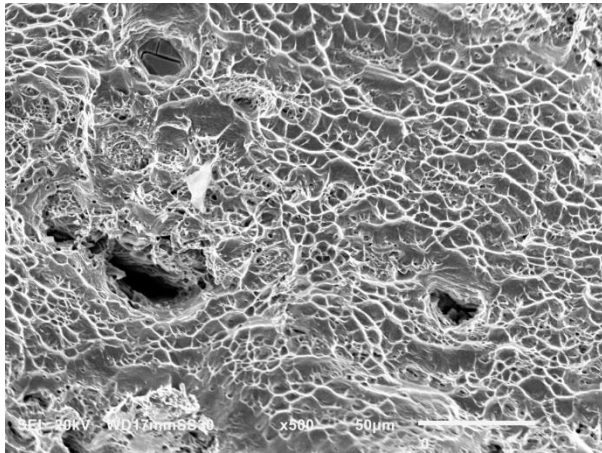
Figure 4.62: SEM micrograph of fractured tensile sample at 21 °C, (SA - 950 °C x 3 hrs + Age - 720 °C x 16 hrs); Original Magnification - 500x

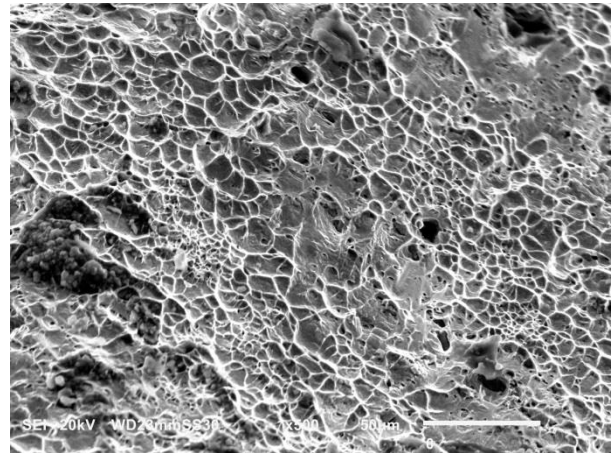
Figure 4.63: SEM micrograph of fractured tensile sample at 450 °C, (SA - 950 °C x 3 hrs + Age - 720 °C x 16 hrs); Original Magnification - 500x

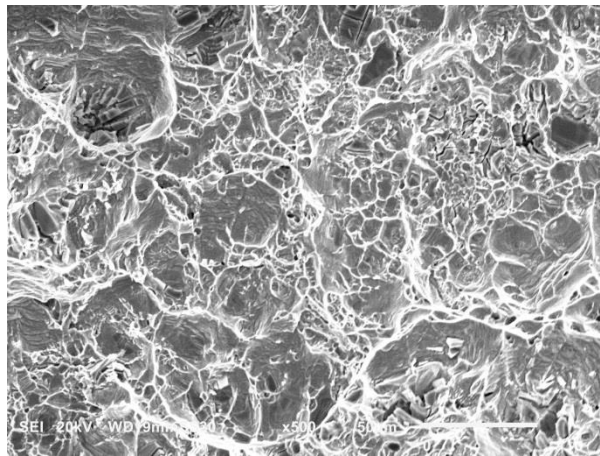
Figure 4.64: SEM micrograph of fractured charpy sample (SA - 950 °C x 3 hrs + Age - 720 °C x 16 hrs); Original Magnification - 500x

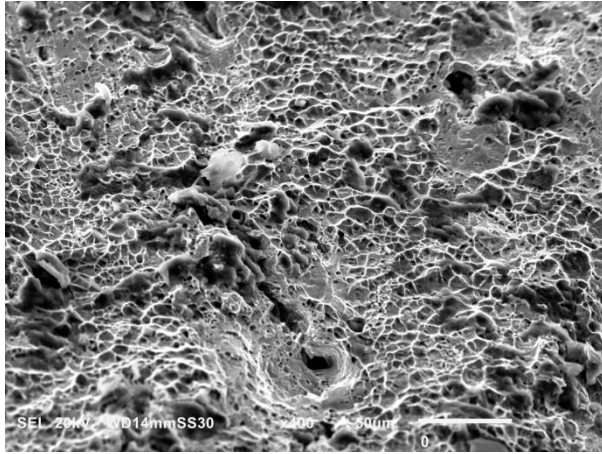
Figure 4.65: SEM micrograph of fractured tensile sample at 21 °C, (SA - 1120 °C x 3 hrs + Age - 720 °C x 16 hrs); Original Magnification - 400x

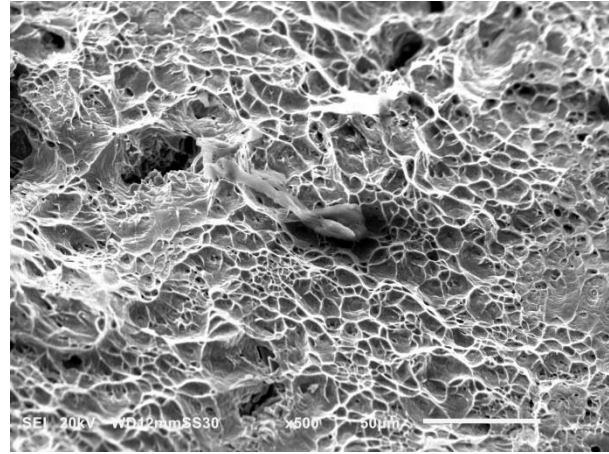
Figure 4.66: SEM micrograph of fractured tensile sample at 450 °C, (SA - 1120 °C x 3 hrs + Age - 720 °C x 16 hrs); Original Magnification - 500x

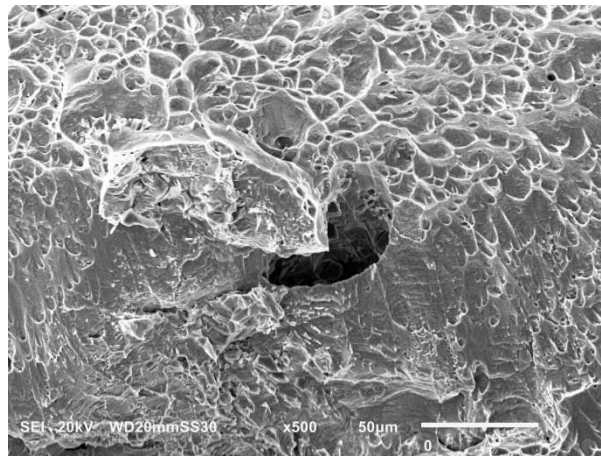
Figure 4.67: SEM micrograph of fractured charpy sample (SA - 1120 °C x 3 hrs + Age - 720 °C x 16 hrs); Original Magnification - 500x

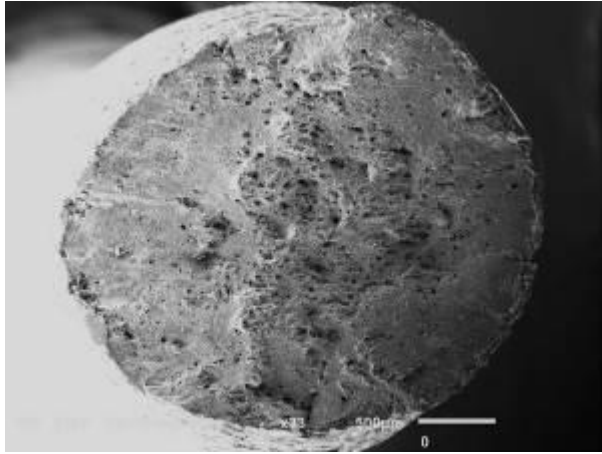
Figure 4.68: SEM micrograph of fractured tensile sample at 21 °C, (SA - 950 °C x 3 hrs + Age - 600 °C x 4 hrs); Original Magnification - 33x

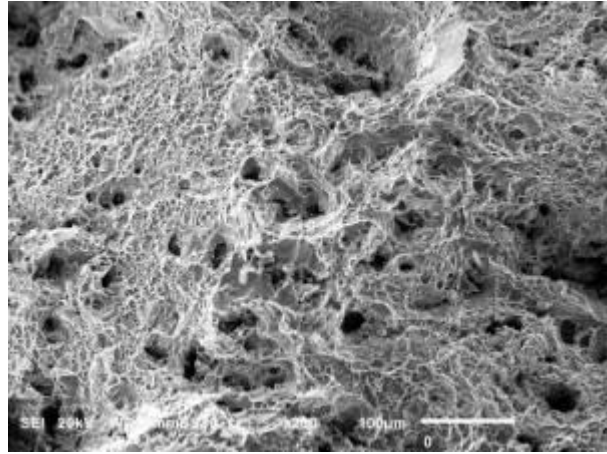
Figure 4.69: SEM micrograph of fractured tensile sample at 21 °C, (SA - 950 °C x 3 hrs + Age - 600 °C x 4 hrs); Original Magnification - 200x

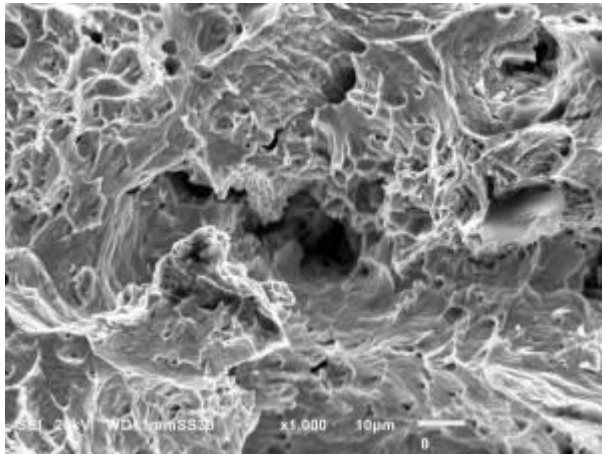
Figure 4.70: SEM micrograph of fractured tensile sample at 21 °C, (SA - 950 °C x 3 hrs + Age - 600 °C x 4 hrs); Original Magnification - 1000x

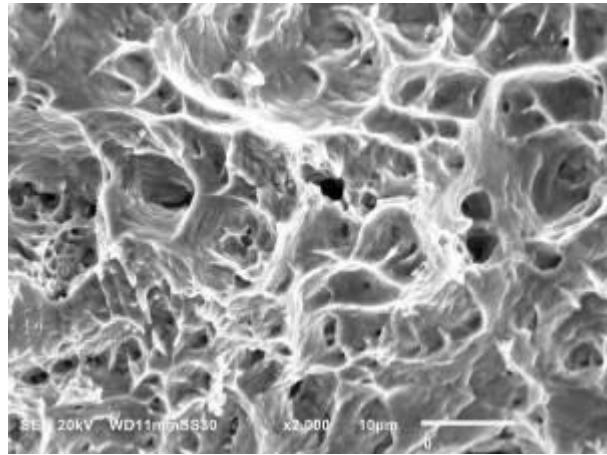
Figure 4.71: SEM micrograph of fractured tensile sample at 21 °C, (SA - 950 °C x 3 hrs + Age - 600 °C x 4 hrs); Original Magnification - 2000x

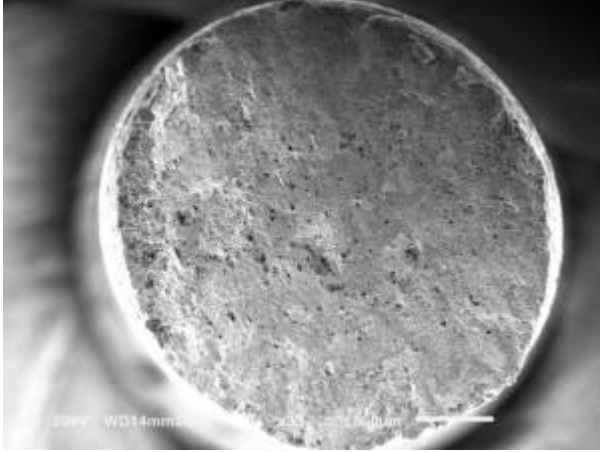
Figure 4.72: SEM micrograph of fractured tensile sample at 450 °C, (SA - 950 °C x 3 hrs + Age - 600 °C x 4 hrs); Original Magnification - 33x

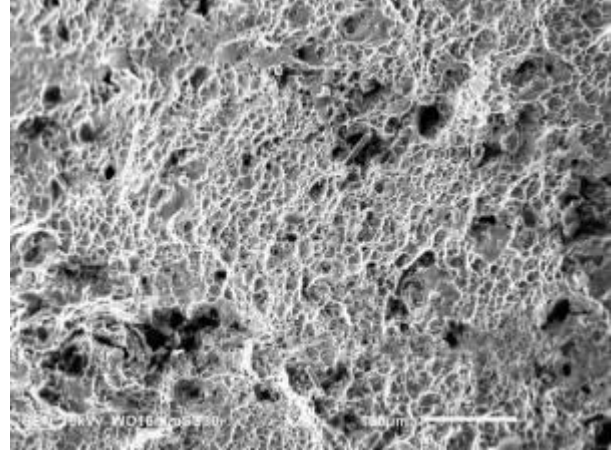
Figure 4.73: SEM micrograph of fractured tensile sample at 450 °C, (SA - 950 °C x 3 hrs + Age - 600 °C x 4 hrs); Original Magnification - 200x

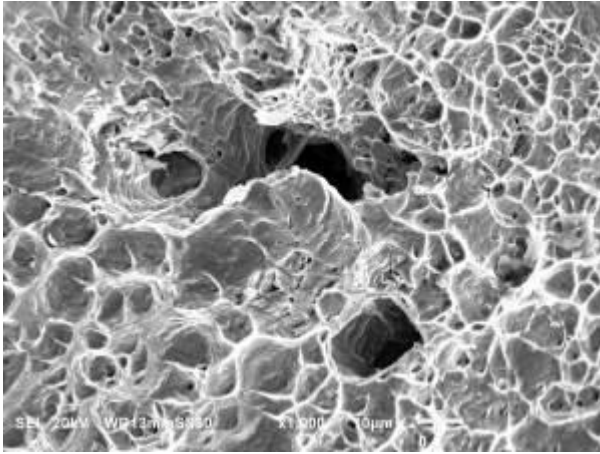
Figure 4.74: SEM micrograph of fractured tensile sample at 450 °C, (SA - 950 °C x 3 hrs + Age - 600 °C x 4 hrs); Original Magnification - 1000x

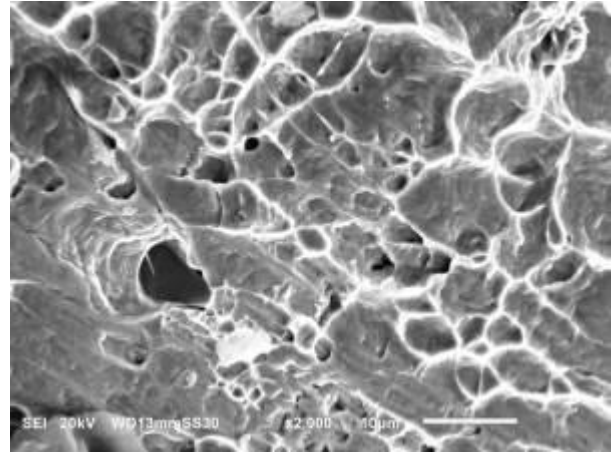
Figure 4.75: SEM micrograph of fractured tensile sample at 450 °C, (SA - 950 °C x 3 hrs + Age - 600 °C x 4 hrs); Original Magnification - 2000x

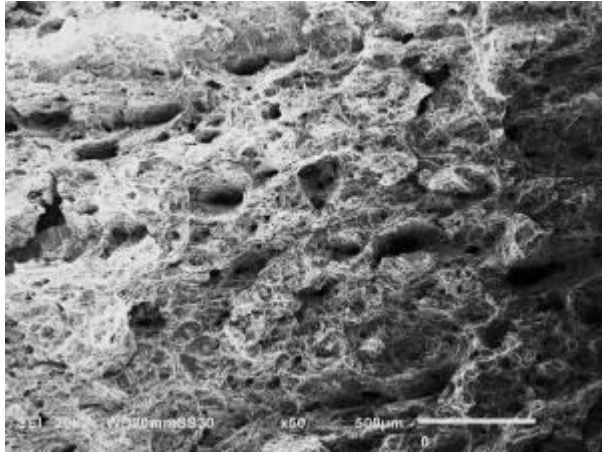
Figure 4.76: SEM micrograph of fractured charpy sample (SA - 950 °C x 3 hrs + Age - 600 °C x 4 hrs); Original Magnification - 50x

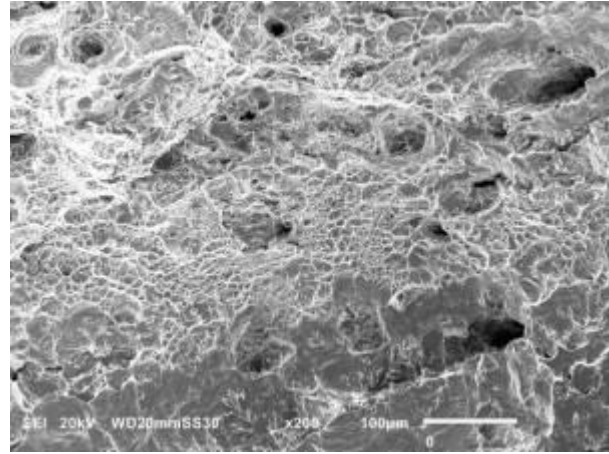
Figure 4.77: SEM micrograph of fractured charpy sample (SA - 950 °C x 3 hrs + Age - 600 °C x 4 hrs); Original Magnification - 200x

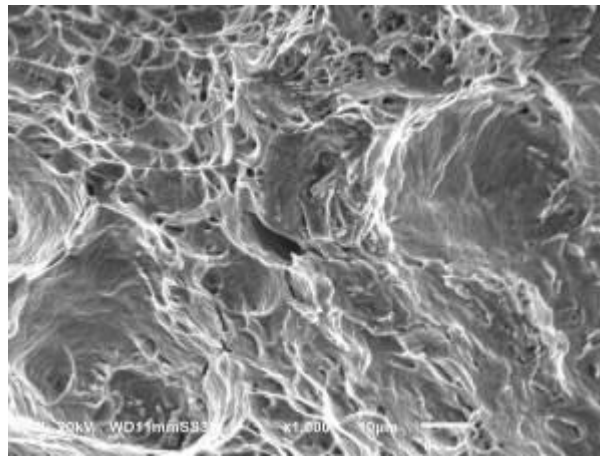
Figure 4.78: SEM micrograph of fractured charpy sample (SA - 950 °C x 3 hrs + Age - 600 °C x 4 hrs); Original Magnification - 1000x

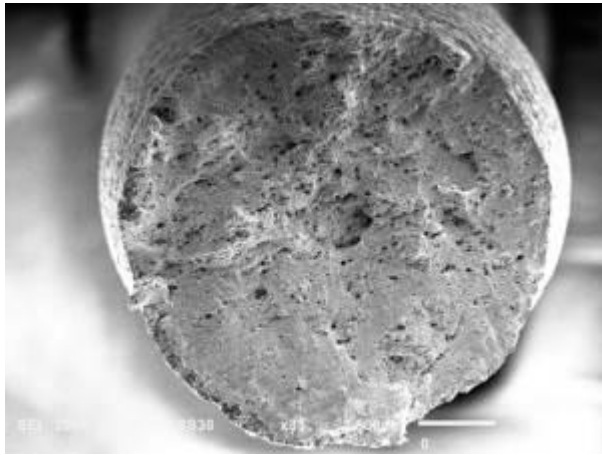
Figure 4.79: SEM micrograph of fractured tensile sample at 21 °C, (SA - 950 °C x 3 hrs + Age - 600 °C x 8 hrs); Original Magnification - 33x

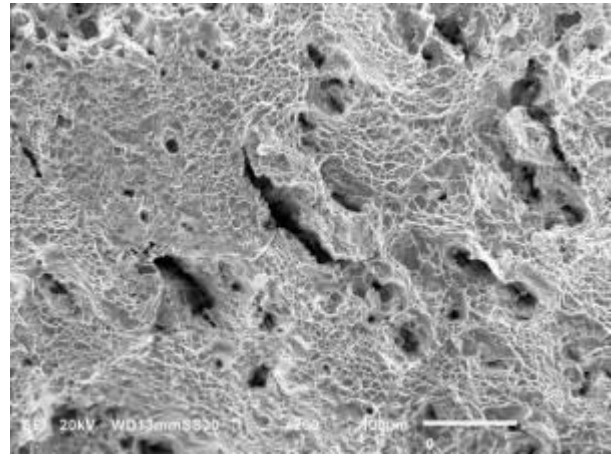
Figure 4.80: SEM micrograph of fractured tensile sample at 21 °C, (SA - 950 °C x 3 hrs + Age - 600 °C x 8 hrs); Original Magnification - 200x

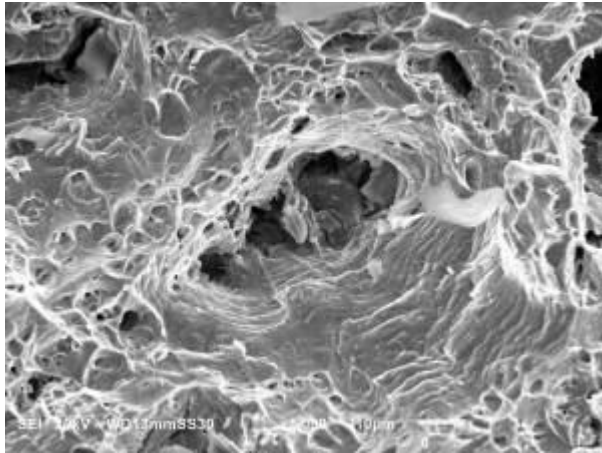
Figure 4.81: SEM micrograph of fractured tensile sample at 21 °C, (SA - 950 °C x 3 hrs + Age - 600 °C x 8 hrs); Original Magnification - 1000x

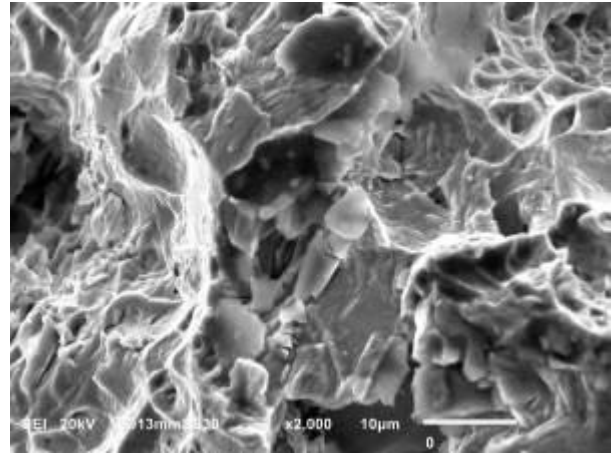
Figure 4.82: SEM micrograph of fractured tensile sample at 21 °C, (SA - 950 °C x 3 hrs + Age - 600 °C x 8 hrs); Original Magnification - 2000x

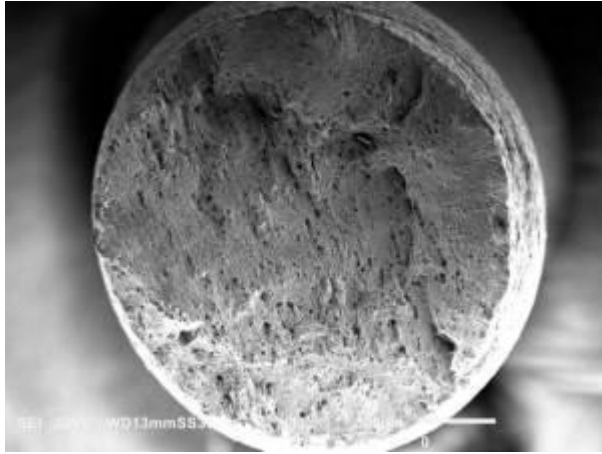
Figure 4.83: SEM micrograph of fractured tensile sample at 450 °C (SA - 950 °C x 3 hrs + Age - 600 °C x 8 hrs); Original Magnification - 33x

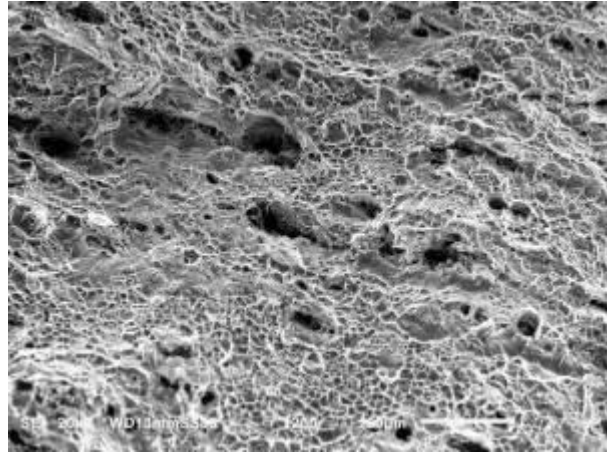
Figure 4.84: SEM micrograph of fractured tensile sample at 450 °C (SA - 950 °C x 3 hrs + Age - 600 °C x 8 hrs); Original Magnification - 200x

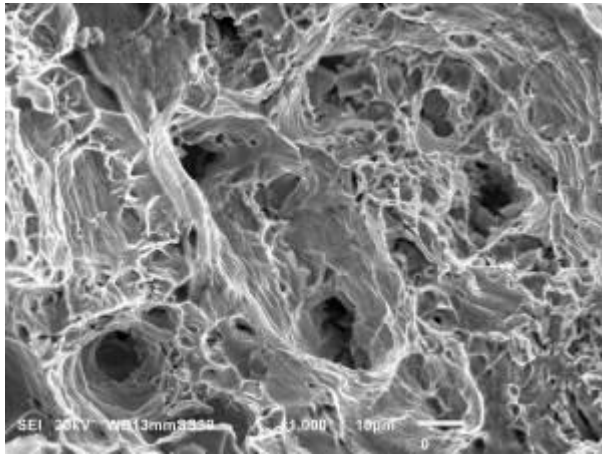
Figure 4.85: SEM micrograph of fractured tensile sample at 450 °C (SA - 950 °C x 3 hrs + Age - 600 °C x 8 hrs); Original Magnification - 1000x

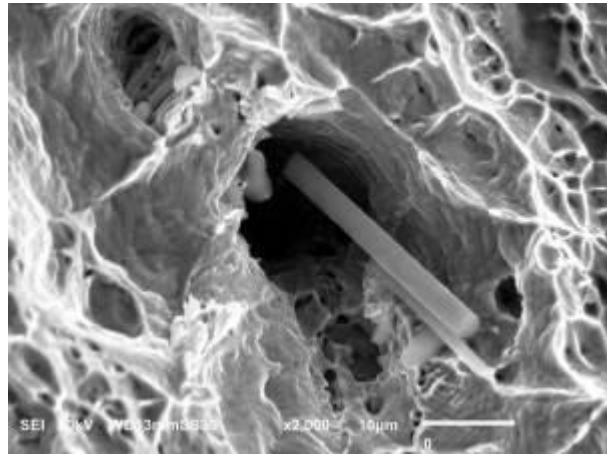
Figure 4.86: SEM micrograph of fractured tensile sample at 450 °C (SA - 950 °C x 3 hrs + Age - 600 °C x 8 hrs); Original Magnification - 2000x

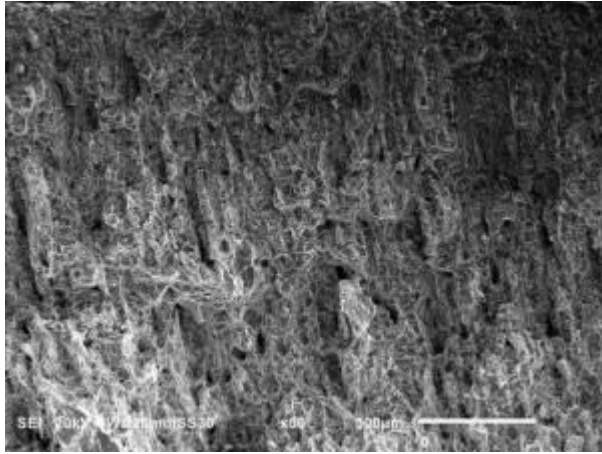
Figure 4.87: SEM micrograph of fractured charpy sample (SA - 950 °C x 3 hrs + Age - 600 °C x 4 hrs); Original Magnification - 50x

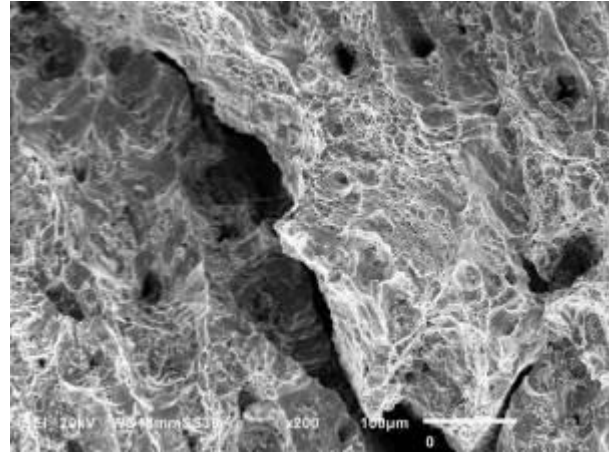
Figure 4.88: SEM micrograph of fractured charpy sample (SA - 950 °C x 3 hrs + Age - 600 °C x 4 hrs); Original Magnification - 200x

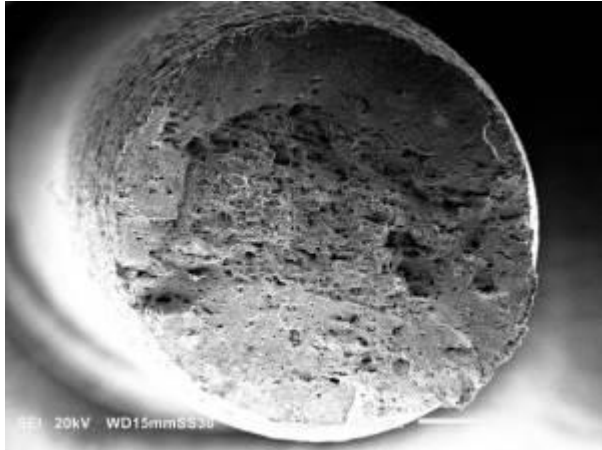
Figure 4.89: SEM micrograph of fractured charpy sample (SA - 950 °C x 3 hrs + Age - 600 °C x 4 hrs); Original Magnification - 1000x

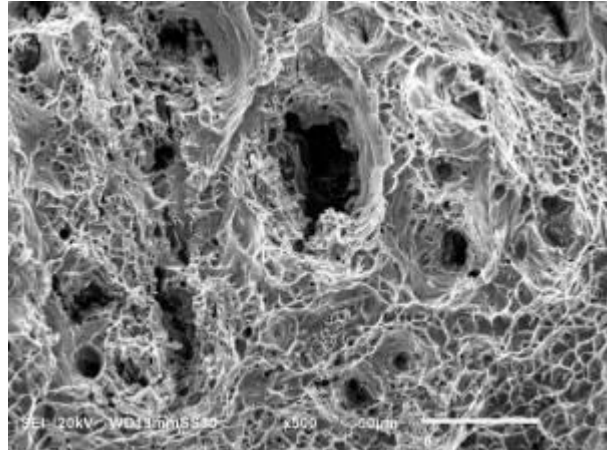
T
Figure 4.90: SEM micrograph of fractured tensile sample at 21 °C, (SA - 950 °C x 3 hrs + Age - 600 °C x 12 hrs); Original Magnification - 33x

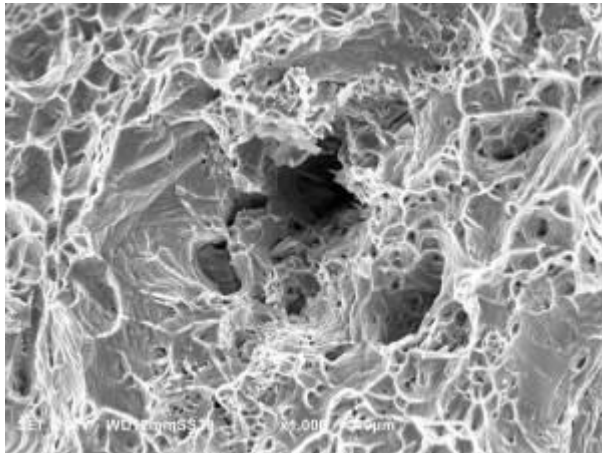
Figure 4.91: SEM micrograph of fractured tensile sample at 21 °C, (SA - 950 °C x 3 hrs + Age - 600 °C x 12 hrs); Original Magnification - 500x

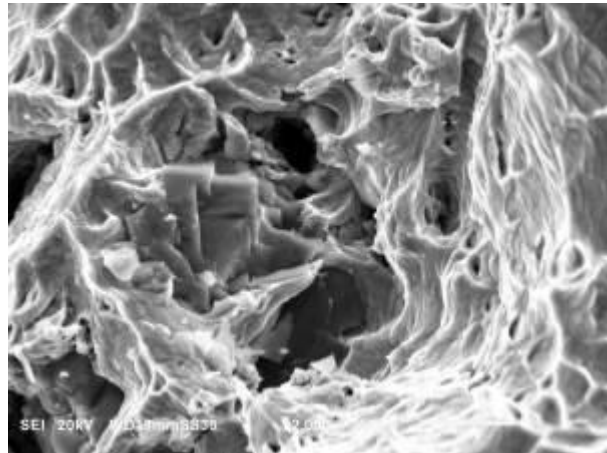
Figure 4.92: SEM micrograph of fractured tensile sample at 21 °C, (SA - 950 °C x 3 hrs + Age - 600 °C x 12 hrs); Original Magnification - 1000x

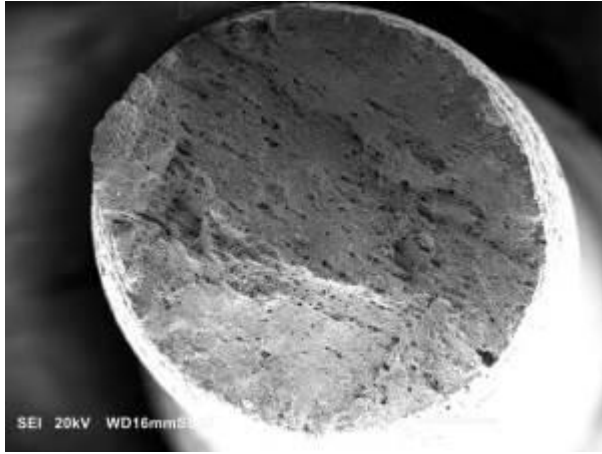
Figure 4.93: SEM micrograph of fractured tensile sample at 21 °C, (SA - 950 °C x 3 hrs + Age - 600 °C x 12 hrs); Original Magnification - 2000x

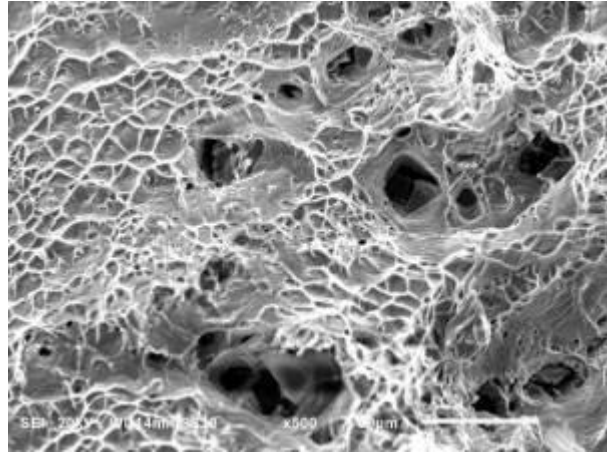
Figure 4.94: SEM micrograph of fractured tensile sample at 450 °C (SA - 950 °C x 3 hrs + Age - 600 °C x 12 hrs); Original Magnification - 33x

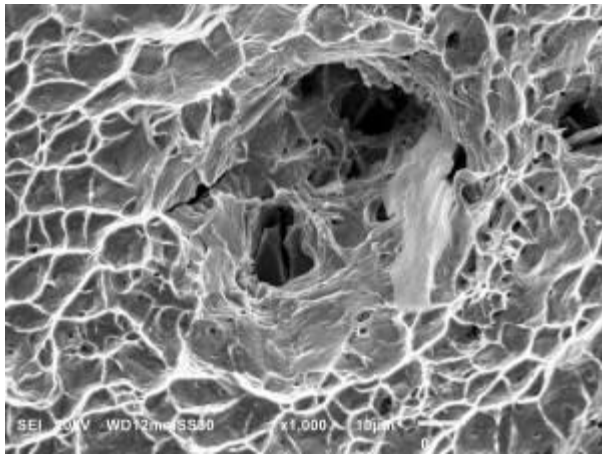
Figure 4.95: SEM micrograph of fractured tensile sample at 450 °C (SA - 950 °C x 3 hrs + Age - 600 °C x 12 hrs); Original Magnification - 500x

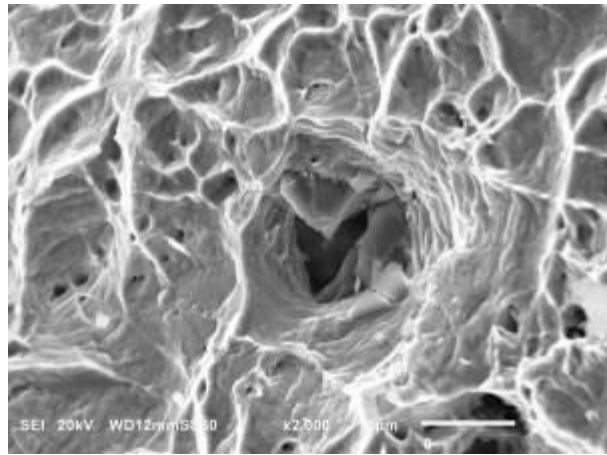
Figure 4.96: SEM micrograph of fractured tensile sample at 450 °C (SA - 950 °C x 3 hrs + Age - 600 °C x 12 hrs); Original Magnification - 1000x

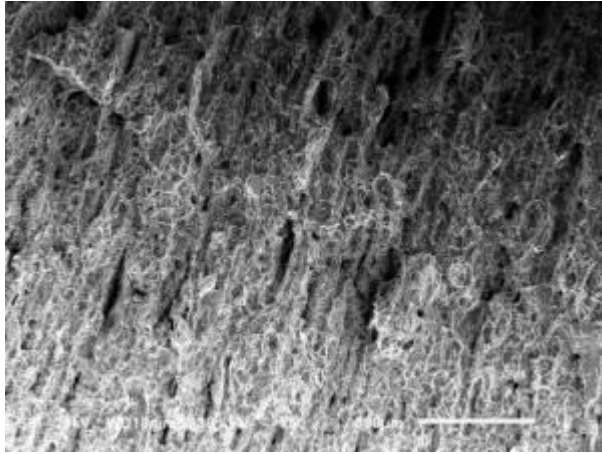
Figure 4.97: SEM micrograph of fractured tensile sample at 450 °C (SA - 950 °C x 3 hrs + Age - 600 °C x 12 hrs); Original Magnification - 2000x

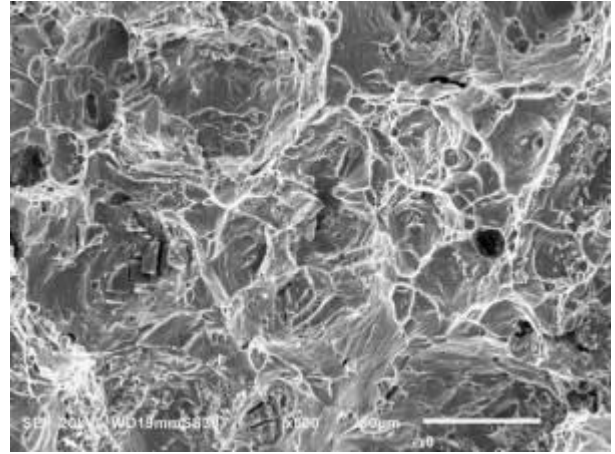
Figure 4.98: SEM micrograph of fractured charpy sample (SA - 950 °C x 3 hrs + Age - 600 °C x 12 hrs); Original Magnification - 50x

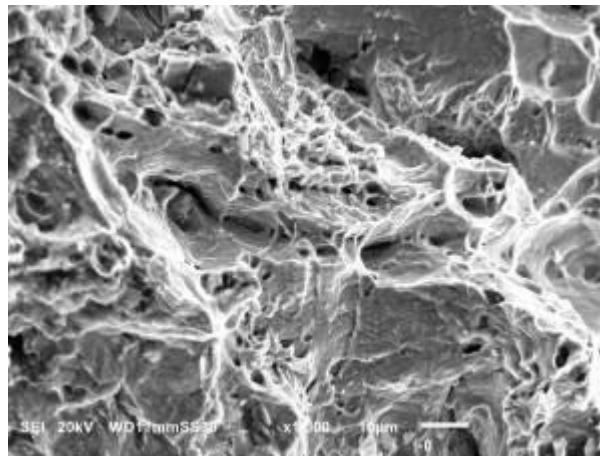
Figure 4.99: SEM micrograph of fractured charpy sample (SA - 950 °C x 3 hrs + Age - 600 °C x 12 hrs); Original Magnification - 500x

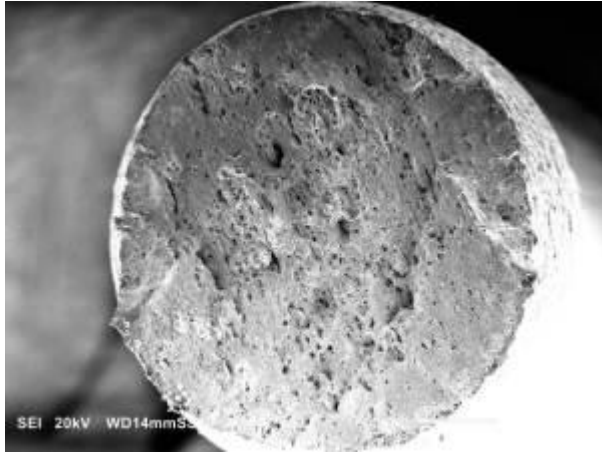
Figure 4.100: SEM micrograph of fractured charpy sample (SA - 950 °C x 3 hrs + Age - 600 °C x 12 hrs); Original Magnification - 1000x

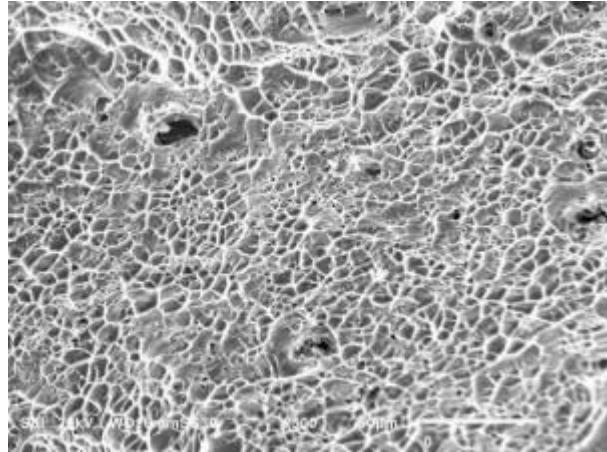
Figure 4.101: SEM micrograph of fractured tensile sample at 21 °C, (SA - 950 °C x 3 hrs + Age - 640 °C x 4 hrs); Original Magnification - 33x

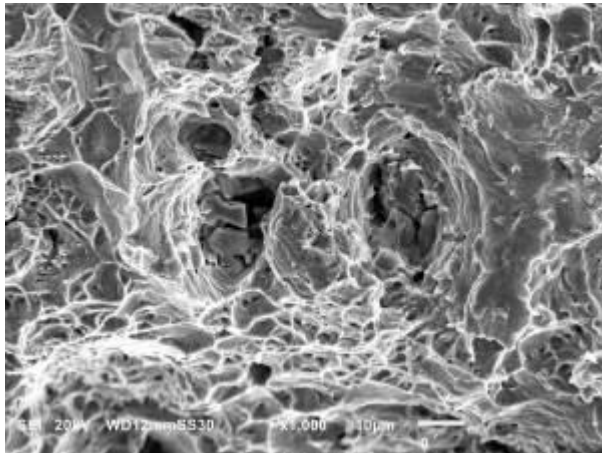
Figure 4.102: SEM micrograph of fractured tensile sample at 21 °C, (SA - 950 °C x 3 hrs + Age - 640 °C x 4 hrs); Original Magnification - 500x
