**Study of Rejuvenation Heat Treatment for Life
Extension of A-286 Gas Turbine Wheels**

Submitted
**IN PARTIAL FULFILLMENT OF THE REQUIREMENT OF
THE DEGREE OF DOCTOR OF PHILOSOPHY**

**UNIVERSITY OF PETROLEUM AND ENERGY STUDIES
DEHRADUN**

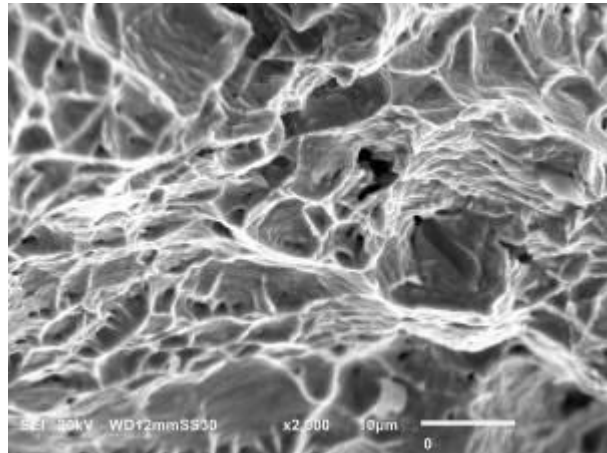
Figure 4.103: SEM micrograph of fractured tensile sample at 21 °C, (SA - 950 °C x 3 hrs + Age - 640 °C x 4 hrs); Original Magnification - 1000x

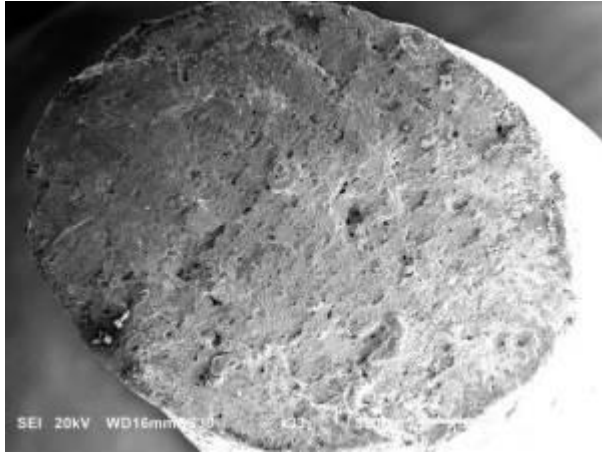
Figure 4.104: SEM micrograph of fractured tensile sample at 21 °C, (SA - 950 °C x 3 hrs + Age - 640 °C x 4 hrs); Original Magnification - 2000x

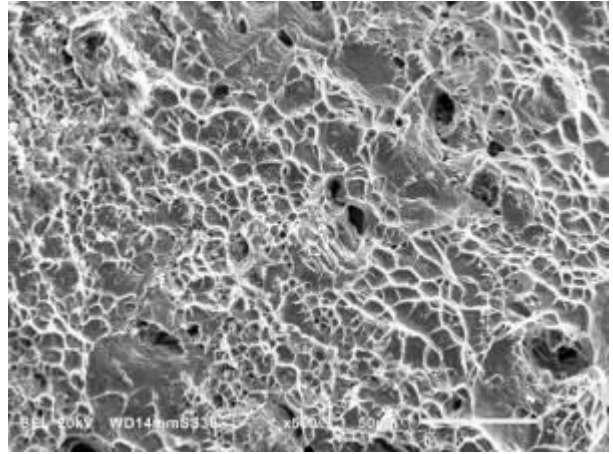
Figure 4.105: SEM micrograph of fractured tensile sample at 450 °C (SA - 950 °C x 3 hrs + Age - 640 °C x 4 hrs); Original Magnification - 33x

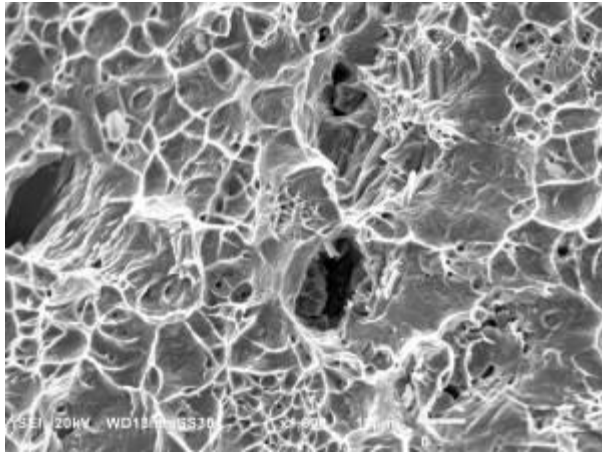
Figure 4.106: SEM micrograph of fractured tensile sample at 450 °C (SA - 950 °C x 3 hrs + Age - 640 °C x 4 hrs); Original Magnification - 500x

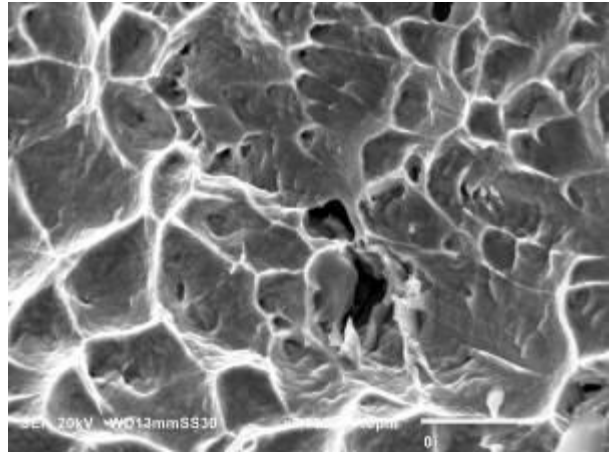
Figure 4.107: SEM micrograph of fractured tensile sample at 450 °C (SA - 950 °C x 3 hrs + Age - 640 °C x 4 hrs); Original Magnification - 1000x

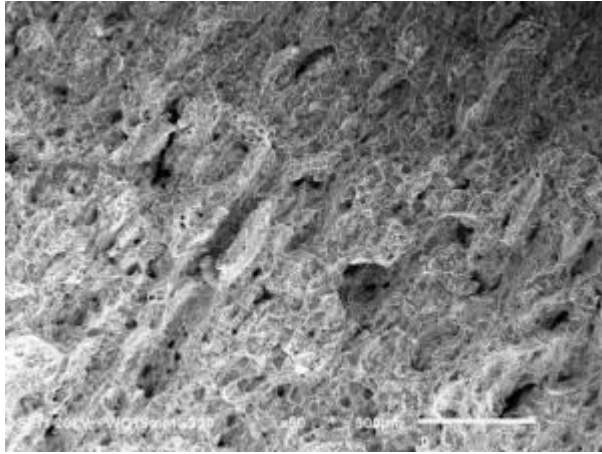
Figure 4.108: SEM micrograph of fractured tensile sample at 450 °C (SA - 950 °C x 3 hrs + Age - 640 °C x 4 hrs); Original Magnification - 2000x

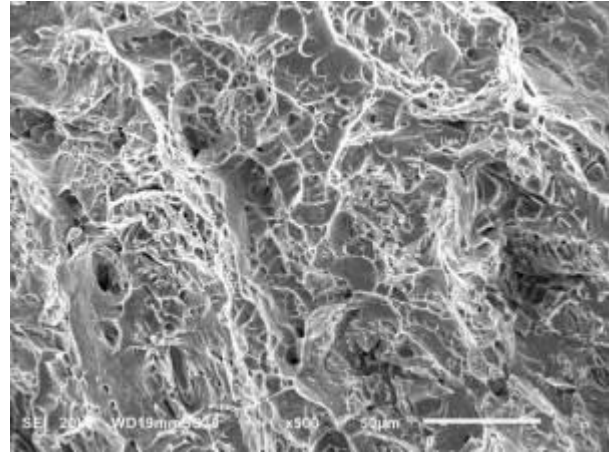
Figure 4.109: SEM micrograph of fractured charpy sample (SA - 950 °C x 3 hrs + Age - 640 °C x 4 hrs); Original Magnification - 50x

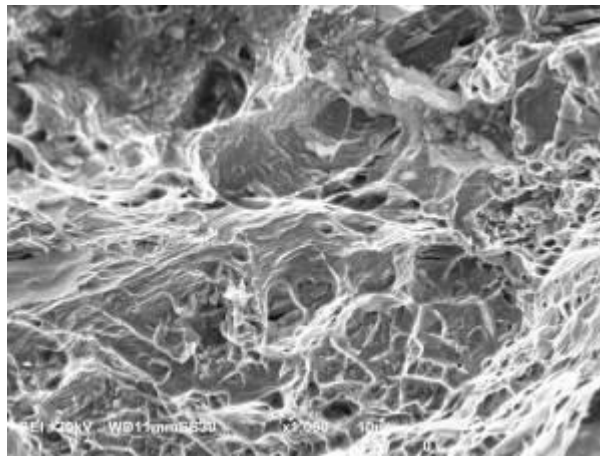
Figure 4.110: SEM micrograph of fractured charpy sample (SA - 950 °C x 3 hrs + Age - 640 °C x 4 hrs); Original Magnification - 500x

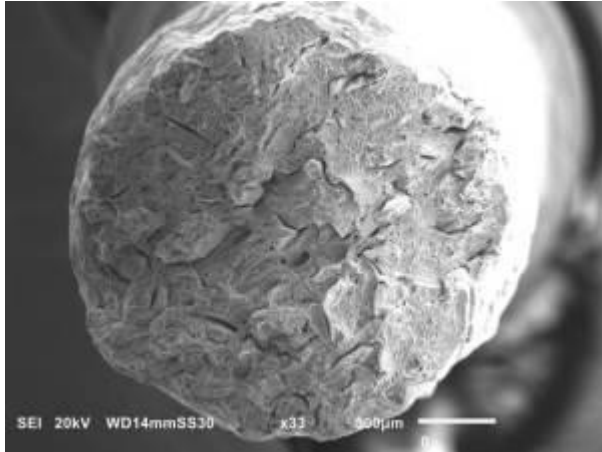
Figure 4.111: SEM micrograph of fractured charpy sample (SA - 950 °C x 3 hrs + Age - 640 °C x 4 hrs); Original Magnification - 1000x

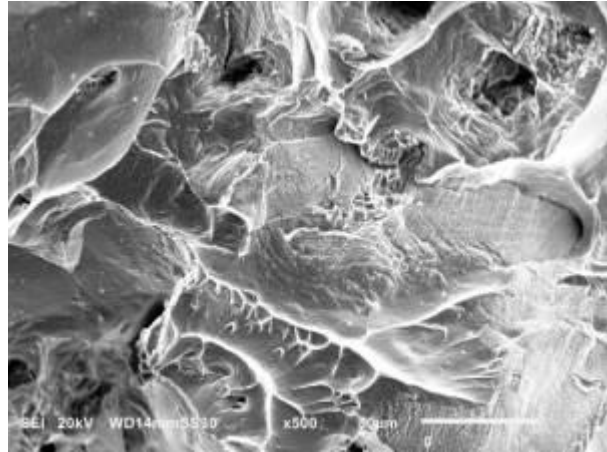
Figure 4.112: SEM micrograph of fractured tensile sample at 21 °C, (SA - 1120 °C x 3 hrs + Age - 640 °C x 8 hrs); Original Magnification - 33x

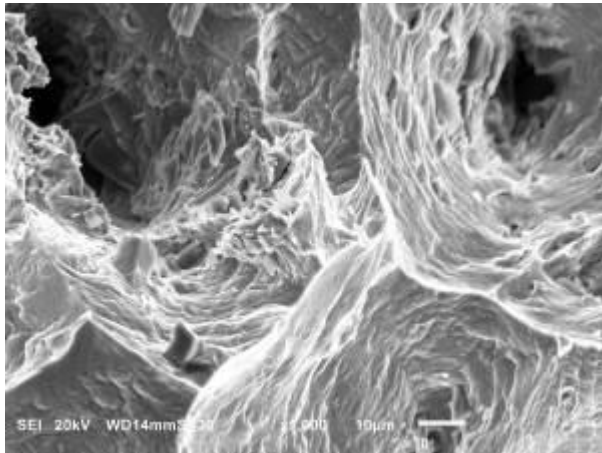
Figure 4.113: SEM micrograph of fractured tensile sample at 21 °C, (SA - 1120 °C x 3 hrs + Age - 640 °C x 8 hrs); Original Magnification - 500x

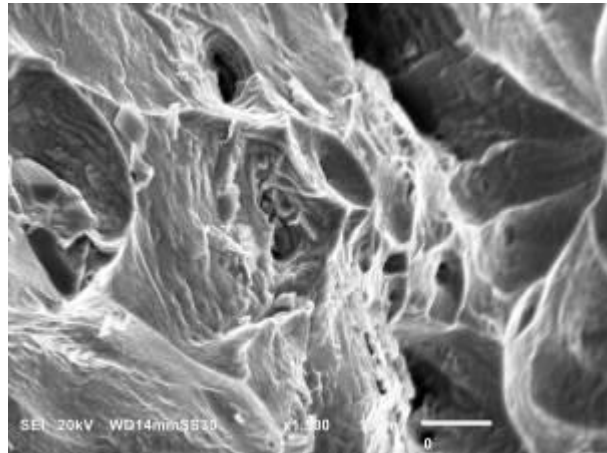
Figure 4.114: SEM micrograph of fractured tensile sample at 21 °C, (SA - 1120 °C x 3 hrs + Age - 640 °C x 8 hrs); Original Magnification - 1000x

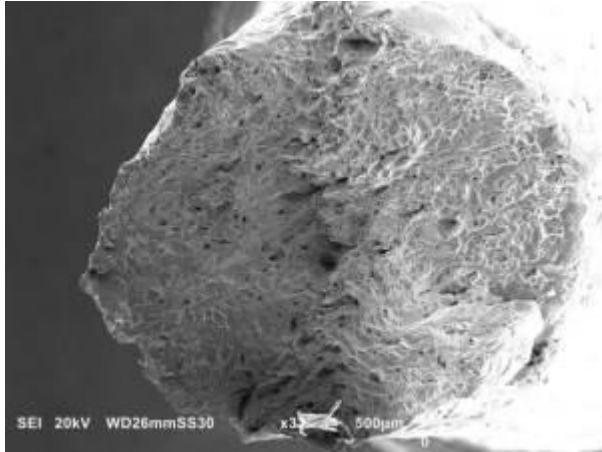
Figure 4.115: SEM micrograph of fractured tensile sample at 21 °C, (SA - 1120 °C x 3 hrs + Age - 640 °C x 8 hrs); Original Magnification - 1500x

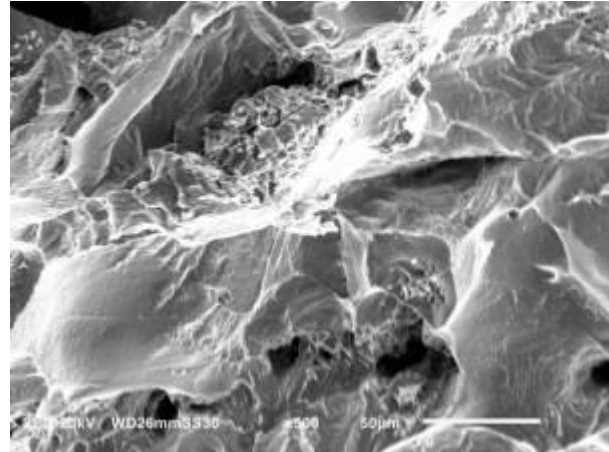
Figure 4.116: SEM micrograph of fractured tensile sample at 450 °C (SA - 1120 °C x 3 hrs + Age - 640 °C x 8 hrs); Original Magnification - 33x

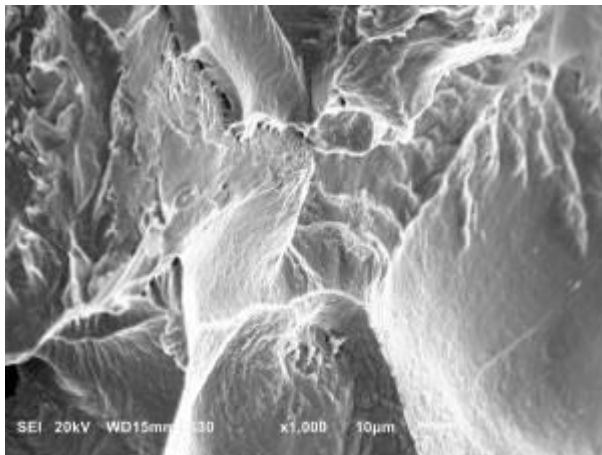
Figure 4.117: SEM micrograph of fractured tensile sample at 450 °C (SA - 1120 °C x 3 hrs + Age - 640 °C x 8 hrs); Original Magnification - 500x

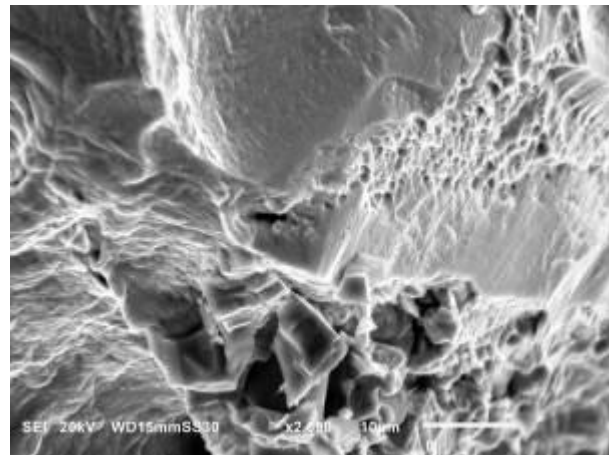
Figure 4.118: SEM micrograph of fractured tensile sample at 450 °C (SA - 1120 °C x 3 hrs + Age - 640 °C x 8 hrs); Original Magnification - 1000x

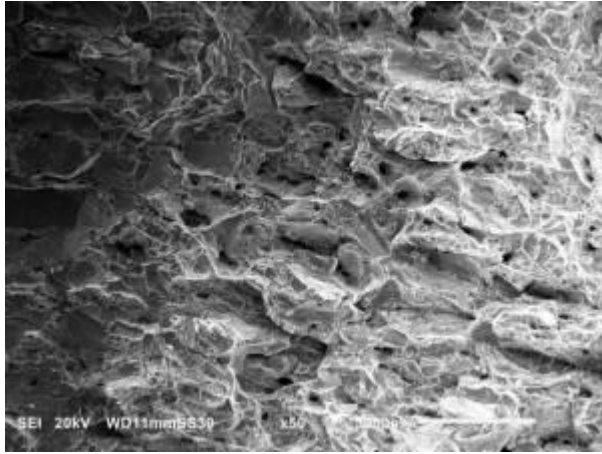
Figure 4.119: SEM micrograph of fractured tensile sample at 450 °C (SA - 1120 °C x 3 hrs + Age - 640 °C x 8 hrs); Original Magnification - 2000x

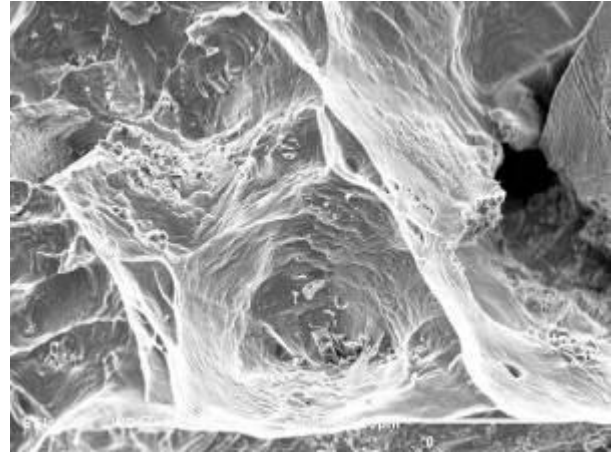
Figure 4.120: SEM micrograph of fractured charpy sample (SA - 1120 °C x 3 hrs + Age - 640 °C x 8 hrs); Original Magnification - 50x

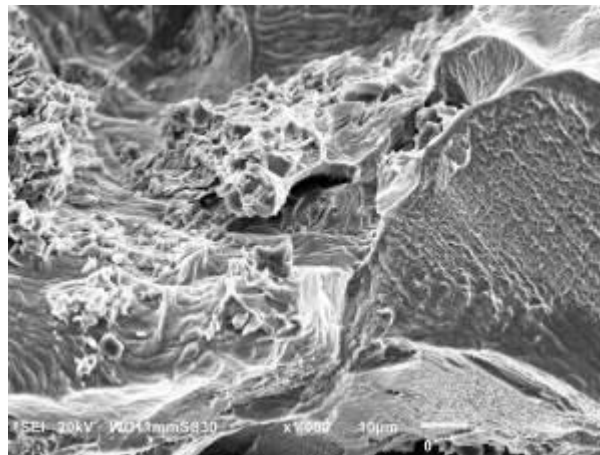
Figure 4.121: SEM micrograph of fractured charpy sample (SA - 1120 °C x 3 hrs + Age - 640 °C x 8 hrs); Original Magnification - 500x

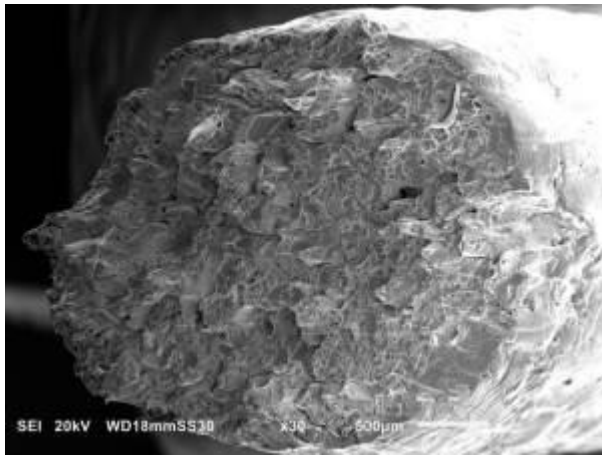
Figure 4.122: SEM micrograph of fractured charpy sample (SA - 1120 °C x 3 hrs + Age - 640 °C x 8 hrs); Original Magnification - 1000x

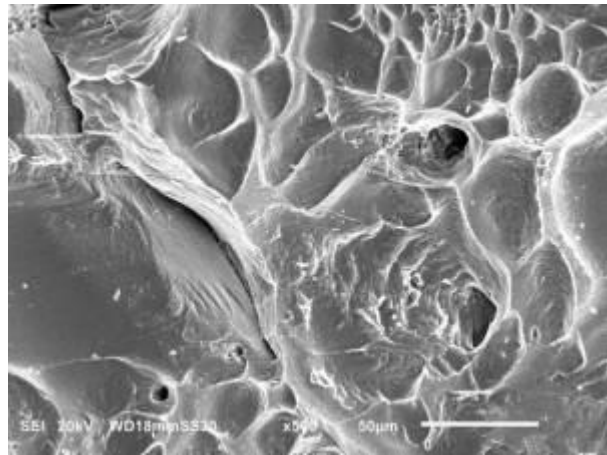
Figure 4.123: SEM micrograph of fractured tensile sample at 21 °C, (SA - 1120 °C x 3 hrs + Age - 640 °C x 12 hrs); Original Magnification - 30x

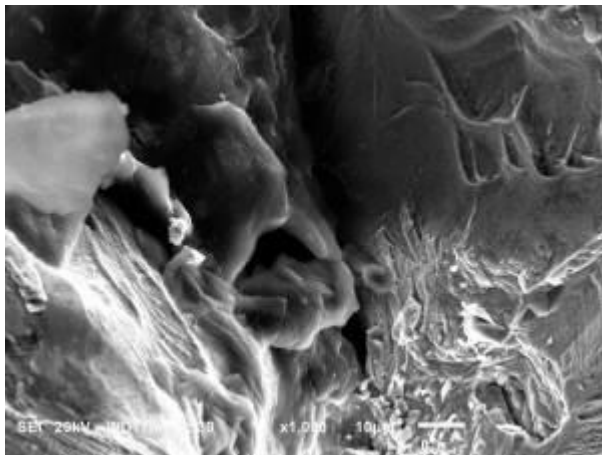
Figure 4.124: SEM micrograph of fractured tensile sample at 21 °C, (SA - 1120 °C x 3 hrs + Age - 640 °C x 12 hrs); Original Magnification - 500x

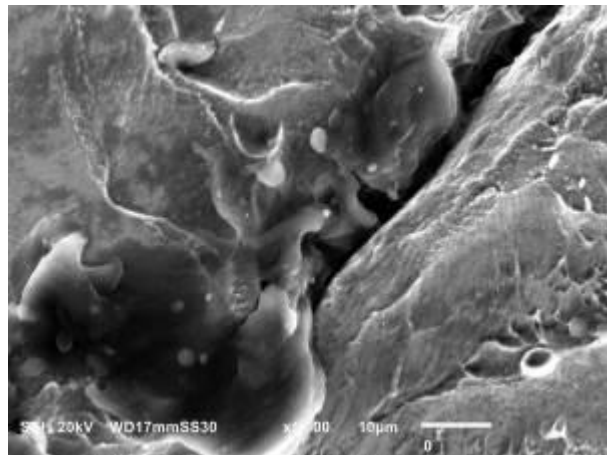
Figure 4.125: SEM micrograph of fractured tensile sample at 21 °C, (SA - 1120 °C x 3 hrs + Age - 640 °C x 12 hrs); Original Magnification - 1000x

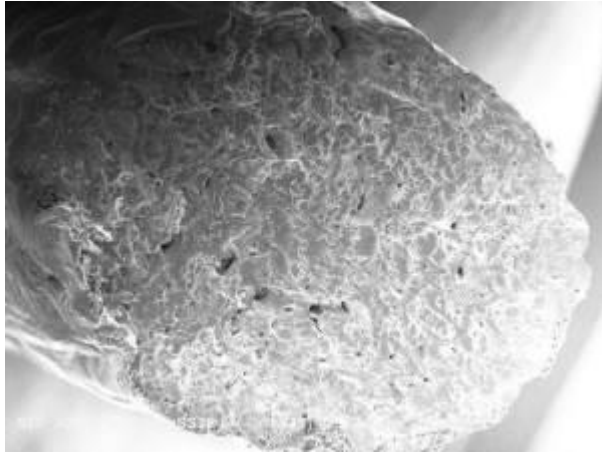
Figure 4.126: SEM micrograph of fractured tensile sample at 21 °C, (SA - 1120 °C x 3 hrs + Age - 640 °C x 12 hrs); Original Magnification - 1500x

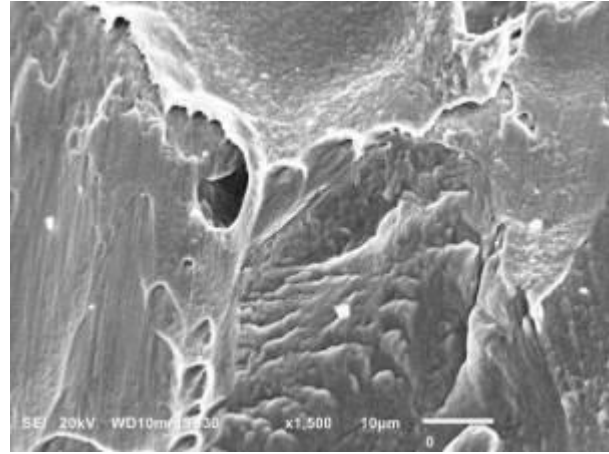
Figure 4.127: SEM micrograph of fractured tensile sample at 450 °C (SA - 1120 °C x 3 hrs + Age - 640 °C x 12 hrs); Original Magnification - 35x

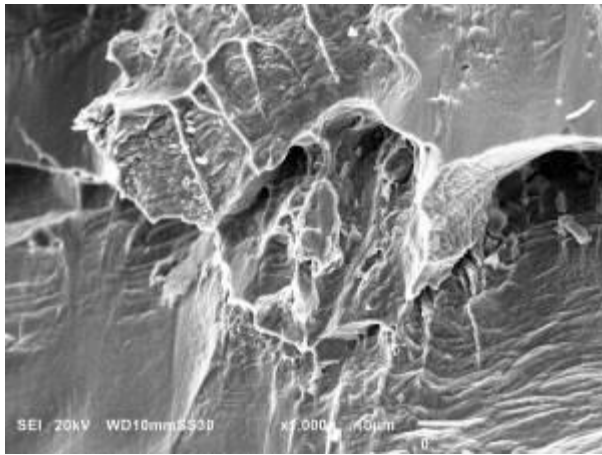
Figure 4.128: SEM micrograph of fractured tensile sample at 450 °C (SA - 1120 °C x 3 hrs + Age - 640 °C x 12 hrs); Original Magnification - 1500x

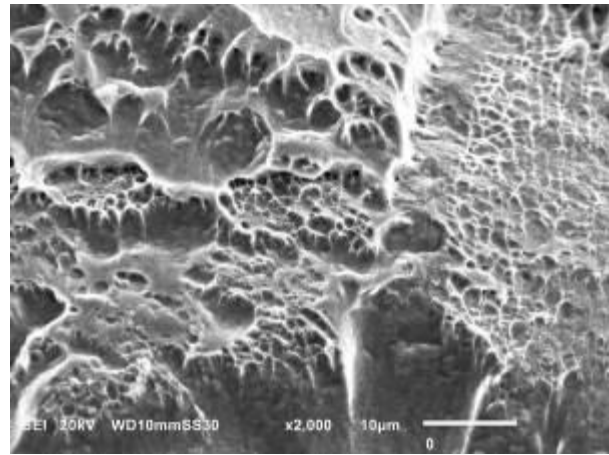
Figure 4.129: SEM micrograph of fractured tensile sample at 450 °C (SA - 1120 °C x 3 hrs + Age - 640 °C x 12 hrs); Original Magnification - 1000x

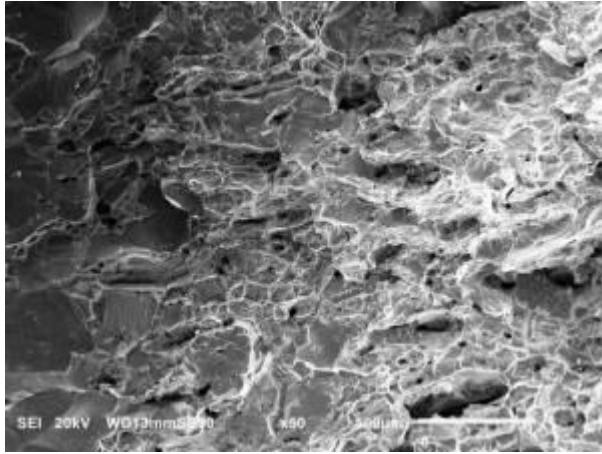
Figure 4.130: SEM micrograph of fractured tensile sample at 450 °C (SA - 1120 °C x 3 hrs + Age - 640 °C x 12 hrs); Original Magnification - 2000x

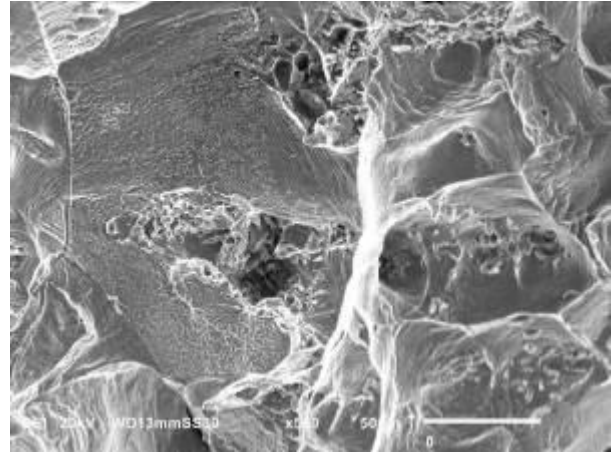
Figure 4.131: SEM micrograph of fractured charpy sample (SA - 1120 °C x 3 hrs + Age - 640 °C x 12 hrs); Original Magnification - 50x

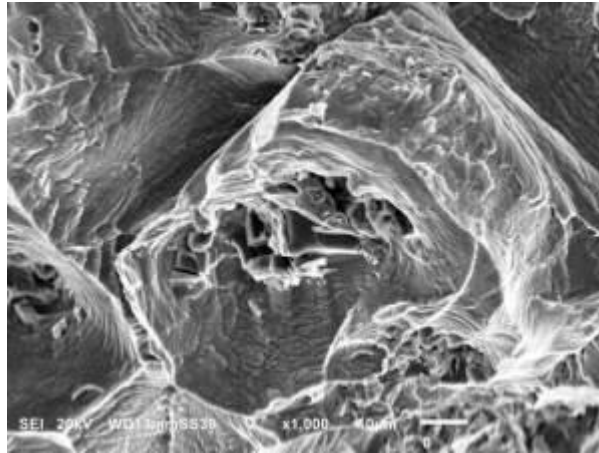
Figure 4.132: SEM micrograph of fractured charpy sample (SA - 1120 °C x 3 hrs + Age - 640 °C x 12 hrs); Original Magnification - 500x

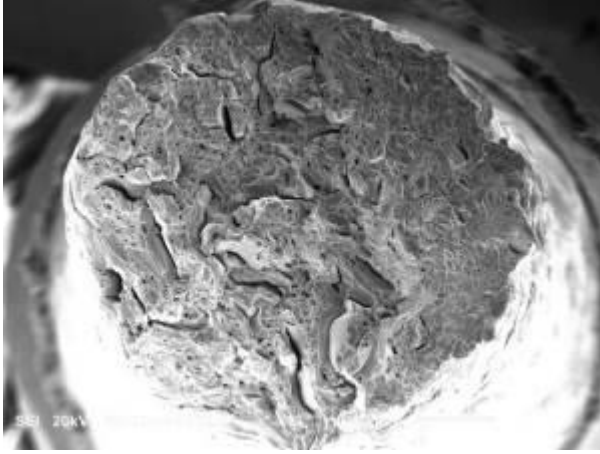
Figure 4.133: SEM micrograph of fractured charpy sample (SA - 1120 °C x 3 hrs + Age - 640 °C x 12 hrs); Original Magnification - 1000x

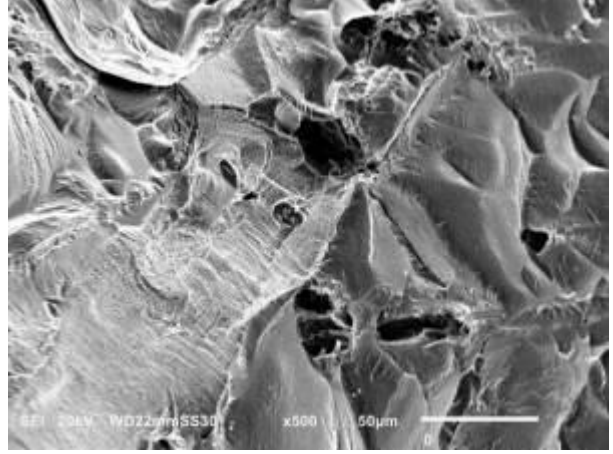
Figure 4.134: SEM micrograph of fractured tensile sample at 21 °C, (SA - 1120 °C x 3 hrs + Age - 640 °C x 4 hrs); Original Magnification - 33x

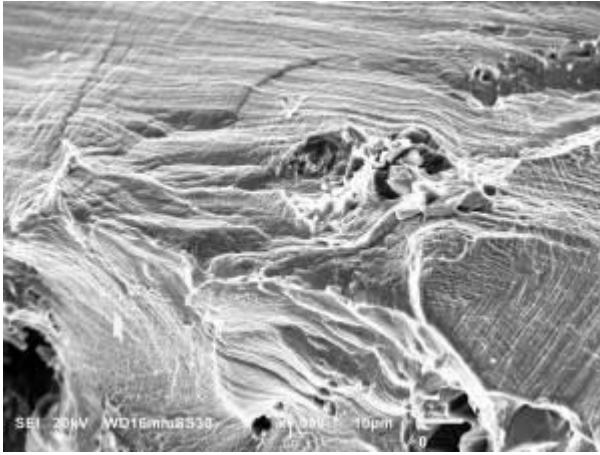
Figure 4.135: SEM micrograph of fractured tensile sample at 21 °C, (SA - 1120 °C x 3 hrs + Age - 640 °C x 4 hrs); Original Magnification - 500x

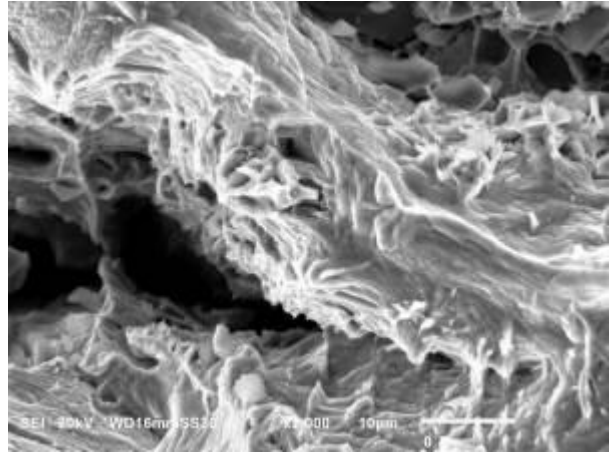
Figure 4.136: SEM micrograph of fractured tensile sample at 21 °C, (SA - 1120 °C x 3 hrs + Age - 640 °C x 4 hrs); Original Magnification - 1000x

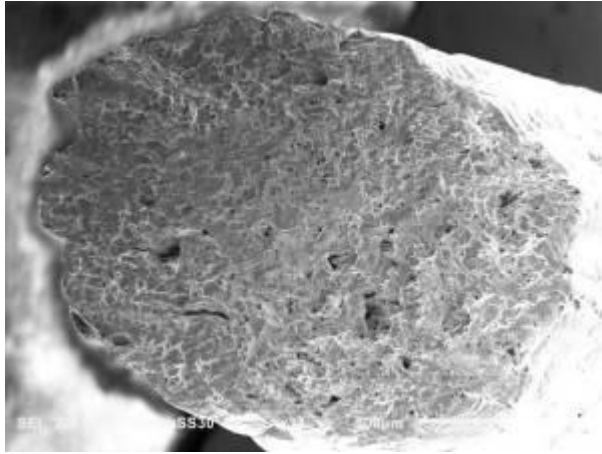
Figure 4.137: SEM micrograph of fractured tensile sample at 21 °C, (SA - 1120 °C x 3 hrs + Age - 640 °C x 4 hrs); Original Magnification - 2000x

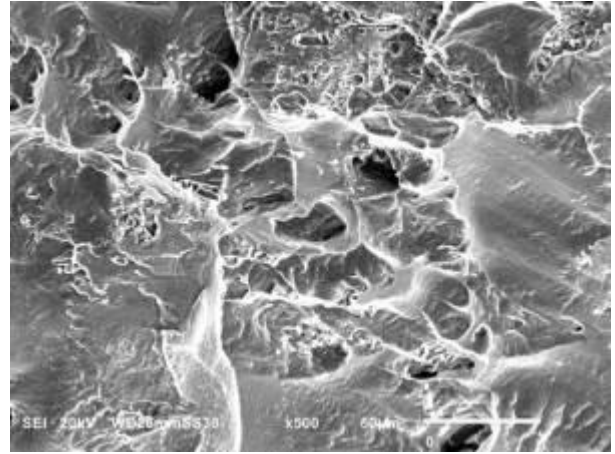
Figure 4.138: SEM micrograph of fractured tensile sample at 450 °C (SA - 1120 °C x 3 hrs + Age - 640 °C x 4 hrs); Original Magnification - 35x

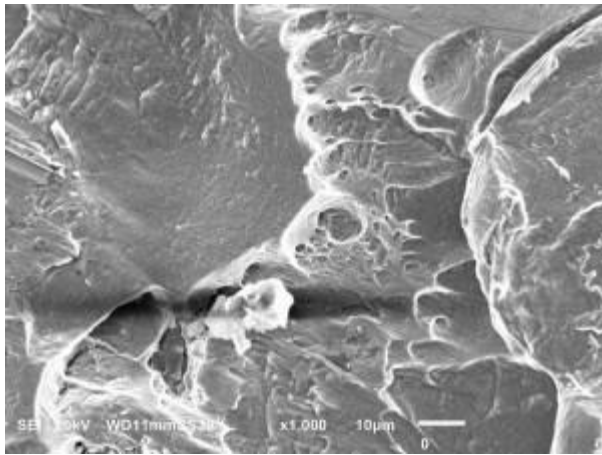
Figure 4.139: SEM micrograph of fractured tensile sample at 450 °C (SA - 1120 °C x 3 hrs + Age - 640 °C x 4 hrs); Original Magnification - 500x

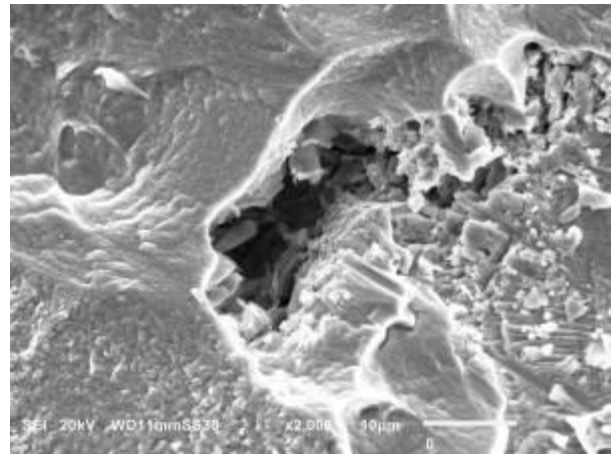
Figure 4.140: SEM micrograph of fractured tensile sample at 450 °C (SA - 1120 °C x 3 hrs + Age - 640 °C x 4 hrs); Original Magnification - 1000x

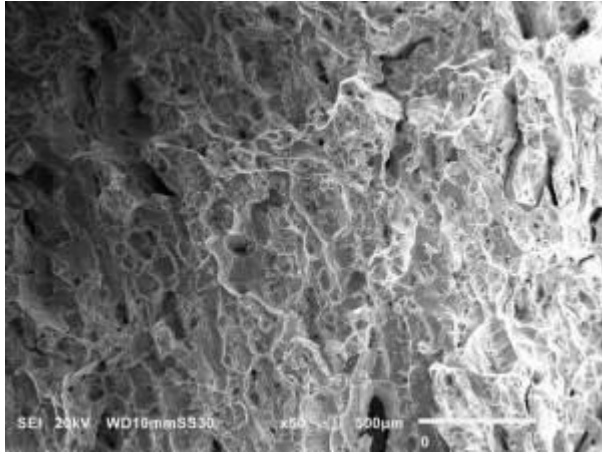
Figure 4.141: SEM micrograph of fractured tensile sample at 450 °C (SA - 1120 °C x 3 hrs + Age - 640 °C x 4 hrs); Original Magnification - 2000x

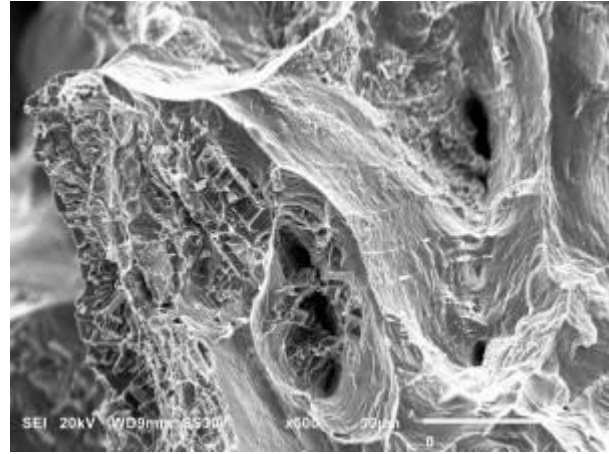
Figure 4.142: SEM micrograph of fractured charpy sample (SA - 1120 °C x 3 hrs + Age - 640 °C x 4 hrs); Original Magnification - 50x

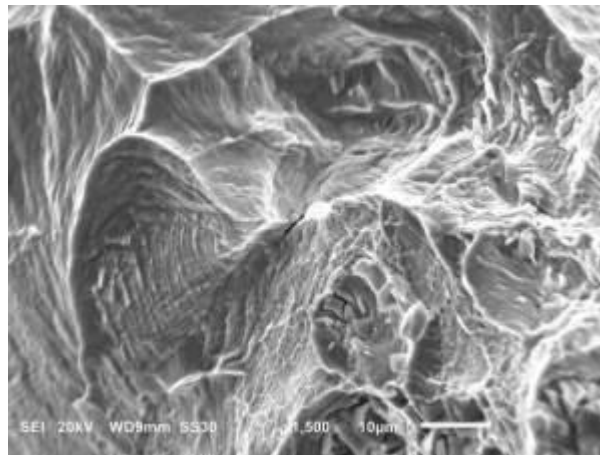
Figure 4.143: SEM micrograph of fractured charpy sample (SA - 1120 °C x 3 hrs + Age - 640 °C x 4 hrs); Original Magnification - 500x

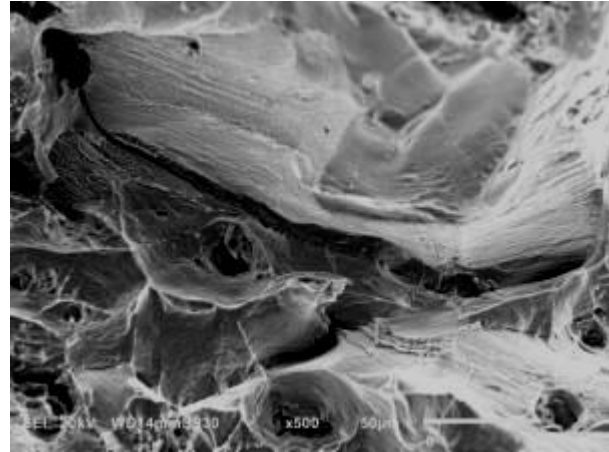
Figure 4.145: SEM micrograph of fractured tensile sample at 21 °C, (SA - 1120 °C x 3 hrs + Age - 600 °C x 8 hrs); Original Magnification - 33x

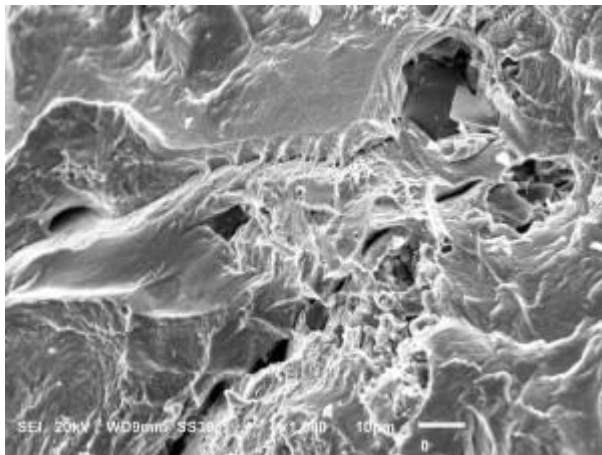
Figure 4.146: SEM micrograph of fractured tensile sample at 21 °C, (SA - 1120 °C x 3 hrs + Age - 600 °C x 8 hrs); Original Magnification - 500x

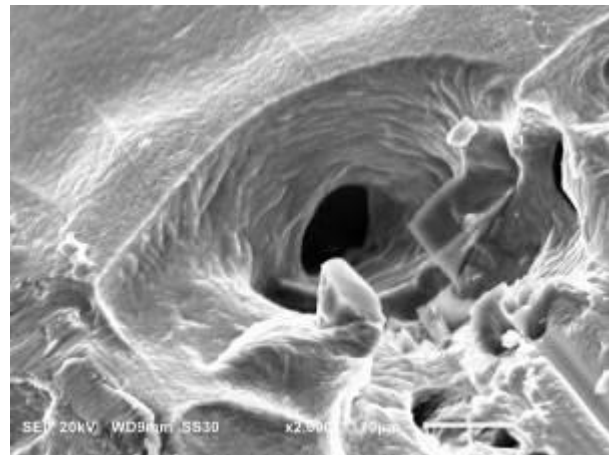
Figure 4.147: SEM micrograph of fractured tensile sample at 21 °C, (SA - 1120 °C x 3 hrs + Age - 600 °C x 8 hrs); Original Magnification - 1000x

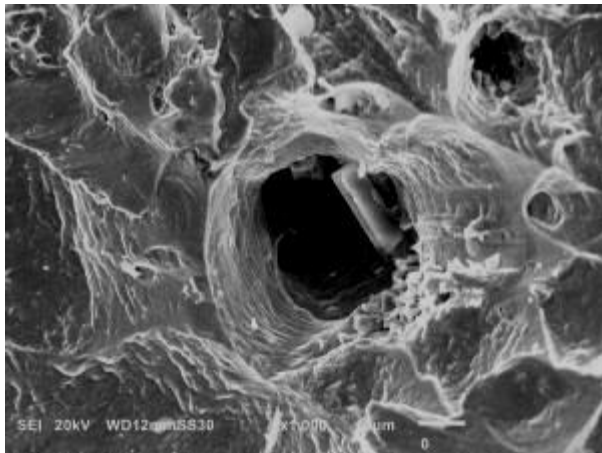
Figure 4.150: SEM micrograph of fractured tensile sample at 450 °C (SA - 1120 °C x 3 hrs + Age - 600 °C x 8 hrs); Original Magnification - 500x

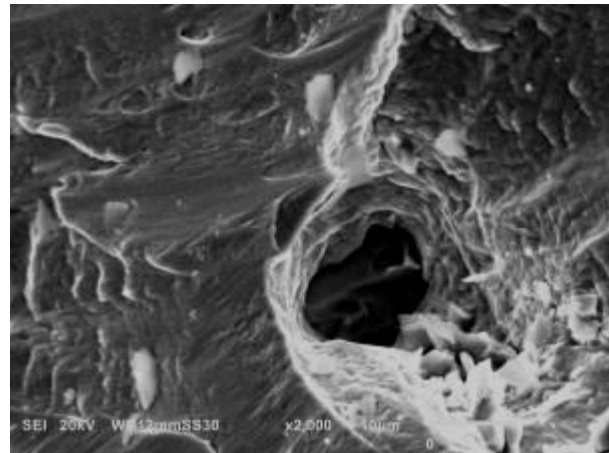
Figure 4.151: SEM micrograph of fractured tensile sample at 450 °C (SA - 1120 °C x 3 hrs + Age - 600 °C x 8 hrs); Original Magnification - 1000x

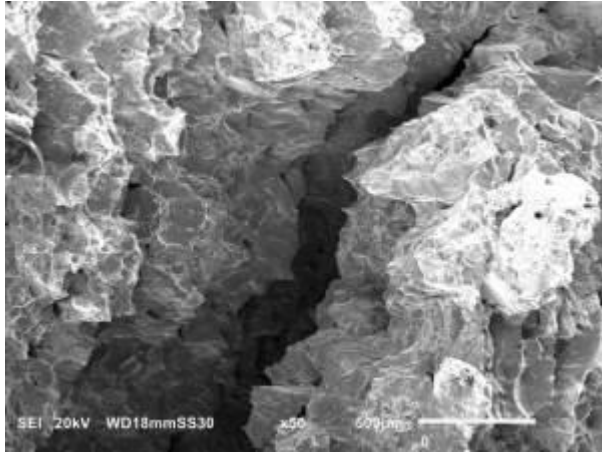
Figure 4.152: SEM micrograph of fractured tensile sample at 450 °C (SA - 1120 °C x 3 hrs + Age - 600 °C x 8 hrs); Original Magnification - 2000x

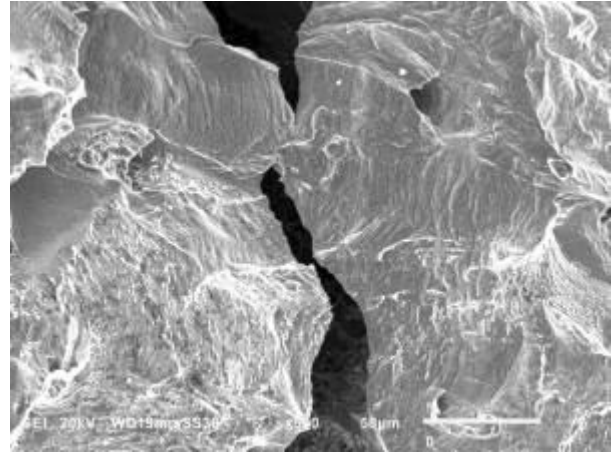
Figure 4.153: SEM micrograph of fractured charpy sample (SA - 1120 °C x 3 hrs + Age - 600 °C x 8 hrs); Original Magnification - 50x

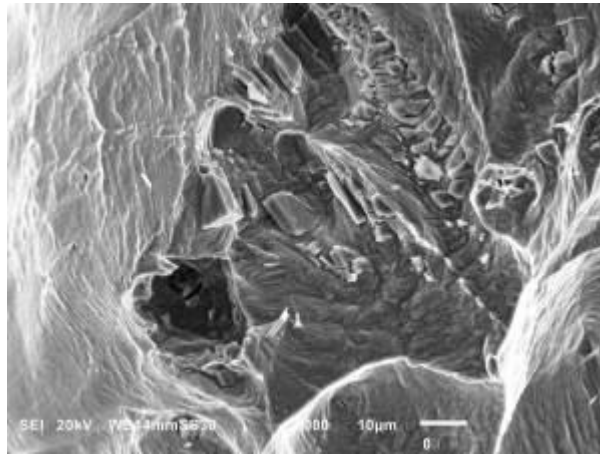
Figure 4.154: SEM micrograph of fractured charpy sample (SA - 1120 °C x 3 hrs + Age - 600 °C x 8 hrs); Original Magnification - 500x

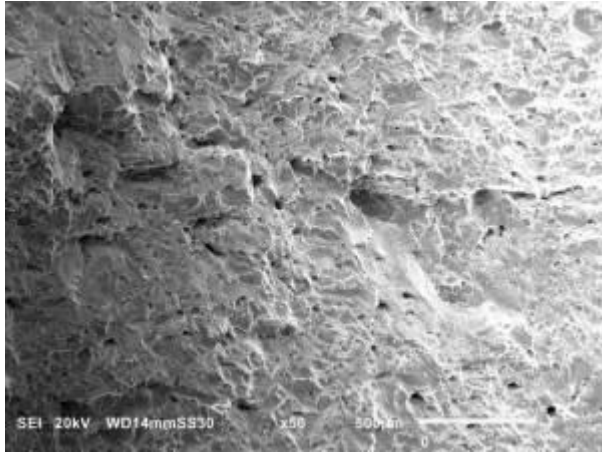
Figure 4.155: SEM micrograph of fractured charpy sample (SA - 1120 °C x 3 hrs + Age - 600 °C x 8 hrs); Original Magnification - 1000x

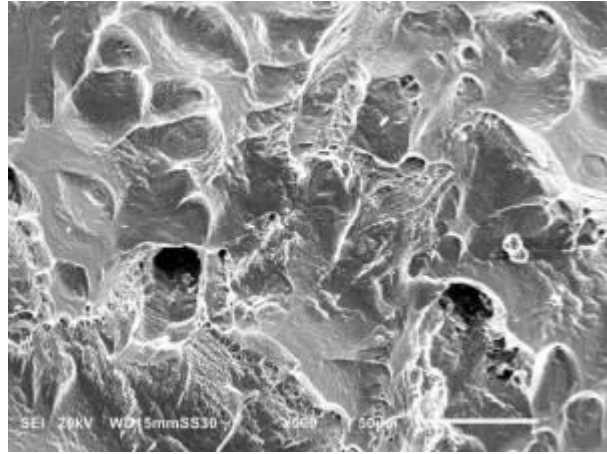
Figure 4.156: SEM micrograph of fractured stress rupture sample (SA - 1120 °C x 3 hrs + Age - 600 °C x 8 hrs); Original Magnification - 50x

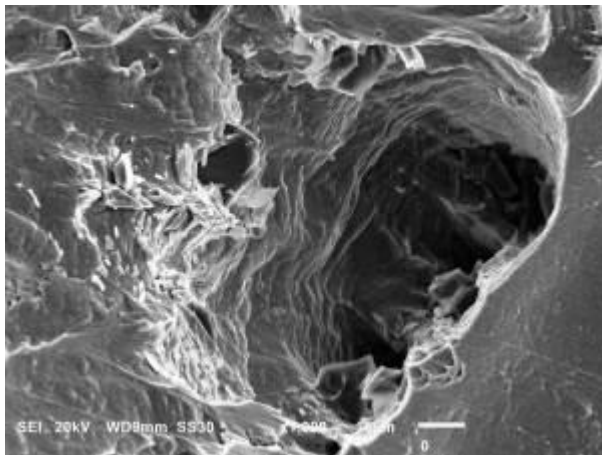
Figure 4.157: SEM micrograph of fractured stress rupture sample (SA - 1120 °C x 3 hrs + Age - 600 °C x 8 hrs); Original Magnification - 500x

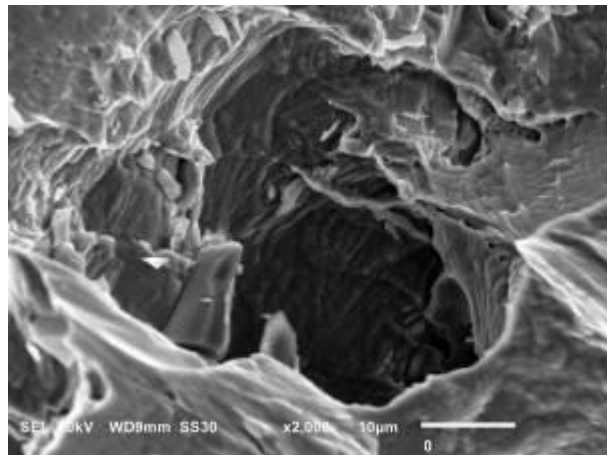
Figure 4.158: SEM micrograph of fractured stress rupture sample (SA - 1120 °C x 3 hrs + Age - 600 °C x 8 hrs); Original Magnification - 1000x

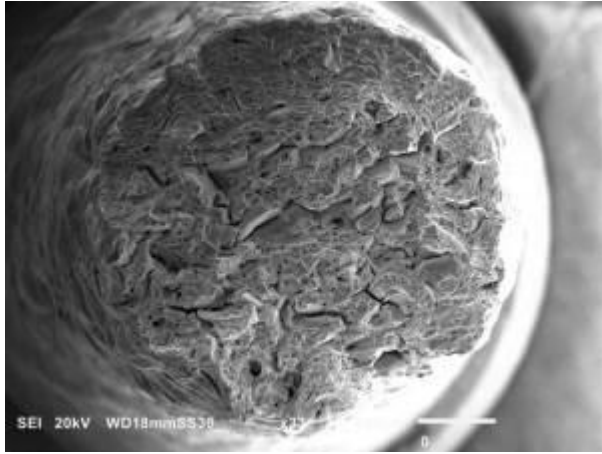
Figure 4.159: SEM micrograph of fractured stress rupture sample (SA - 1120 °C x 3 hrs + Age - 600 °C x 8 hrs); Original Magnification - 2000x

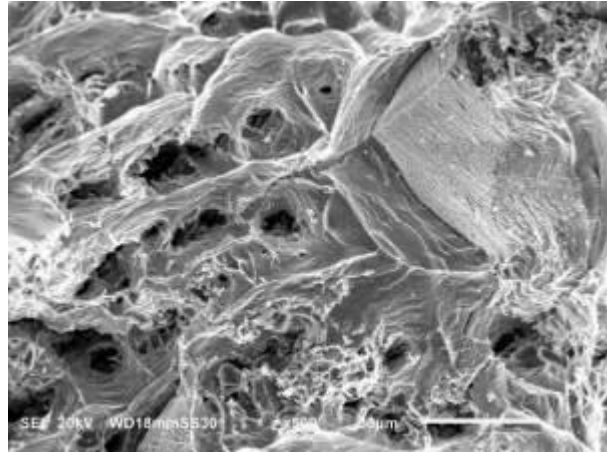
Figure 4.160: SEM micrograph of fractured tensile sample at 21 °C, (SA - 1120 °C x 3 hrs + Age - 600 °C x 12 hrs); Original Magnification - 33x

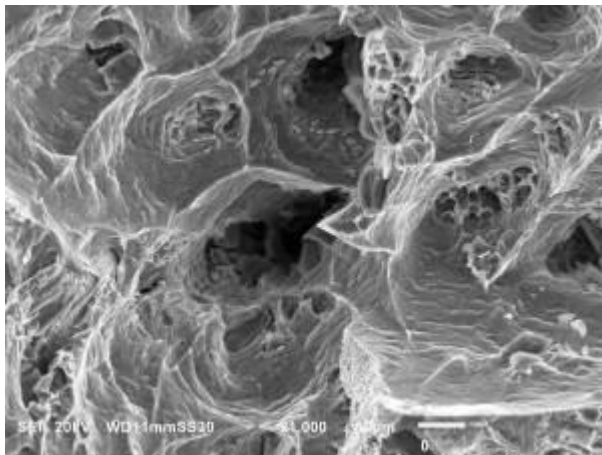
Figure 4.161: SEM micrograph of fractured tensile sample at 21 °C, (SA - 1120 °C x 3 hrs + Age - 600 °C x 12 hrs); Original Magnification - 500x

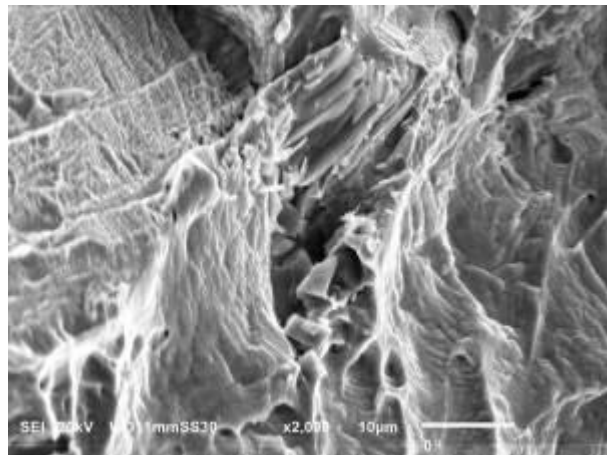
Figure 4.162: SEM micrograph of fractured tensile sample at 21 °C, (SA - 1120 °C x 3 hrs + Age - 600 °C x 12 hrs); Original Magnification - 1000x

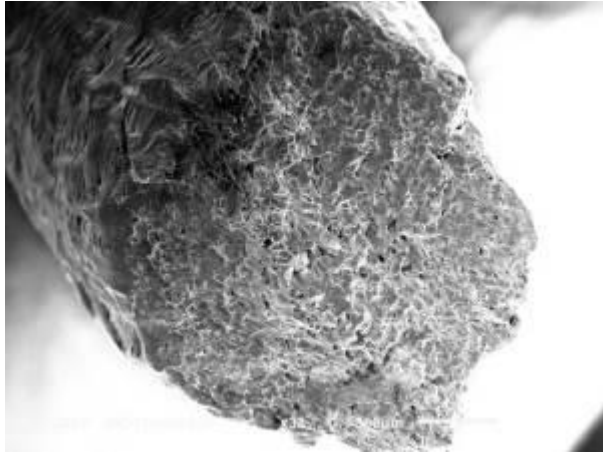
Figure 4.163: SEM micrograph of fractured tensile sample at 21 °C, (SA - 1120 °C x 3 hrs + Age - 600 °C x 12 hrs); Original Magnification - 2000x

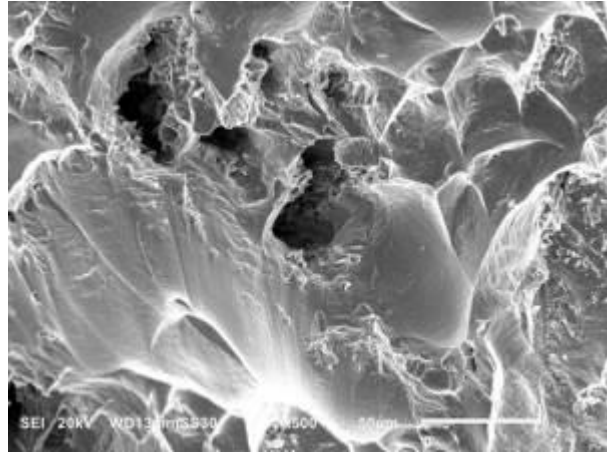
Figure 4.164: SEM micrograph of fractured tensile sample at 450 °C (SA - 1120 °C x 3 hrs + Age - 600 °C x 12 hrs); Original Magnification - 35x

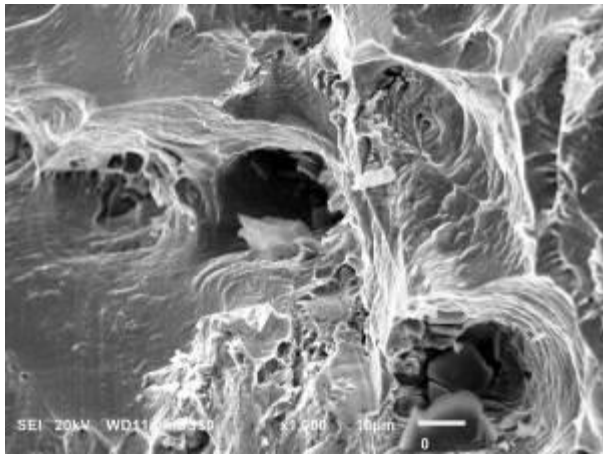
Figure 4.165: SEM micrograph of fractured tensile sample at 450 °C (SA - 1120 °C x 3 hrs + Age - 600 °C x 12 hrs); Original Magnification - 500x

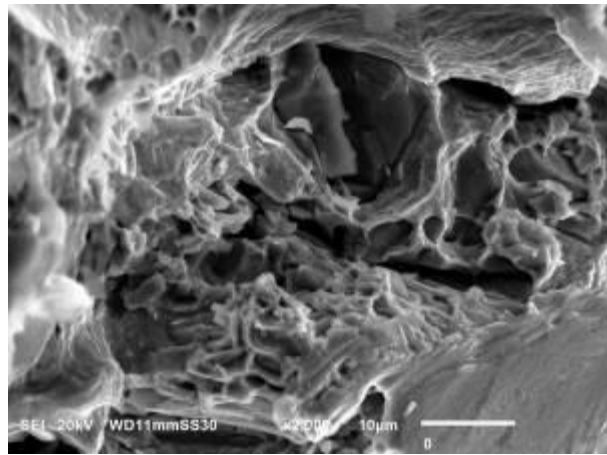
Figure 4.166: SEM micrograph of fractured tensile sample at 450 °C (SA - 1120 °C x 3 hrs + Age - 600 °C x 12 hrs); Original Magnification - 1000x

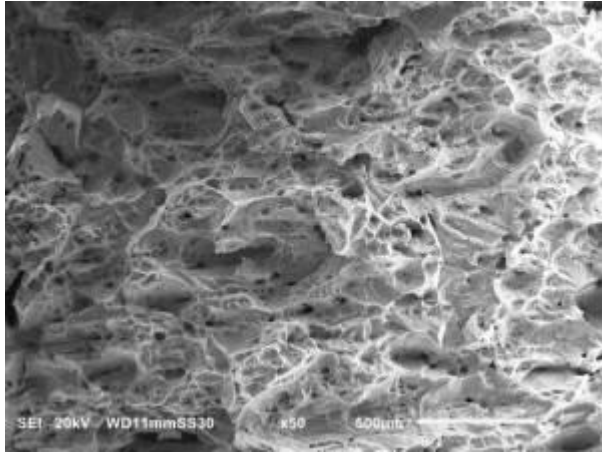
Figure 4.167: SEM micrograph of fractured tensile sample at 450 °C (SA - 1120 °C x 3 hrs + Age - 600 °C x 12 hrs); Original Magnification - 2000x

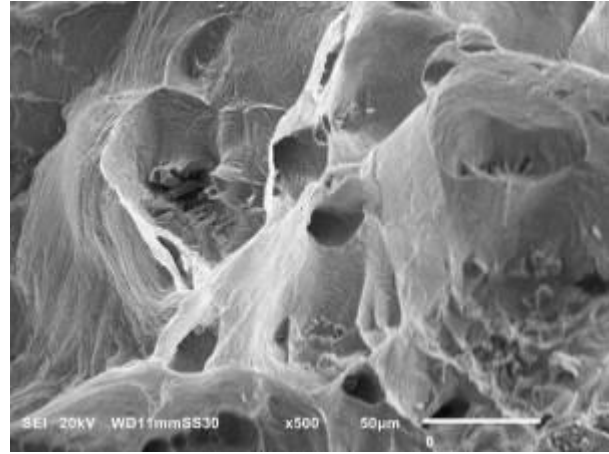
Figure 4.168: SEM micrograph of fractured charpy sample (SA - 1120 °C x 3 hrs + Age - 600 °C x 12 hrs); Original Magnification - 50x

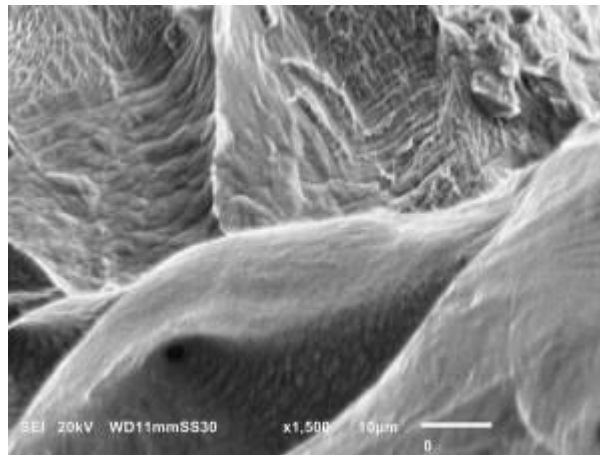
Figure 4.169: SEM micrograph of fractured charpy sample (SA - 1120 °C x 3 hrs + Age - 600 °C x 12 hrs); Original Magnification - 500x

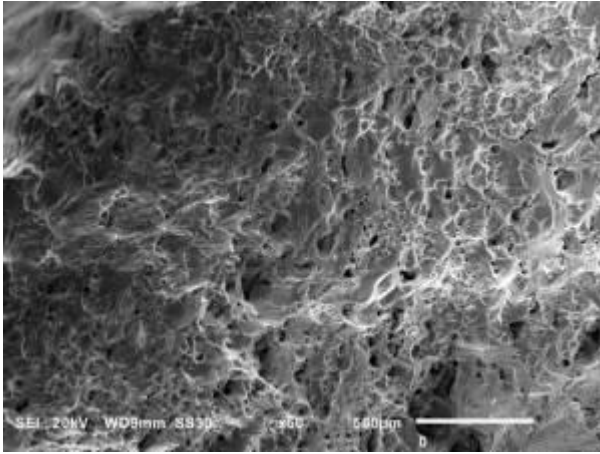
Figure 4.171: SEM micrograph of fractured stress rupture sample (SA - 1120 °C x 3 hrs + Age - 600 °C x 12 hrs); Original Magnification - 50x

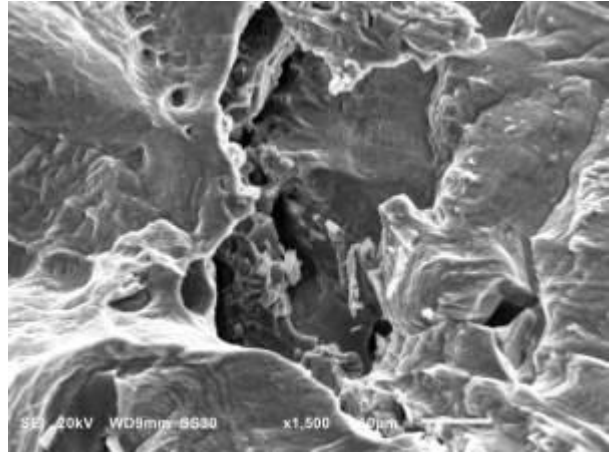
Figure 4.172: SEM micrograph of fractured stress rupture sample (SA - 1120 °C x 3 hrs + Age - 600 °C x 12 hrs); Original Magnification - 500x

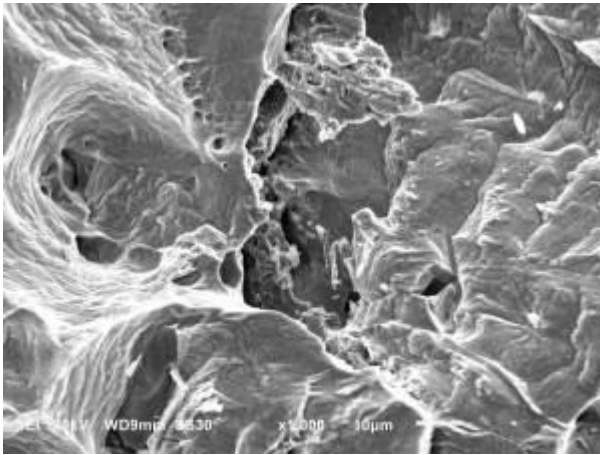
Figure 4.173: SEM micrograph of fractured stress rupture sample (SA - 1120 °C x 3 hrs + Age - 600 °C x 12 hrs); Original Magnification - 1000x

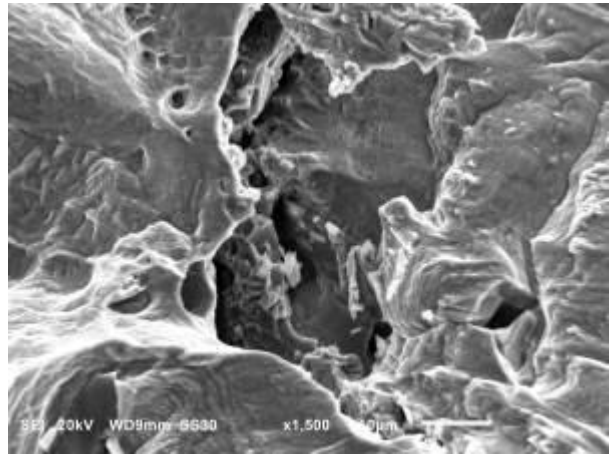
Figure 4.174: SEM micrograph of fractured stress rupture sample (SA - 1120 °C x 3 hrs + Age - 600 °C x 12 hrs); Original Magnification - 1500x

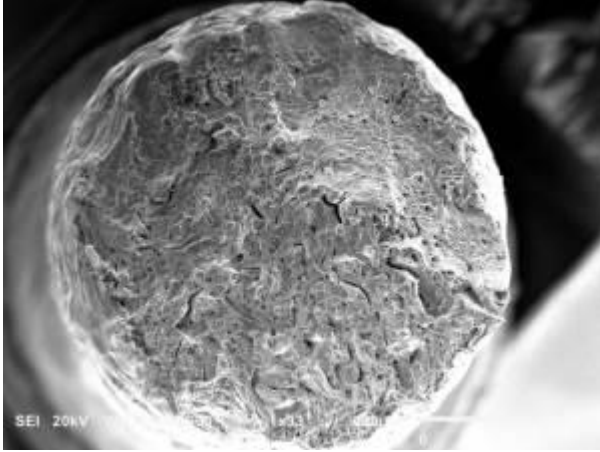
Figure 4.175: SEM micrograph of fractured tensile sample at 21 °C, (SA - 1120 °C x 3 hrs + Age - 600 °C x 4 hrs); Original Magnification - 33x

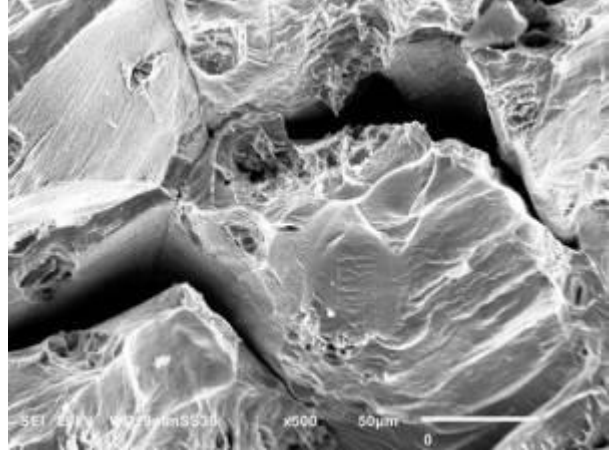
Figure 4.176: SEM micrograph of fractured tensile sample at 21 °C, (SA - 1120 °C x 3 hrs + Age - 600 °C x 4 hrs); Original Magnification - 500x

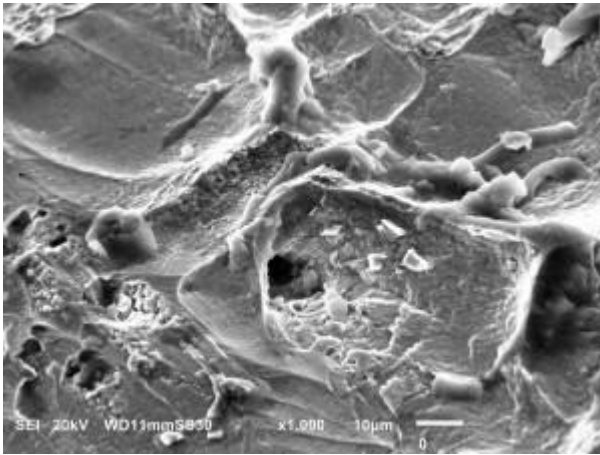
Figure 4.177: SEM micrograph of fractured tensile sample at 21 °C, (SA - 1120 °C x 3 hrs + Age - 600 °C x 4 hrs); Original Magnification - 1000x

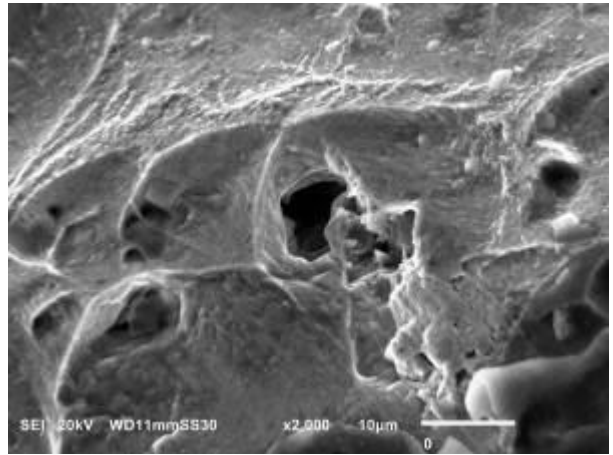
Figure 4.178: SEM micrograph of fractured tensile sample at 21 °C, (SA - 1120 °C x 3 hrs + Age - 600 °C x 4 hrs); Original Magnification - 2000x

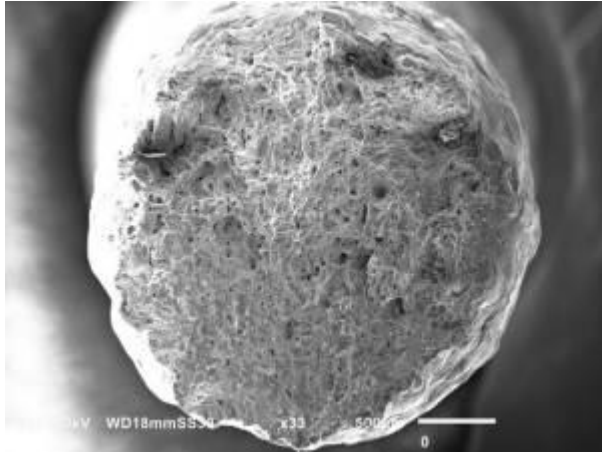
Figure 4.179: SEM micrograph of fractured tensile sample at 450 °C, (SA - 1120 °C x 3 hrs + Age - 600 °C x 4 hrs); Original Magnification - 33x
