**Study of Rejuvenation Heat Treatment for Life
Extension of A-286 Gas Turbine Wheels**

Submitted
**IN PARTIAL FULFILLMENT OF THE REQUIREMENT OF
THE DEGREE OF DOCTOR OF PHILOSOPHY**

**UNIVERSITY OF PETROLEUM AND ENERGY STUDIES
DEHRADUN**

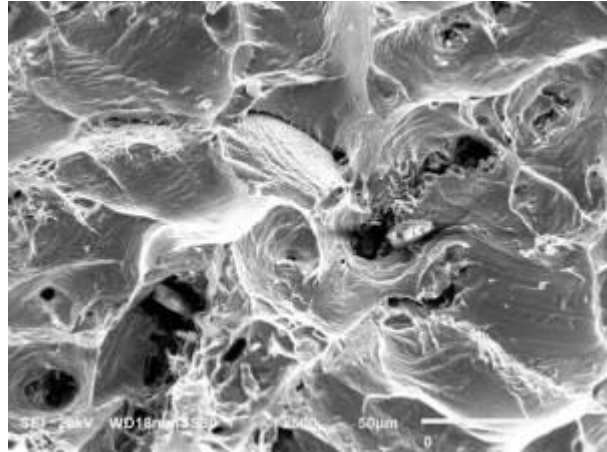
Figure 4.180: SEM micrograph of fractured tensile sample at 450 °C, (SA - 1120 °C x 3 hrs + Age - 600 °C x 4 hrs); Original Magnification - 500x

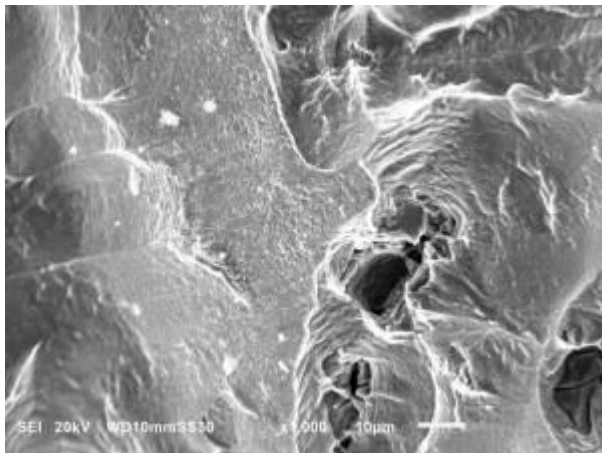
Figure 4.181: SEM micrograph of fractured tensile sample at 450 °C, (SA - 1120 °C x 3 hrs + Age - 600 °C x 4 hrs); Original Magnification - 1000x

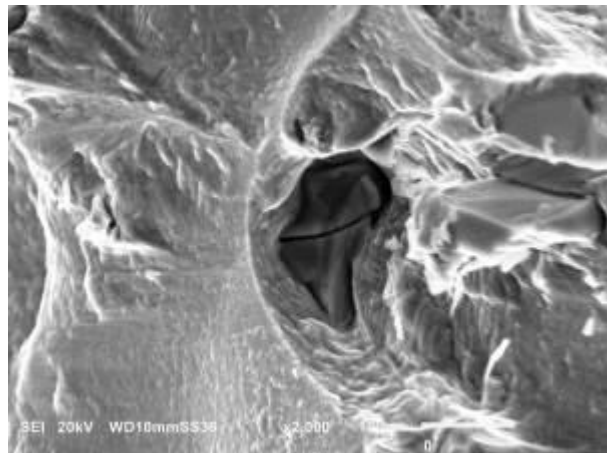
Figure 4.182: SEM micrograph of fractured tensile sample at 450 °C, (SA - 1120 °C x 3 hrs + Age - 600 °C x 4 hrs); Original Magnification - 2000x

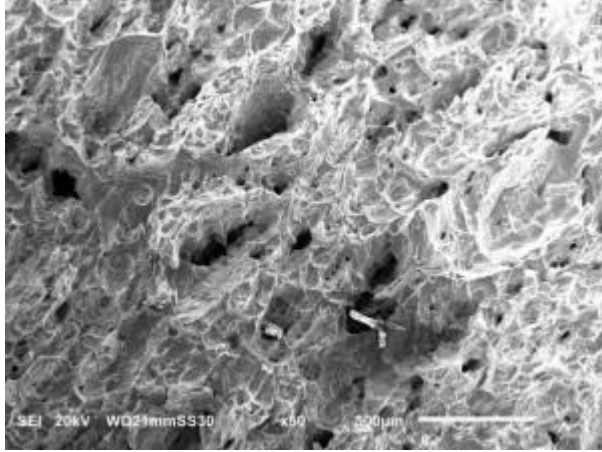
Figure 4.183: SEM micrograph of fractured charpy sample (SA - 1120 °C x 3 hrs + Age - 600 °C x 4 hrs); Original Magnification - 50x

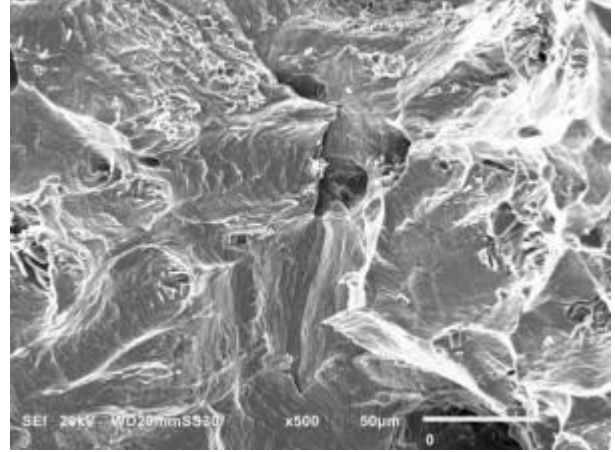
Figure 4.184: SEM micrograph of fractured charpy sample (SA - 1120 °C x 3 hrs + Age - 600 °C x 4 hrs); Original Magnification - 500x

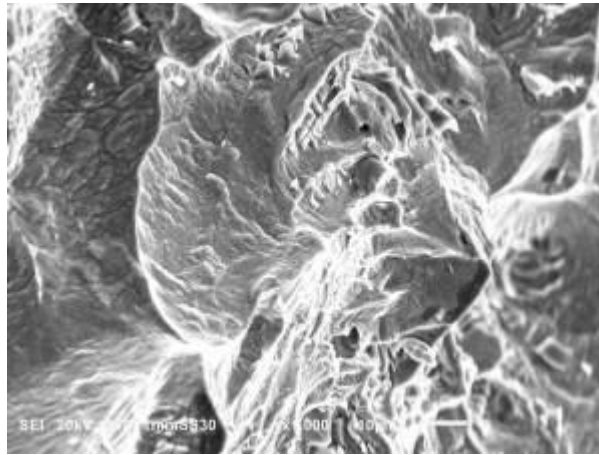
Figure 4.185: SEM micrograph of fractured charpy sample (SA - 1120 °C x 3 hrs + Age - 600 °C x 4 hrs); Original Magnification - 1000x

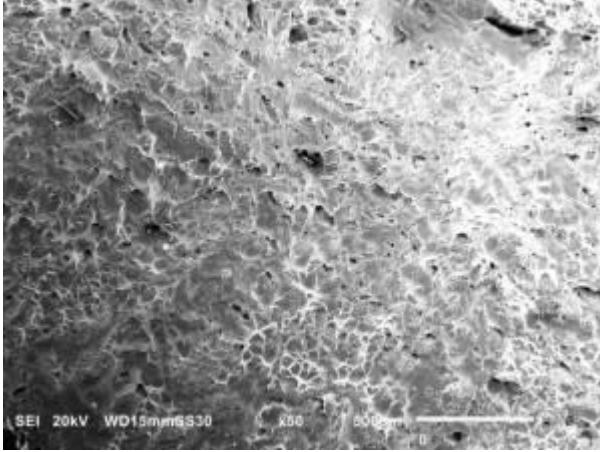
Figure 4.186: SEM micrograph of fractured stress rupture sample (SA - 1120 °C x 3 hrs + Age - 600 °C x 4 hrs); Original Magnification - 50x

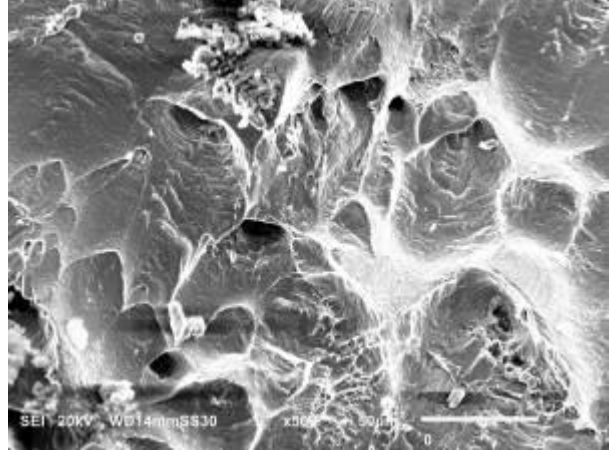
Figure 4.187: SEM micrograph of fractured stress rupture sample (SA - 1120 °C x 3 hrs + Age - 600 °C x 4 hrs); Original Magnification - 500x

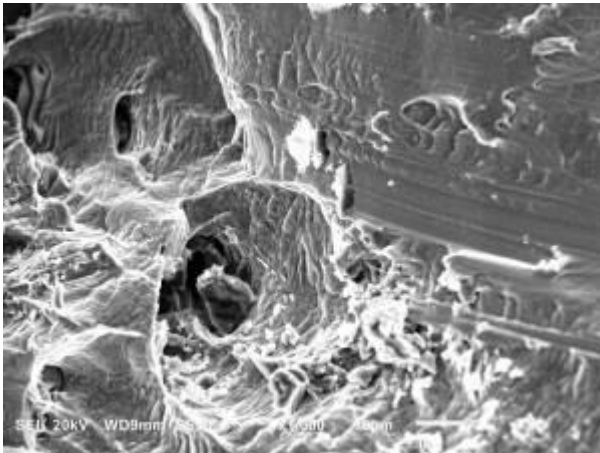
Figure 4.188: SEM micrograph of fractured stress rupture sample (SA - 1120 °C x 3 hrs + Age - 600 °C x 4 hrs); Original Magnification - 1000x

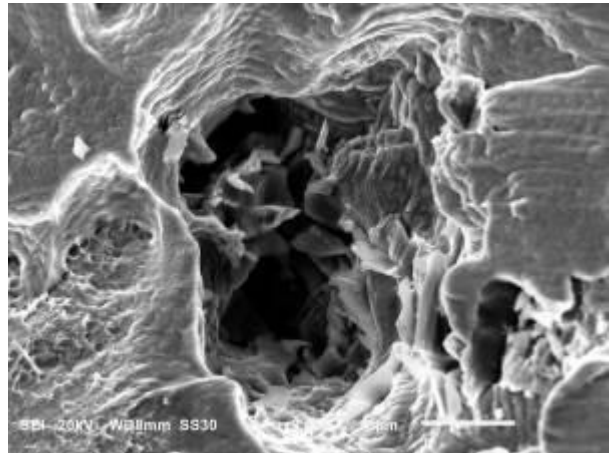
Figure 4.189: SEM micrograph of fractured stress rupture sample (SA - 1120 °C x 3 hrs + Age - 600 °C x 4 hrs); Original Magnification - 2000x

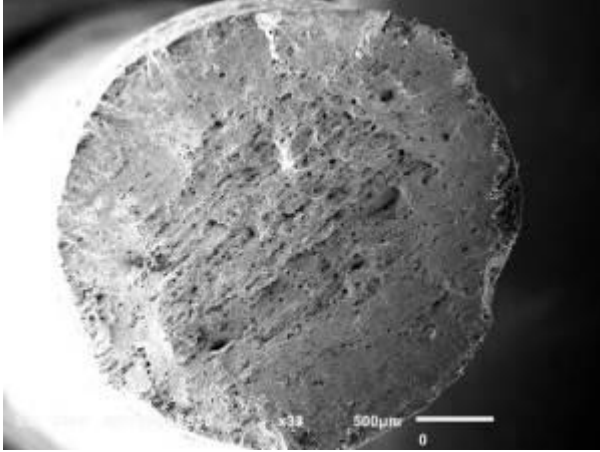
Figure 4.190: SEM micrograph of fractured tensile sample at 21 °C, (SA - 950 °C x 3 hrs + Age - 640 °C x 8 hrs); Original Magnification - 33x

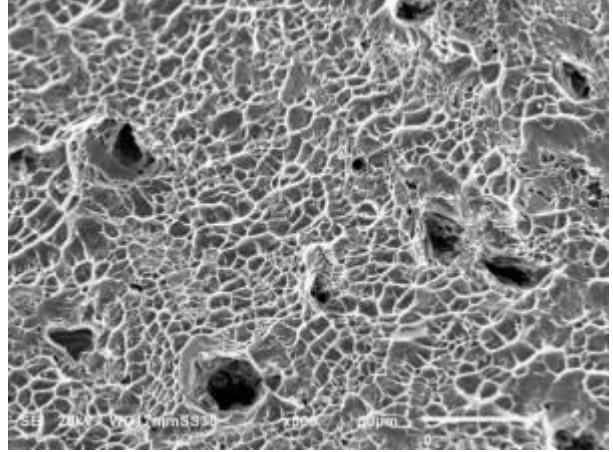
Figure 4.191: SEM micrograph of fractured tensile sample at 21 °C, (SA - 950 °C x 3 hrs + Age - 640 °C x 8 hrs); Original Magnification - 500x

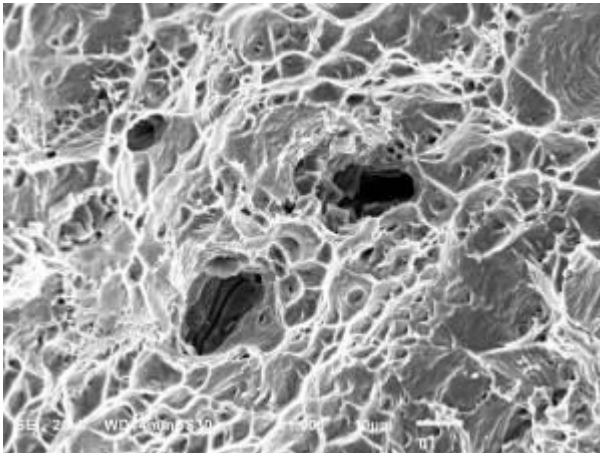
Figure 4.192: SEM micrograph of fractured tensile sample at 21 °C, (SA - 950 °C x 3 hrs + Age - 640 °C x 8 hrs); Original Magnification - 1000x

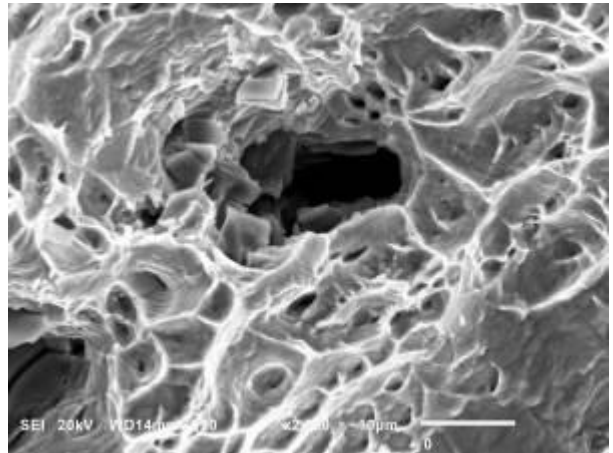
Figure 4.193: SEM micrograph of fractured tensile sample at 21 °C, (SA - 950 °C x 3 hrs + Age - 640 °C x 8 hrs); Original Magnification - 2000x

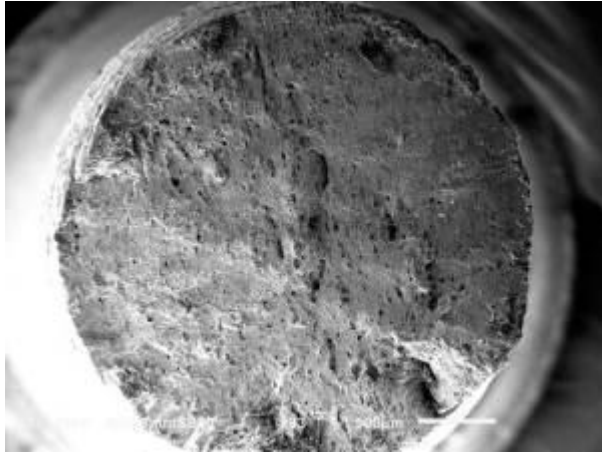
Figure 4.194: SEM micrograph of fractured tensile sample at 450 °C, (SA - 950 °C x 3 hrs + Age - 640 °C x 8 hrs); Original Magnification - 33x

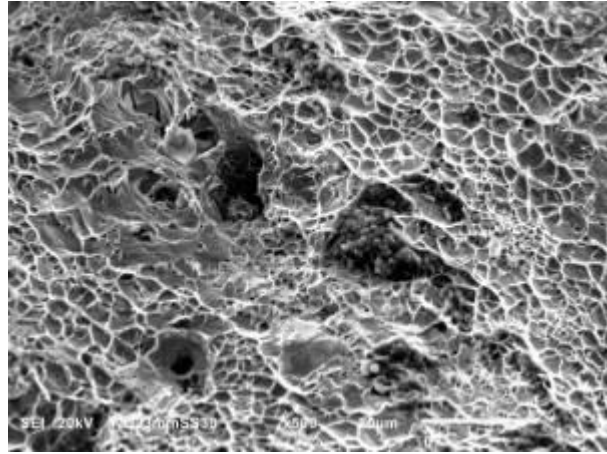
Figure 4.195: SEM micrograph of fractured tensile sample at 450 °C, (SA - 950 °C x 3 hrs + Age - 640 °C x 8 hrs); Original Magnification - 500x

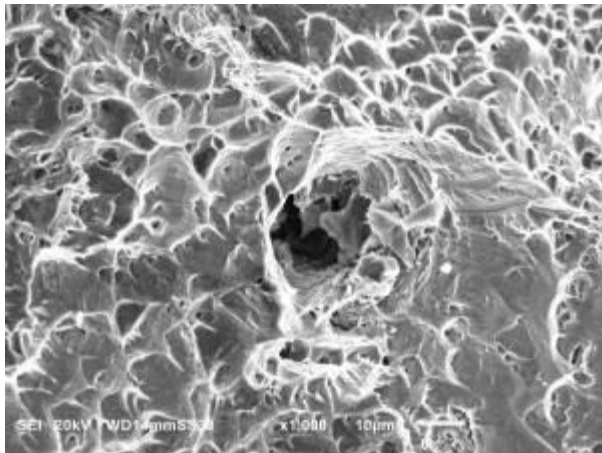
Figure 4.196: SEM micrograph of fractured tensile sample at 450 °C, (SA - 950 °C x 3 hrs + Age - 640 °C x 8 hrs); Original Magnification - 1000x

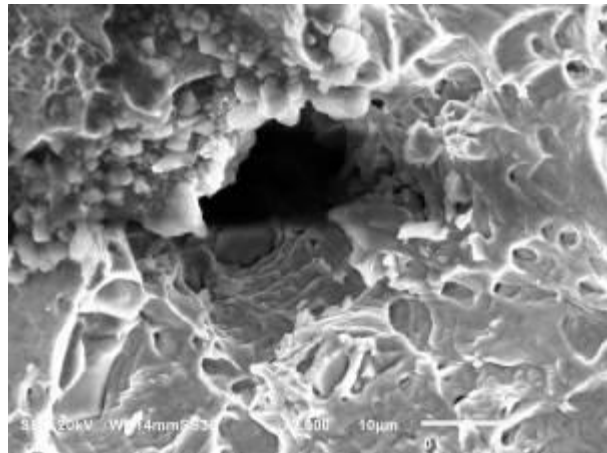
Figure 4.197: SEM micrograph of fractured tensile sample at 450 °C, (SA - 950 °C x 3 hrs + Age - 640 °C x 8 hrs); Original Magnification - 2000x

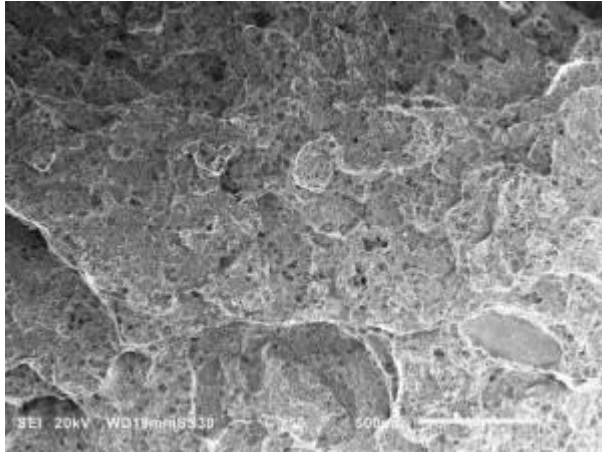
Figure 4.198: SEM micrograph of fractured charpy sample (SA - 950 °C x 3 hrs + Age - 640 °C x 8 hrs); Original Magnification - 50x

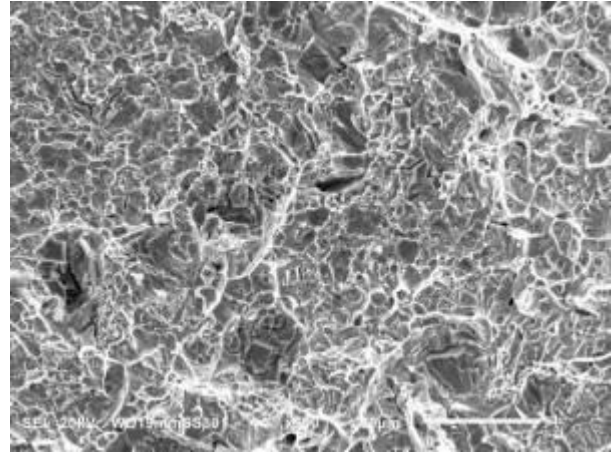
Figure 4.199: SEM micrograph of fractured charpy sample (SA - 950 °C x 3 hrs + Age - 640 °C x 8 hrs); Original Magnification - 500x

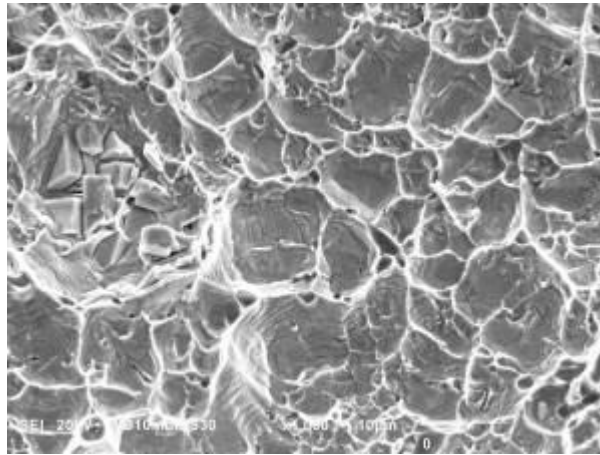
Figure 4.200: SEM micrograph of fractured charpy sample (SA - 950 °C x 3 hrs + Age - 640 °C x 8 hrs); Original Magnification - 1000x

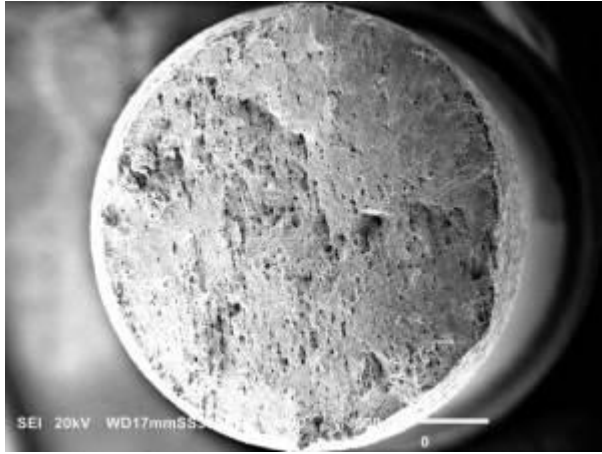
Figure 4.201: SEM micrograph of fractured tensile sample at 21 °C, (SA - 950 °C x 3 hrs + Age - 640 °C x 12 hrs); Original Magnification - 30x

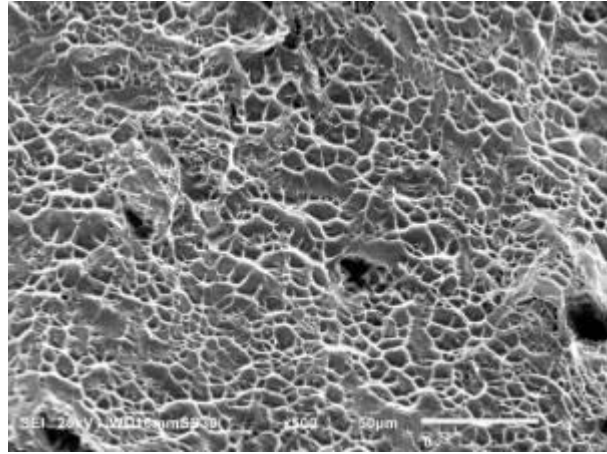
Figure 4.202: SEM micrograph of fractured tensile sample at 21 °C, (SA - 950 °C x 3 hrs + Age - 640 °C x 12 hrs); Original Magnification - 500x

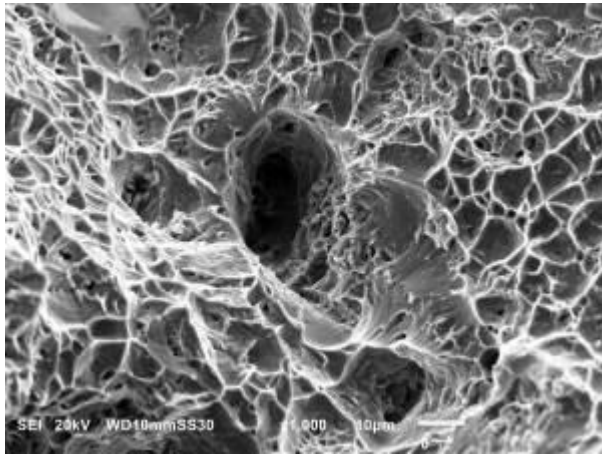
Figure 4.203: SEM micrograph of fractured tensile sample at 21 °C, (SA - 950 °C x 3 hrs + Age - 640 °C x 12 hrs); Original Magnification - 1000x

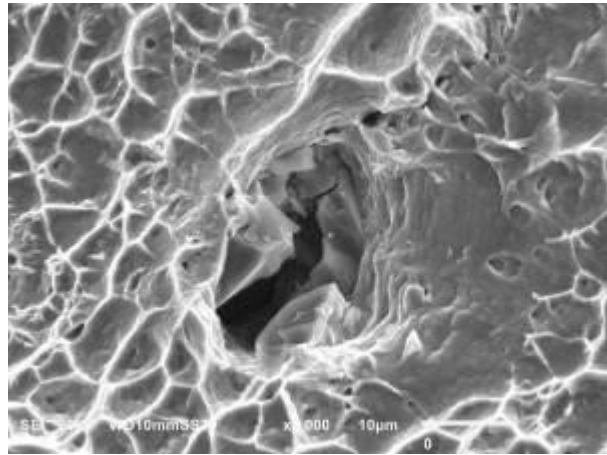
Figure 4.204: SEM micrograph of fractured tensile sample at 21 °C, (SA - 950 °C x 3 hrs + Age - 640 °C x 12 hrs); Original Magnification - 2000x

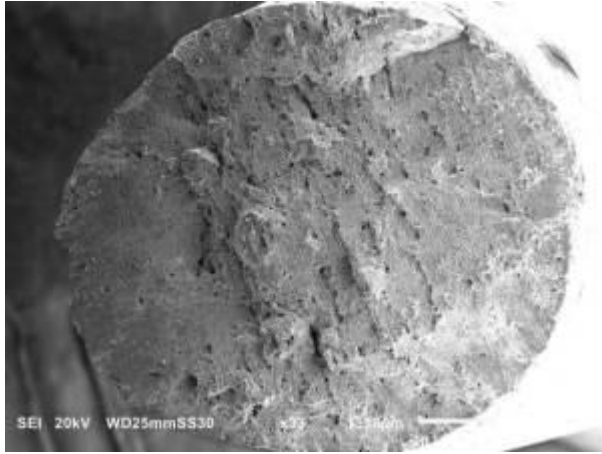
Figure 4.205: SEM micrograph of fractured tensile sample at 450 °C, (SA - 950 °C x 3 hrs + Age - 640 °C x 12 hrs); Original Magnification - 33x

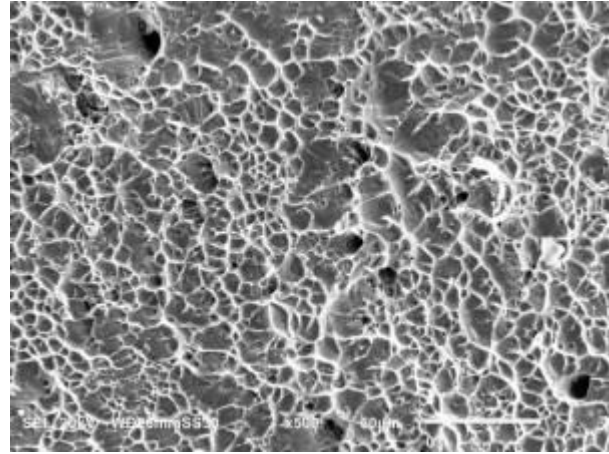
Figure 4.206: SEM micrograph of fractured tensile sample at 450 °C, (SA - 950 °C x 3 hrs + Age - 640 °C x 12 hrs); Original Magnification - 500x

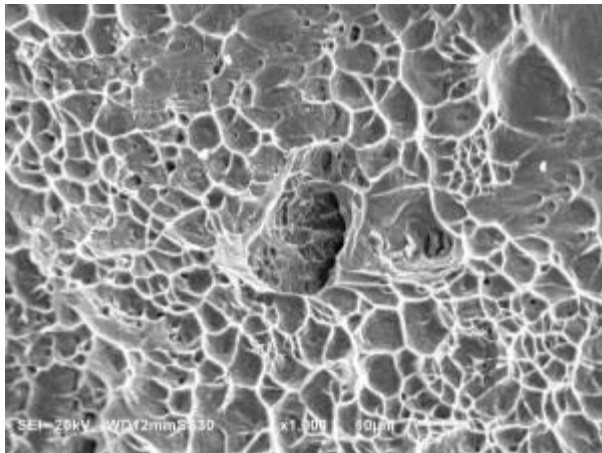
Figure 4.207: SEM micrograph of fractured tensile sample at 450 °C, (SA - 950 °C x 3 hrs + Age - 640 °C x 12 hrs); Original Magnification - 1000x

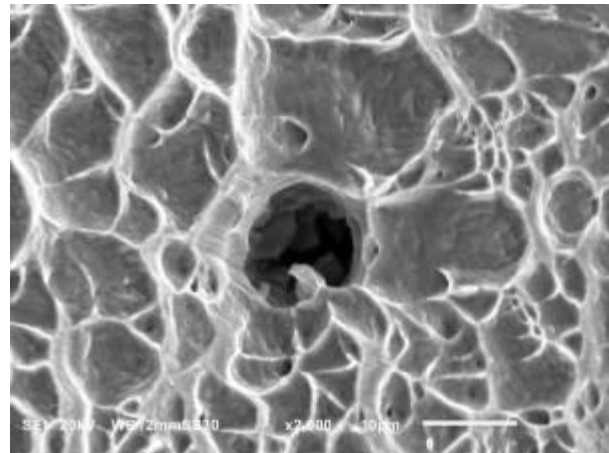
Figure 4.208: SEM micrograph of fractured tensile sample at 450 °C, (SA - 950 °C x 3 hrs + Age - 640 °C x 12 hrs); Original Magnification - 2000x

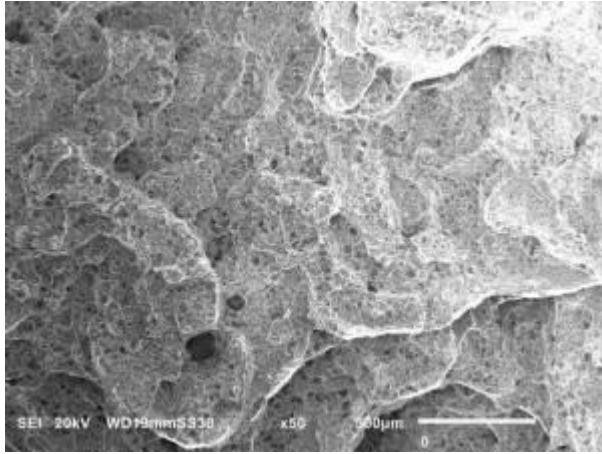
Figure 4.209: SEM micrograph of fractured charpy sample (SA - 950 °C x 3 hrs + Age - 640 °C x 12 hrs); Original Magnification - 50x

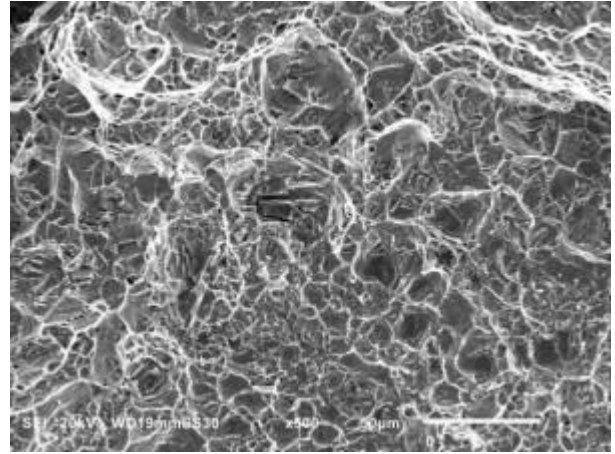
Figure 4.210: SEM micrograph of fractured charpy sample (SA - 950 °C x 3 hrs + Age - 640 °C x 12 hrs); Original Magnification - 500x

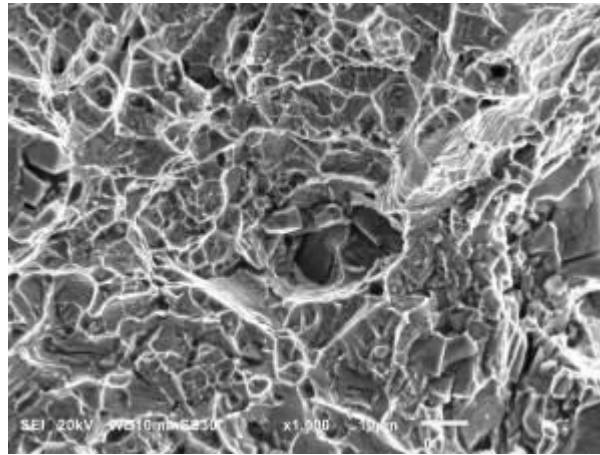
Figure 4.211: SEM micrograph of fractured charpy sample (SA - 950 °C x 3 hrs + Age - 640 °C x 12 hrs); Original Magnification - 1000x

The fractured surfaces of the tensile and Charpy specimens, exhibits dimpled and quasi-cleavage fracture morphology respectively. While, the tensile fractured samples predominately exhibits dimpled fracture, the Charpy fractured surfaces exhibited a mixed mode of dimple and cleavage.

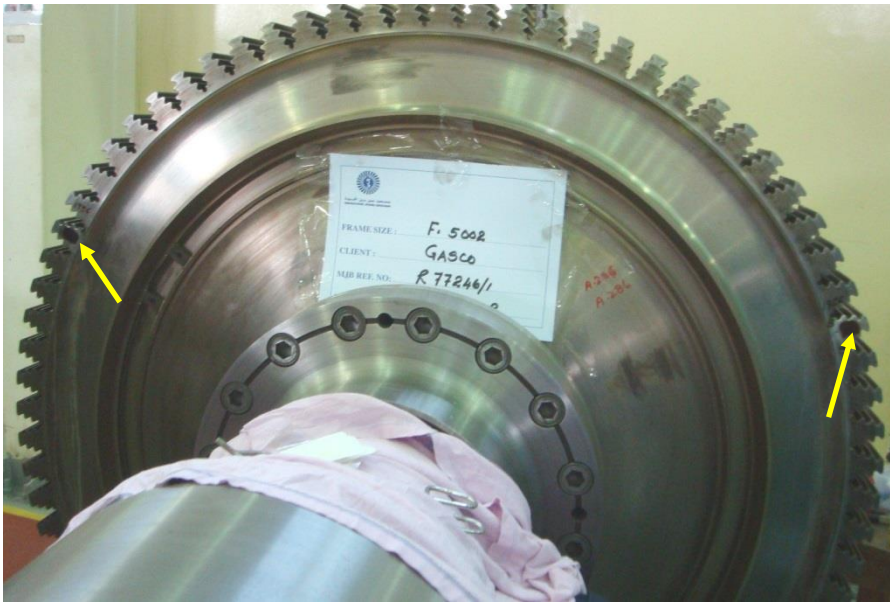
Figure 5.1: Replication Locations at Dove Tail areas shown by arrows

the wheel did not reveal any flaws. Replica metallography, a widely accepted non-destructive technique to assess the life of aged components was performed on the turbine wheel in the assembled condition at four different locations to examine the microstructure [219]. The replica locations are shown in Figures 5.1 and 5.2.

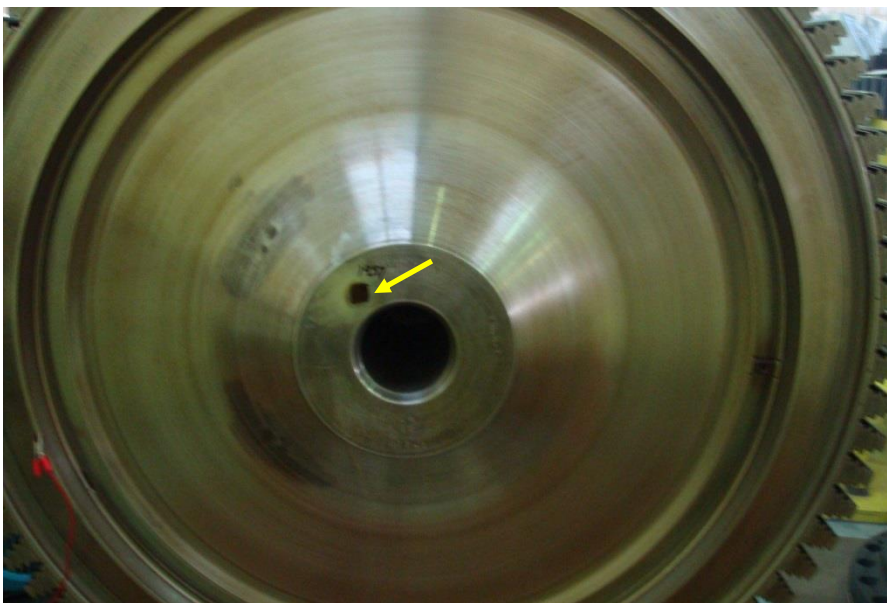
Figure 5.2: Replication Location at the Bore area shown by arrow

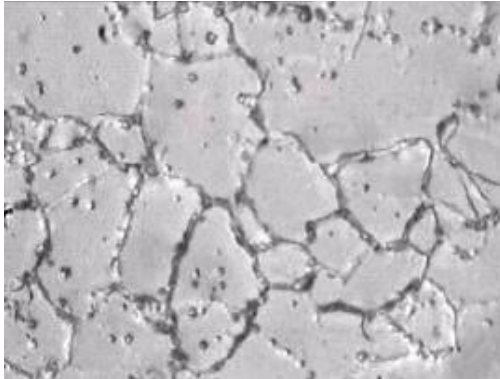
Figure 5.3: Micrograph of the replica at bore area showing carbide precipitation; Original Magnification – 500x

The replica evaluation of the A-286 turbine wheel at the dovetail area and the bore area revealed significant amounts of carbide precipitation, primarily along the grain boundaries. The representative optical microscope micrographs and scanning electron micrograph showing carbide precipitation are shown in Figure 5.3 and Figure 5.4

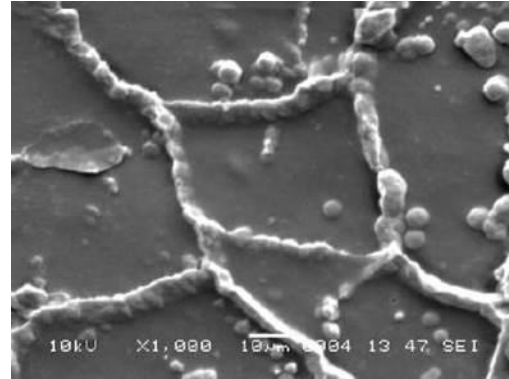
Figure 5.4: SEM micrograph of replica at the dove tail area showing significant carbide precipitation; Original Magnification – 1000x

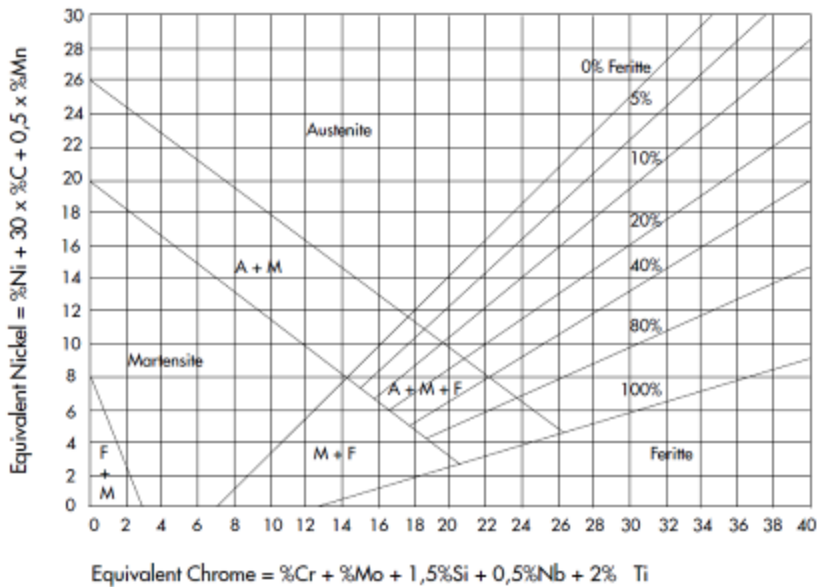
Figure 5.5: Schaeffler diagram for A-286 alloy

This particular Schaeffler diagram displays the limits of phases such as austenite, ferrite and martensite in relation to the chromium and nickel equivalent. The chromium and nickel equivalent is calculated by the equations below:

In order to get an idea of the initial microstructure by the chemical constituents, the Schaeffler Diagram was used. The Schaeffler diagram represents the effect of the composition of the alloy and proportion of two elements on the microstructure after heat treatments [227]. The Schaeffler diagram for an A-286 alloy is shown in Figure 5.5.

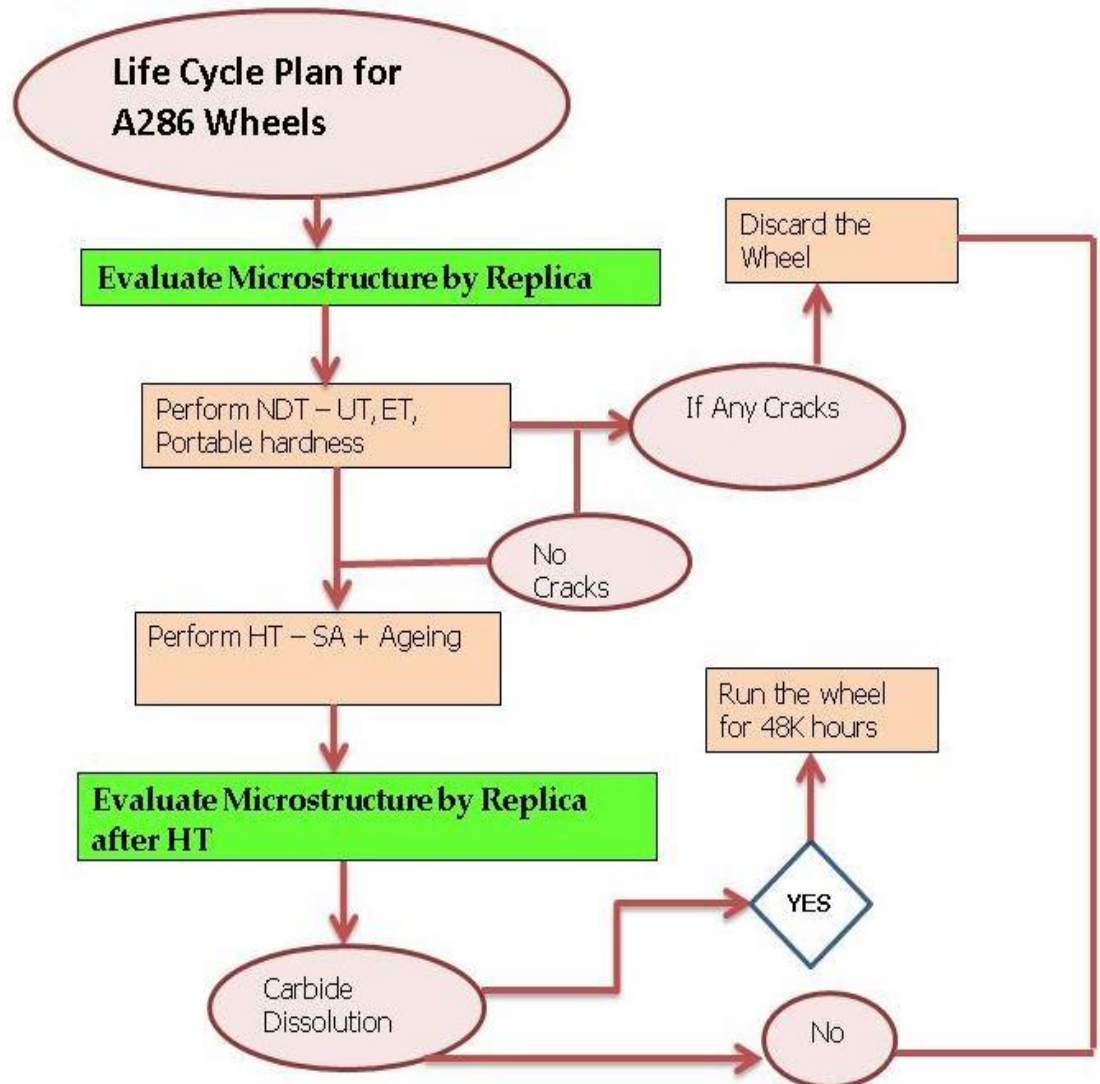
Figure 6.1: Life Cycle Management of Turbine Wheel - Flow Chart

4. In case, the microstructure displays evidence of significant grain boundary carbide precipitation, solution annealing and ageing heat treatment should be performed on the turbine wheel. To assure, the carbides have dissolved in solid solution matrix replica metallography needs to be performed on the turbine wheel after solution annealing and heat treatment.
5. If carbide dissolution is to satisfactory extent after rejuvenation heat treatment, the wheel can be continued further in service.
6. The turbine wheel can be in service until another inspection cycle, which is normally 48,000 hours.
7. On completion of the 48,000 hours, the turbine wheel needs to be inspected for any cracks and carbide precipitation.

The life cycle management flow chart for the turbine wheel is presented in Figure 6.1.
